**6364 SUBSIDENCE REPORT
30 ELSWORTHY ROAD,
LONDON, NW3 3DL
03.11.2023**

**ARBORICULTURAL ASSESSMENT OF TREES
IN RELATION TO ALLEGED SUBSIDENCE**

PROPERTY ADDRESS: 30 ELSWORTHY ROAD
LONDON
NW3 3DL

DATE OF REPORT: 3rd NOVEMBER 2023

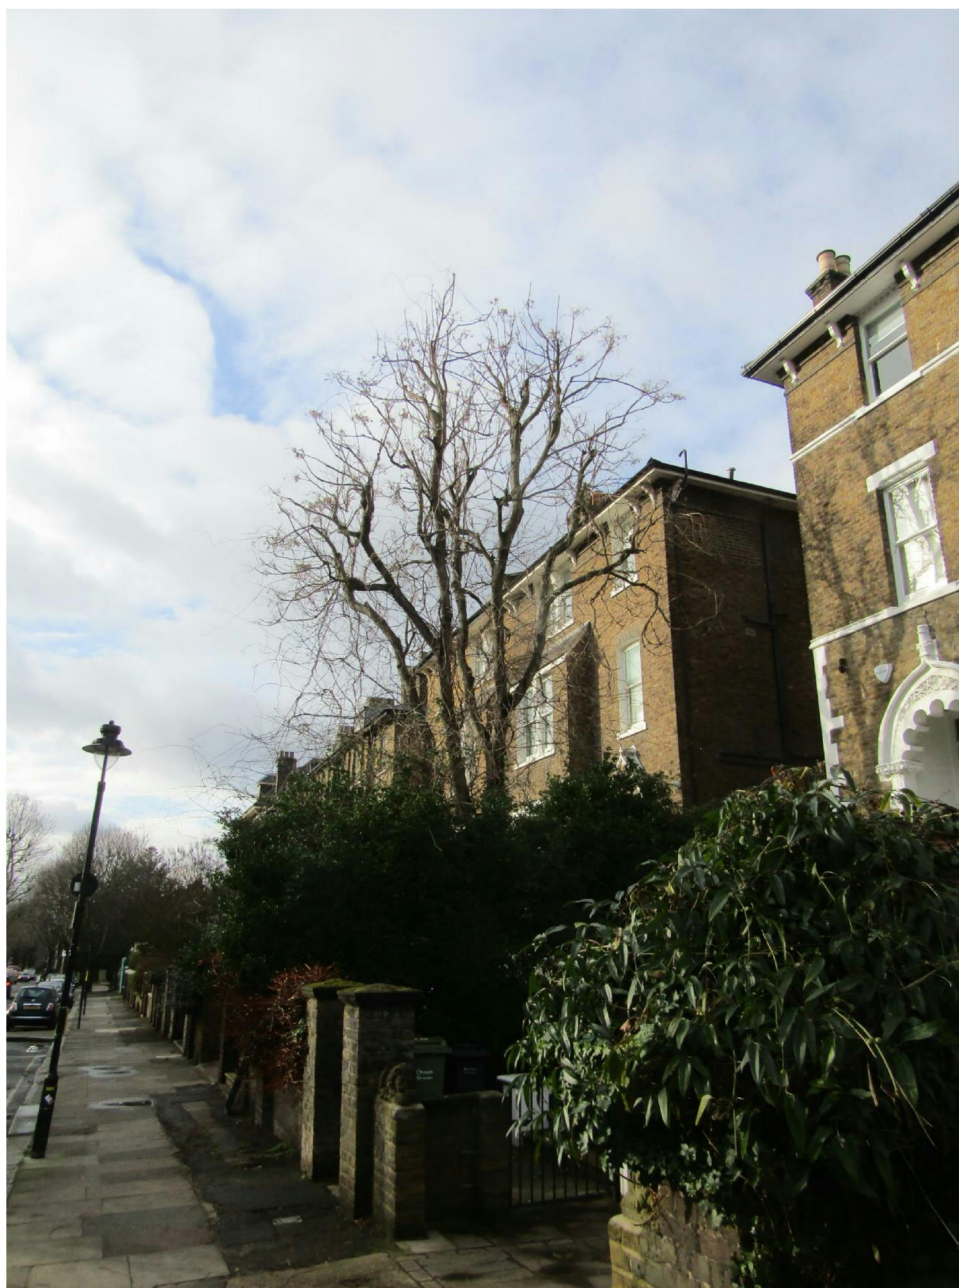
- 5.3 The site investigations identified highly shrinkable Clay based soils with desiccation present to depth. Roots were also noted in all locations up to 3m depth with samples from TP1 and TP2 indicating T2 Tree of Heaven to have roots present well below foundation depths. This is the largest tree present and the most likely source of soil drying, contributed to by the surrounding large shrubs. Their proximity to the steps will represent significant localised soil drying, sufficient to cause a subsidence event.

- 5.4 The Tree of Heaven has been crown raised in the past and canopy reduced on at least several occasions. This will have controlled overall moisture demands to an extent but the restricted growing conditions and proximity of the steps in particular mean that it is inappropriately large for the situation. The surrounding shrubs have developed considerably over the years and the Himalayan Cotoneaster (T1) in particular is over dominant of the relatively small planting bed. It is assumed this has been allowed to develop to such dimensions to provide year round screening.

T2 Tree of Heaven with T1 beneath to right and shrubs G3 to left, viewed from east. Note previous reduction points in canopy.

Tree No.	Species	Works recommended
T1	Himalayan Cotoneaster	Fell to ground level. Grind out or poison stumps to prevent regrowth.
T2	Tree of Heaven	Fell to ground level. Grind out or poison stump to prevent regrowth.
G3	Escallonia	Maintain at maximum 2m height and 2m radial spread.
-	Castor Oil	Maintain at current dimensions.
-	Large Climber	Fell to ground level and grind out or poison stumps to prevent regrowth.

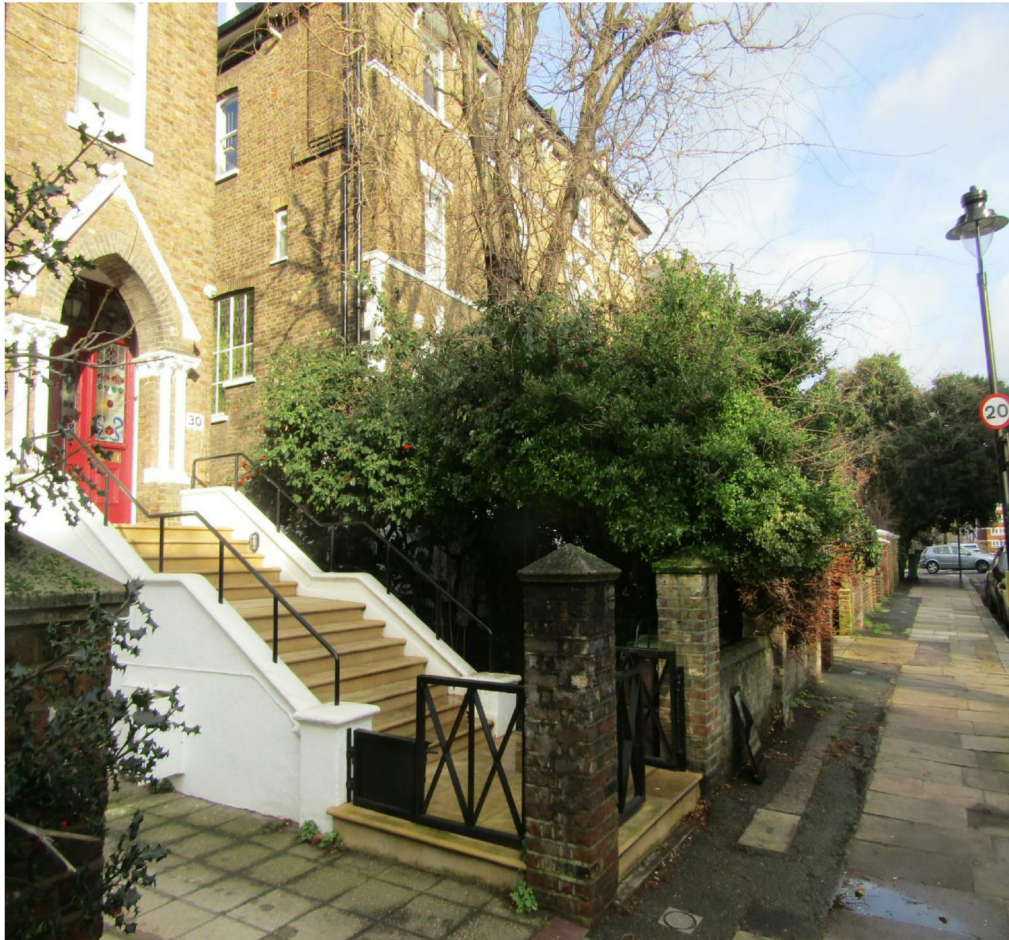
View from west of T2 Tree of Heaven (centre)
with T1 to left and G3 to right.

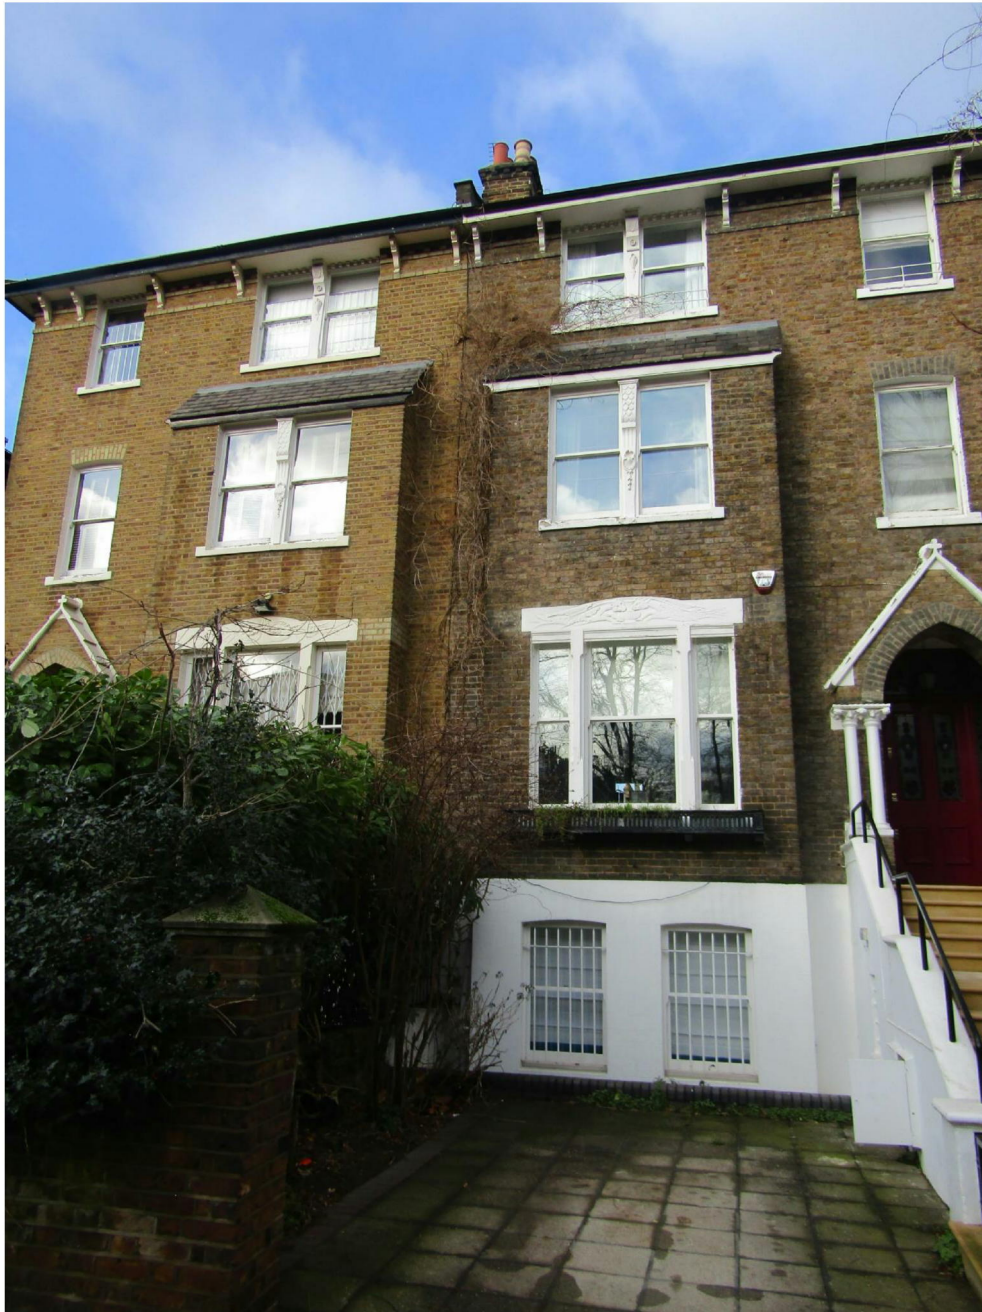
- 5.5 To the west side the shrub/tree presence is more limited with the dominant vegetation located in the garden of No. 32. Cracking to the boundary wall is likely a combination effect of the shrubs and various Laurels, together with the root system of the large climber on the front of the building. This will have a considerable moisture demand not just due to its foliar area but due to additional evapotranspiration occurring due to the solar heating of the brickwork. This represents a concentrated drying influence close to the wall and front of No. 30 and 32 with associated subsidence risks.

View of western boundary between No's 30 and 32 to show extent of climber on house.

- 5.10 For the large climber on the building no notification to the Council would be necessary as this would not be covered by the Conservation Area Regulations.

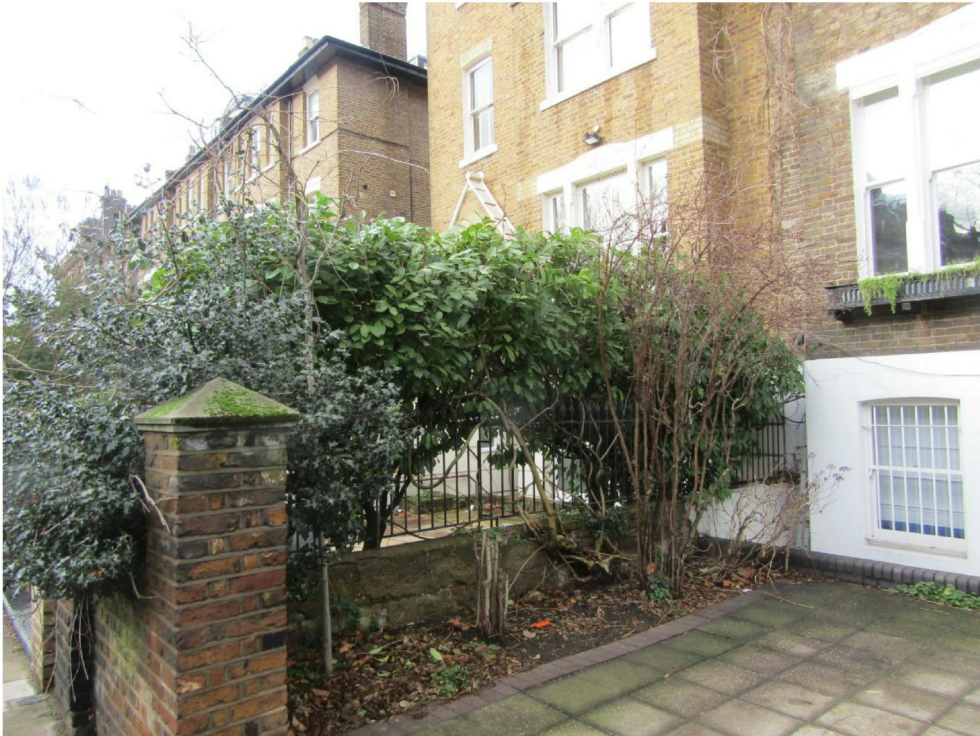
View of vegetation along western boundary with G4 Cherry Laurel in adjoining garden.

Tree No.	Species	Works recommended
G4	Cherry Laurel	Fell to ground level. Grind out or poison stumps to prevent regrowth.
-	Spotted Laurel	Fell to ground level. Grind out or poison stumps to prevent regrowth.
-	3m Shrub	Fell to ground level. Grind out or poison stumps to prevent regrowth.
