project  
**Brookfield Primary**  
**School Chester Rd**  
**London**  
**N19 5DH**

drawing name  
**elevations remedial works**

scale (@ A1)	date	drawn
1:100	07/08/2023	YB
drawing number		rev
2011_313		A

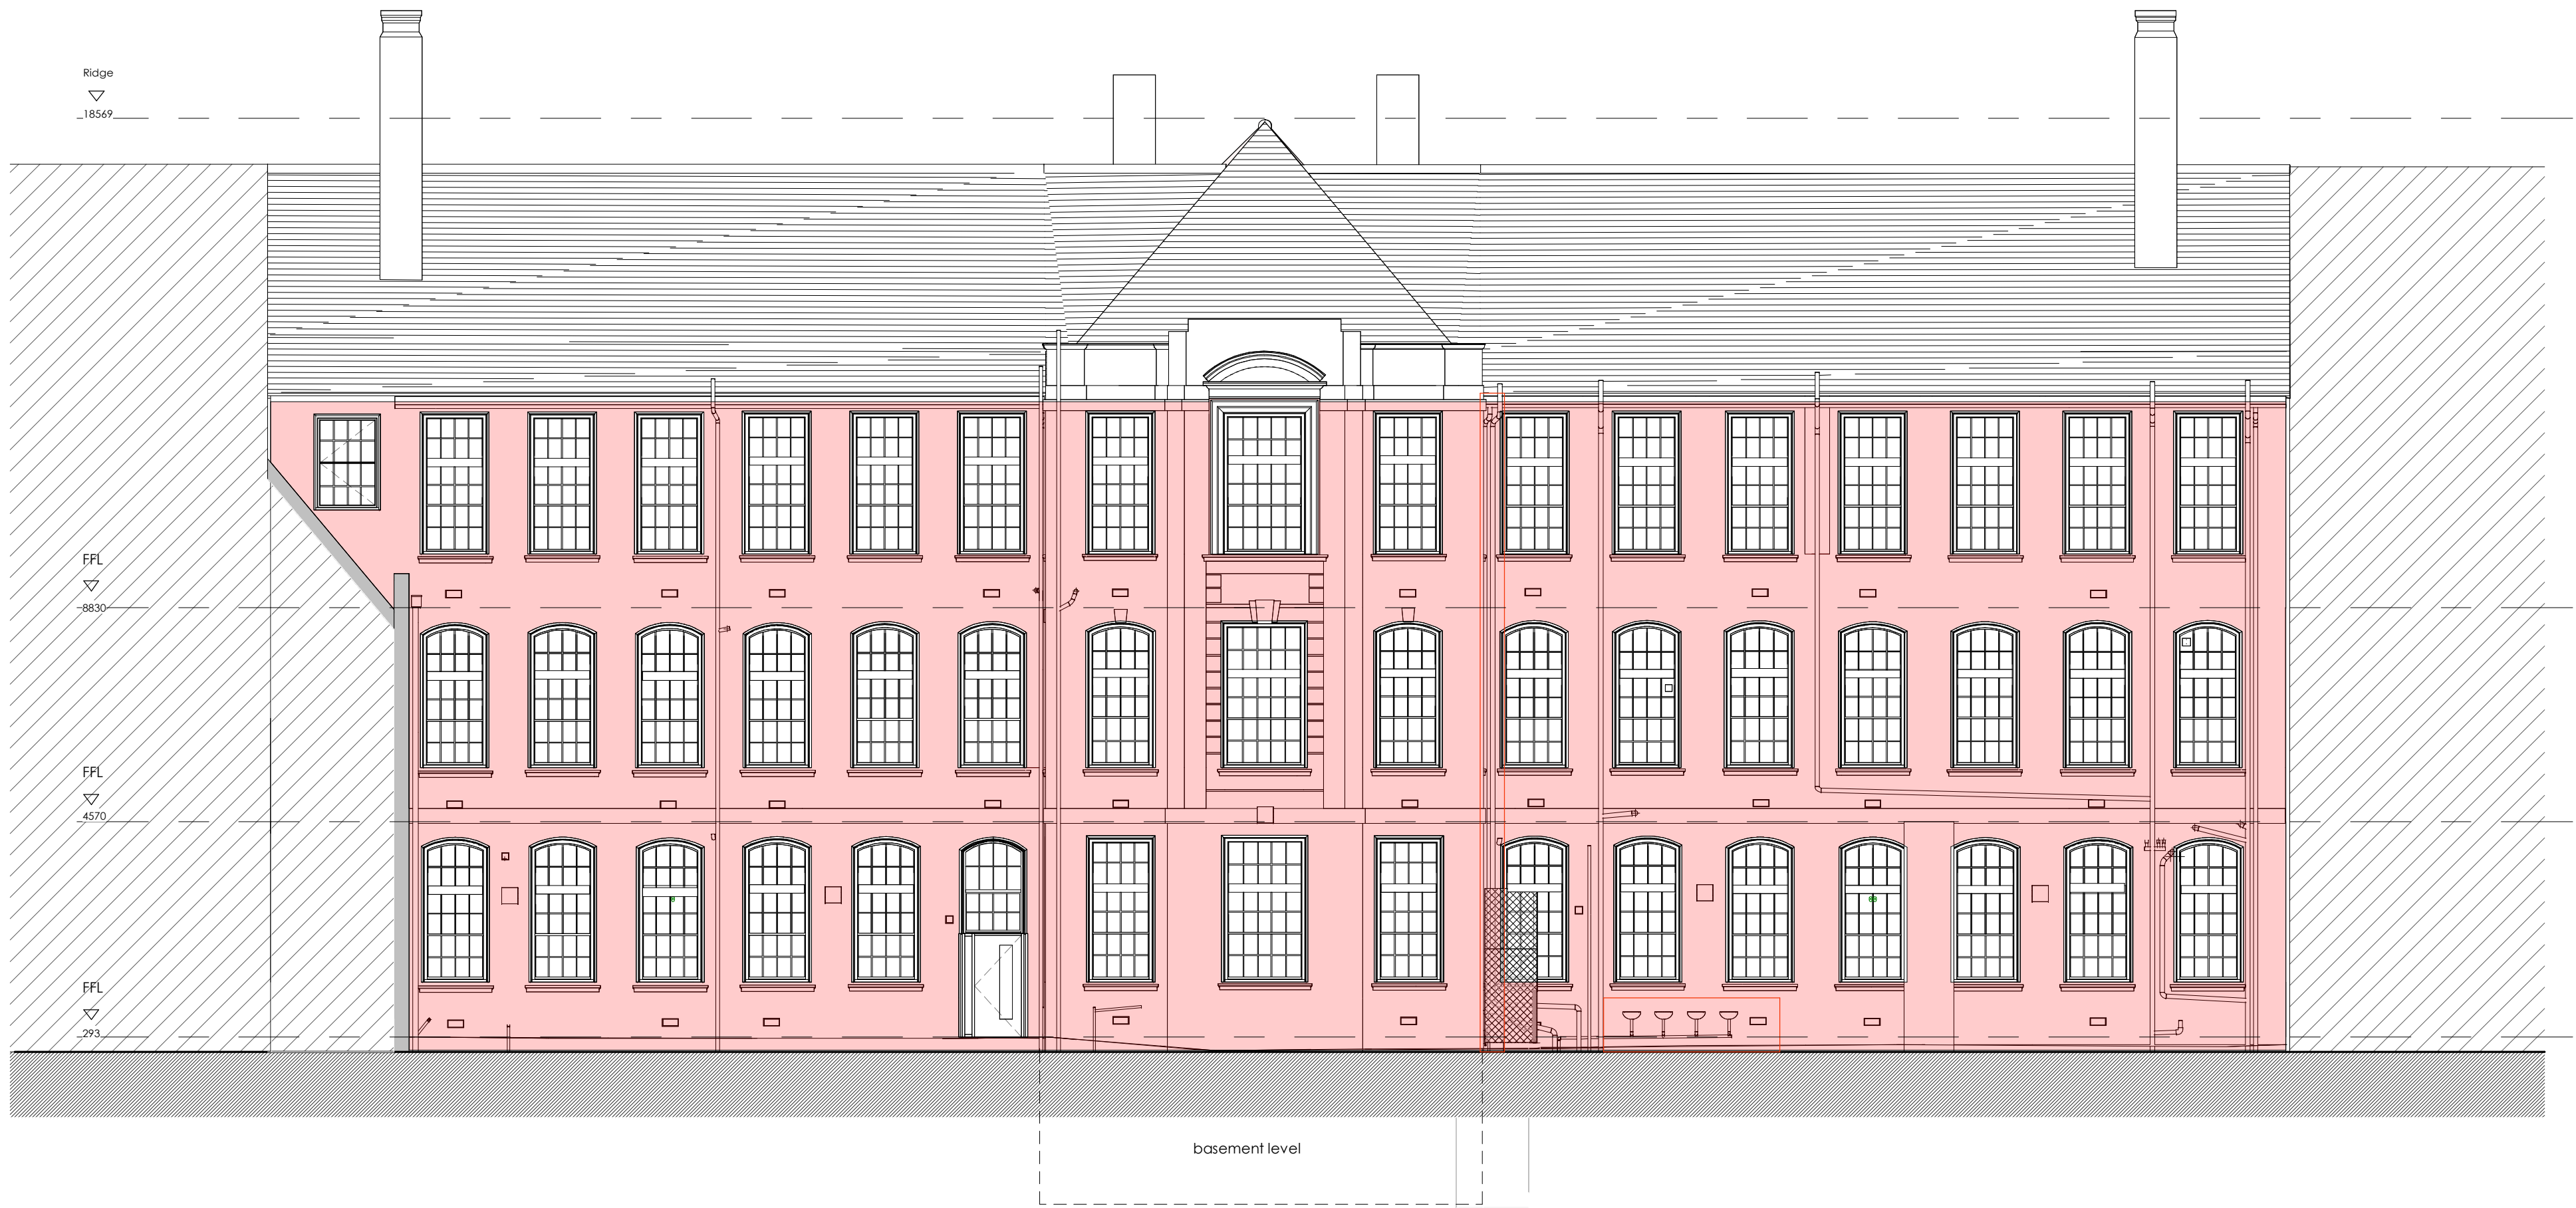
south west elevation (A) - **repair & maintenance works**

repair and maintenance works	
general	condition report
	identified that brickwork / mortar joints have been subject to previous repairs to a poor standard (cement based mortars used for repainting - to be hacked out and repointed with lime based mortar)
	numerous redundant service penetrations have not been adequately filled / sealed. Where penetration through wall exceeds 10mm diameter, to be filled with appropriate material (brick / mortar joint)
	significant moss growth identified around down pipes to south west elevation (AOF-138)
	efflorescence identified to brickwork around drinking fountains and associated services (outside A-OF-140) - all pipework to be tested / checked for leaks and repaired where necessary
