S1278-J2-R1

REPORT

on selected trees at

35 Templewood Avenue, London, NW3 7UY

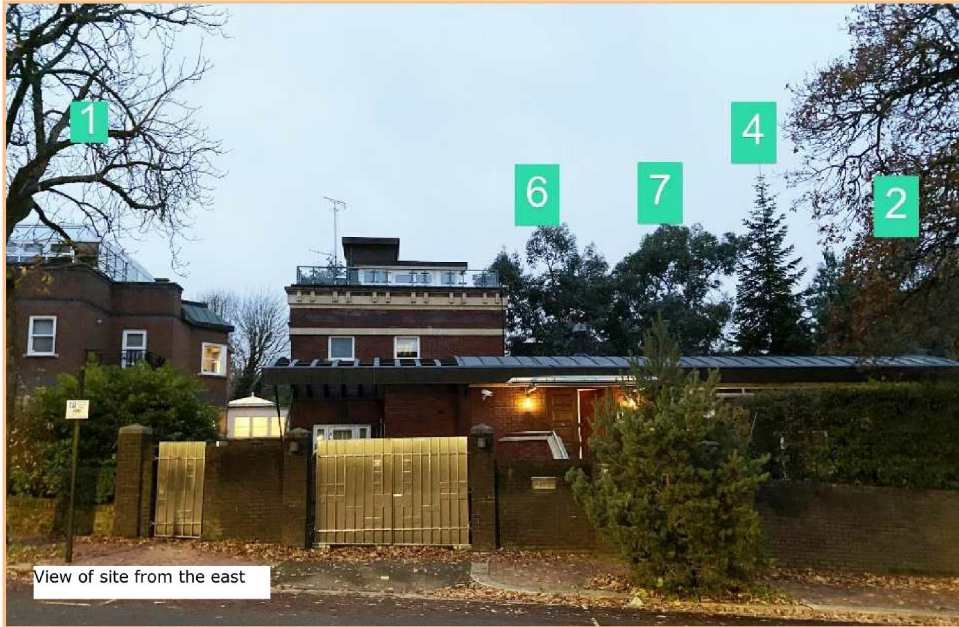
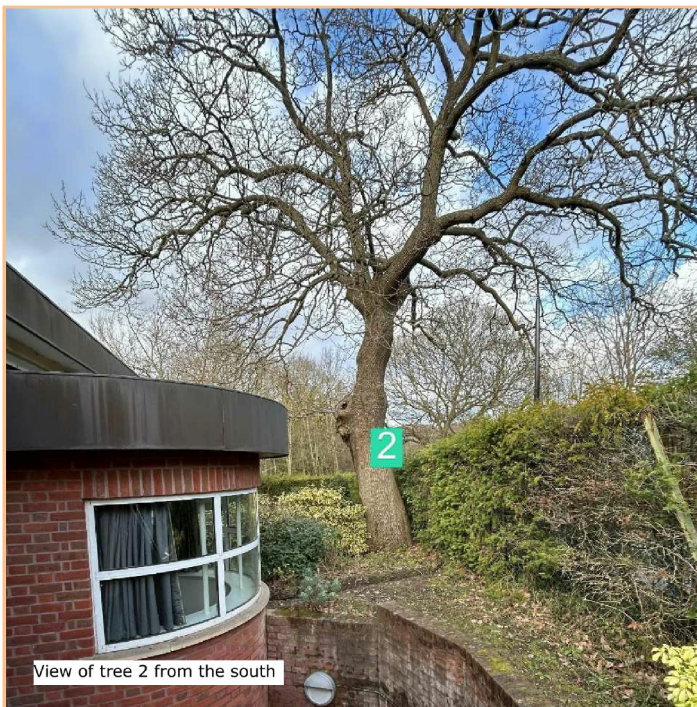
Tree number	Tree type	Height (m)	Stem diameters (mm)	Comments	Age class	Condition summary	Heritage assessment	Landscape contribution
1	horse chestnut	12	600	Street tree.	mature	fair	low	medium
2	English oak TPO	12.5	822	Small cavity where a large branch was removed on the western side of the tree at about 3m above ground level. A tap test directly below the cavity opening somewhat abnormal indicating an internal cavity. Tap test at based slightly abnormal probably relating to historic root cutting for the construction of the current building. Pruning to the proposed crown line indicated on plan would entail cuts of no more than 100mm diameter; pruning to suitable side growth not less than one-third of the diameter of the parent branch would be aesthetically pleasing and in accordance with BS3998:2010.	young mature	fair	medium	medium

Tree number	Tree type	Height (m)	Stem diameters (mm)	Comments	Age class	Condition summary	Heritage assessment	Landscape contribution
3	London plane	12	850	Subjected to typical street tree pruning with some heavy removal of limbs over the carriageway; no aesthetic or arboricultural reason not to cut crown back to about 1.5m of the boundary, on the south side only.	young mature	good	low	medium
4	fir	12.5	260	Good form. Potential for considerable growth. Rather restricted root run due to hard structures nearby	young mature	good	low	medium
5	Gleditsia triacanthos	5	140	Very degraded; extremely poor form	young	poor	low	low
6	gum	9	325	Etiolated; dominated by 7. Trunk defects at both 1.7m above ground level and at about 8m	young	poor	low	low
7	gum	15	604	Large sprawling tree of extremely poor form dominating the garden; makes some contribution to the Conservation Area but has uncompleted windthrow and must be considered unstable, as is fairly typical of gums in the UK.	young mature	poor	low	low

Tree number	Tree type	Height (m)	Stem diameters (mm)	Comments
2	English oak TPO	12.5	822	Prune to the proposed crown line indicated on plan would entail cuts of no more than 100mm diameter; prune to suitable side growth not less than one-third of the diameter of the parent branch.
3	London plane	12	850	Prune back on the south side only to an overhang over the site of not less than 1.5m.
5	Gleditsia triacanthos	5	140	Remove including stump.
6	gum	9	325	Remove including stump.
7	gum	15	604	Remove including stump.

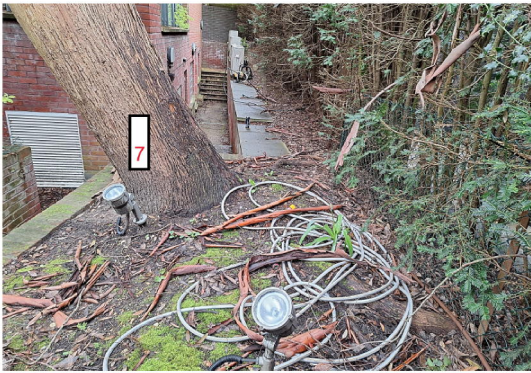
Base of tree 7 showing uncompleted windthrow
