## Addendum Arboricultural Report

### Subsidence Damage Investigation at:

73 Aberdare Gardens  
London  
NW6 3AN

CLIENT:	Davies Group Ltd
CLIENT REF:	[REDACTED]
MWA REF:	SUB200414-7073Rev01
MWA CONSULTANT:	Andy Clark
REPORT DATE:	07/10/2020

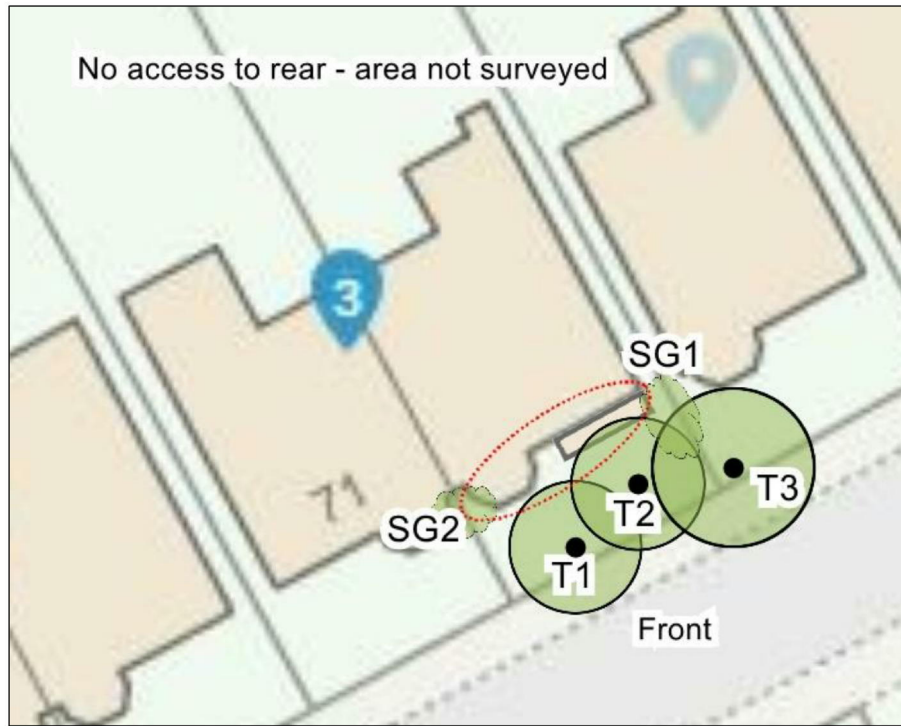
Site Plan

Approximate areas of damage

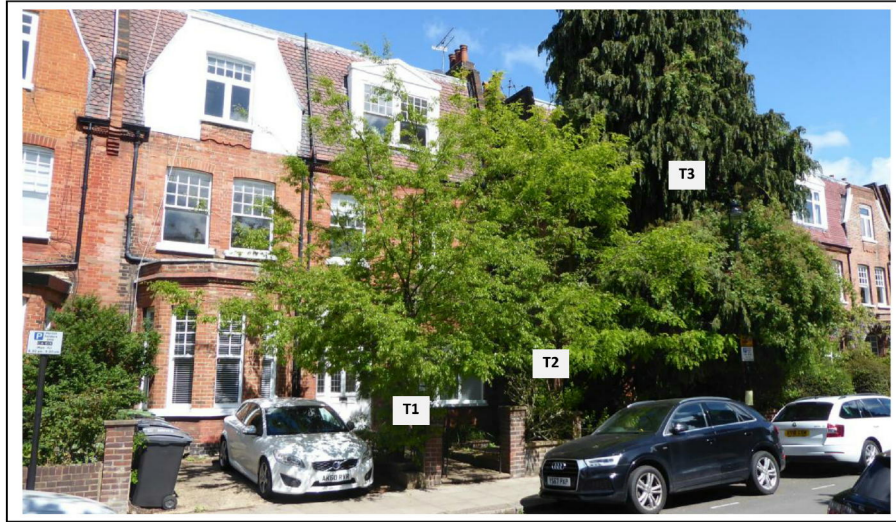
Our survey has previously identified vegetation within influencing distance of the building with a current potential to influence soil volumes below foundation level, the most significant of which in relation to the current damage were identified as T1 Oak [Quercus spp.], T2 False Acacia [Leguminosae spp.] and T3 Cypress [Cupressaceae spp.]. A potential for localised influence from SG1 and SG2 Privet groups [Oleaceae spp.] was also identified. The presence of corresponding roots samples retrieved from below the property foundations now confirms the influence of the related vegetation.

Overview of T1 Oak, T2 False Acacia and T3 Cypress

If an arboricultural solution is to be implemented to mitigate the influence of the trees/shrubs considered to be responsible for the damage we recommend that T1 Oak, T2 False Acacia, T3 Cypress are removed and that SG1 and SG2 Privet groups are reduced.

Tree No.	Species	Ht (m)	Dia (mm)	Crown Spread (m)	Dist. to building (m)	Age Classification	Ownership
T1	Oak	8.0	150	7.0	4.3	Younger than Property	Policy Holder
Management history		No significant past management noted.					
Recommendation		Remove (fell) to near ground level and treat stump to inhibit regrowth.					
T2	False Acacia	8.0	160	5.5	3.8	Younger than Property	Policy Holder
Management history		No significant past management noted.					
Recommendation		Remove (fell) to near ground level and treat stump to inhibit regrowth.					
T3	Cypress with climbing shrub throughout	16.0	420 *	5.0	4.1	Younger than Property	Third Party: 75 Abdare Gdns, NW6 3AN
Management history		No significant past management noted.					
Recommendation		Remove (fell) to near ground level and treat stump to inhibit regrowth.					
SG1	Privet	3.0	30 Ms *	2.5	1.4	Younger than Property	Policy Holder
Management history		Subject to past management/pruning - appears regularly trimmed.

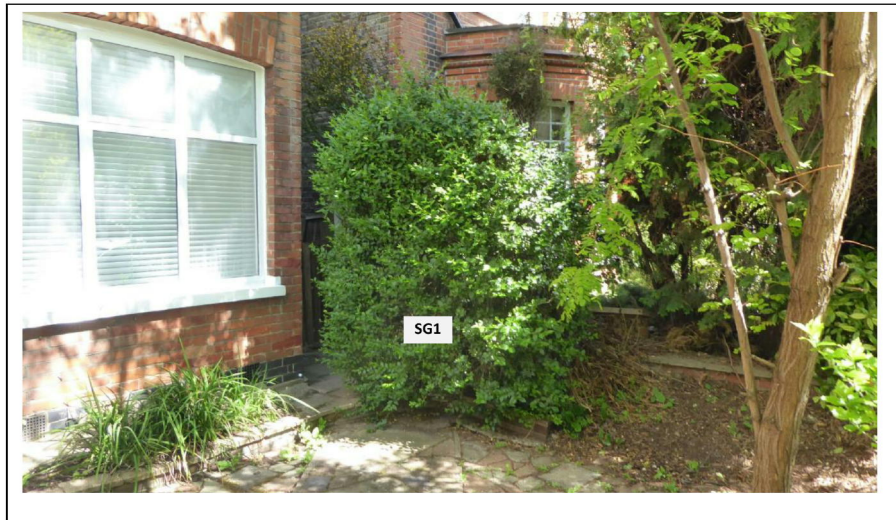
View of SG1 Privet

Recommendation		Reduce to ~2.0m height and prune annually to maintain at reduced size.					
SG2	Privet	3.5	30	2.5	0.8 *	Younger than Property	Policy Holder
Management history		No significant past management noted.					
Recommendation		Reduce to ~2.0m height and prune annually to maintain at reduced size.

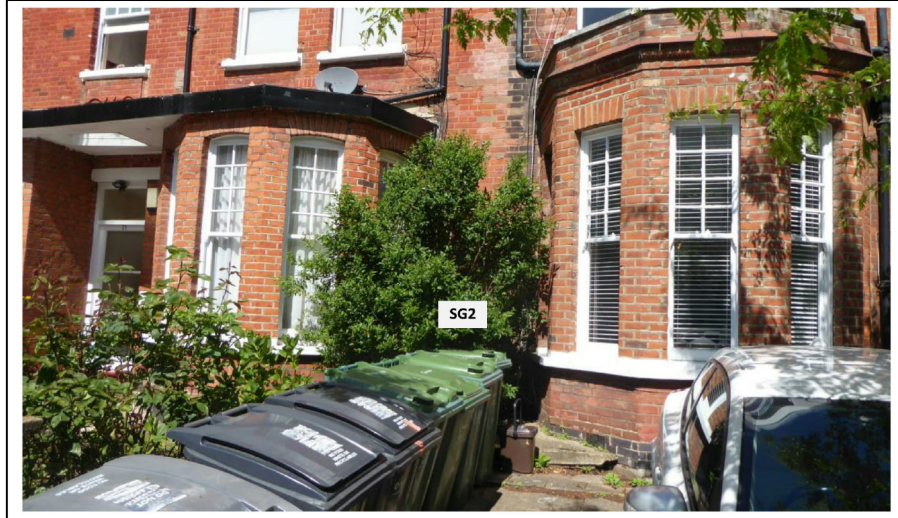
View of SG2 Privet
