Arboricultural Consultancy for Aviva - Commercial

Insured		Address	33 Belsize Park, London, NW3 4DX		
Client	Subsidence Management Services	Contact		Claim No.	
ES Ref		Consultant		Contact No.	
Report Date	06/04/2023 Revised: 02/11/2023

Scope of Report: To survey the property and determine significant vegetation contributing to subsidence damage, make recommendation for remedial action and assess initial mitigation and recovery prospects. The survey does not make an assessment for decay or hazard evaluation. This is a revised report updating management advice based on a review of recent site investigations.

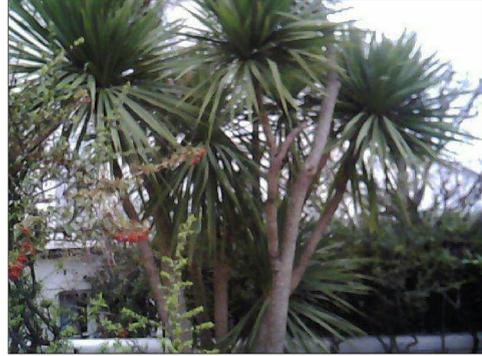
T2 - Cordyline

However, whilst not positively implicated by root analysis, the Cordyline (T2) cannot be discounted as contributing to the overall level of soil drying proximate to the area of damage and is therefore also considered to retain a contributory influence, albeit in a limited / secondary capacity when compared to the above.

Consequently, we have advocated the complete removal of H4, T2 and T3 as it will offer the most certain arboricultural solution likely to restore long-term stability.

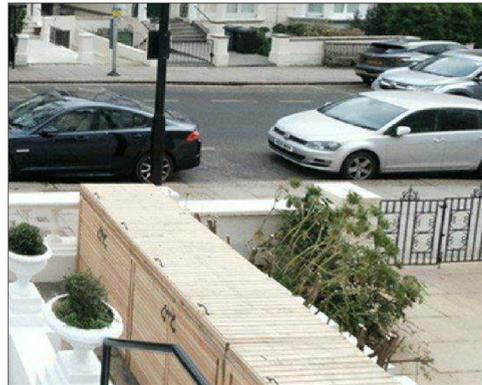
H4 - Privet (recently reduced)

Samples of the roots recovered from underside of foundations have been identified (using anatomical analysis) as having emanated from the genera Acer spp. & Ligustrum spp.

Our survey of the site identified T3 (Maple) and H4 (Privet) which, in our opinion, will be the source of the Acer spp. & Ligustrum spp. roots recovered, and as such we have identified them as the primary cause of the current movement / damage.

Tree No.	Species	Age Cat	Approx. Height (m)	Distance to Building (m) *	Ownership	Action	Requirement
H4	Privet	1	3.2	2	C - Insured	Maintain as detailed	Remove unpruned section (house side of bin store (see site plan) close to ground level; do not treat stumps due to translocation risk. Where such a risk exists, we advise that any emergent regrowth is removed annually. Maintain pruned section (to rear of storage bins) at reduced dimensions by re-pruning back to points of previous reduction on a 2 year (max) cycle.
T2	Cordyline	1	4	3.5	C - Insured	Remove	Remove close to ground level and treat stump to inhibit regrowth.
T3	Maple	1	5	7	A - Third Party	Remove	Remove close to ground level and treat stump to inhibit regrowth.
