CFBL WINDOW REPAIRS: DESIGN & ACCESS STATEMENT & HERITAGE IMPACT ASSESSMENT.

87 Holmes Road, Kentish Town, London NW5
3AX

LISTED BUILDING APPLICATION EXISTING WINDOW REPAIRS

Repairs to selected existing windows at CFBL & proposals for their repair in 2024.

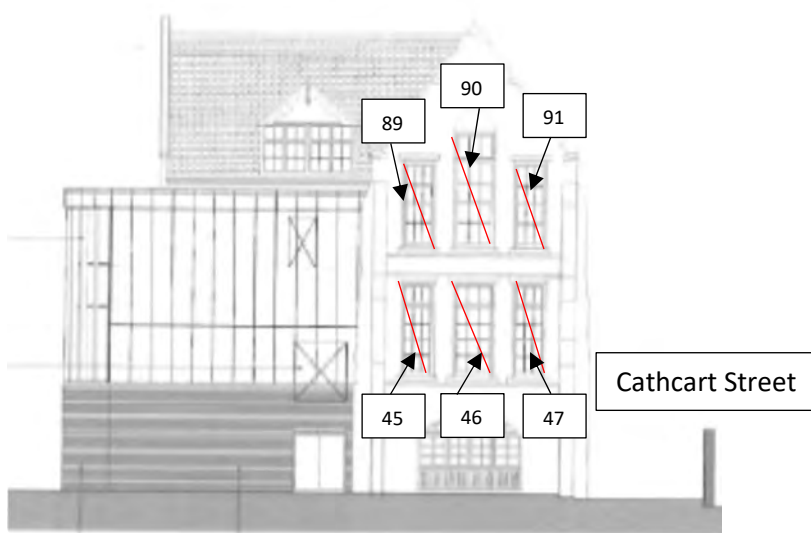
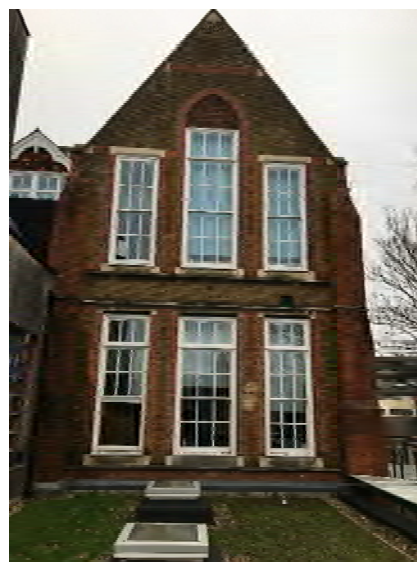
South Elevation to Cathcart Street wing –
 Type 2 sash windows selected for this phase.

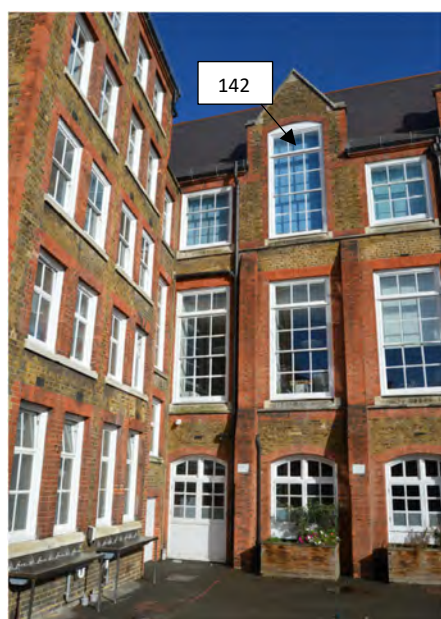
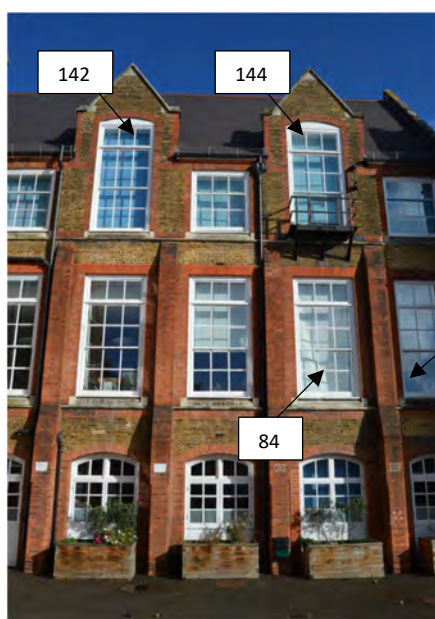
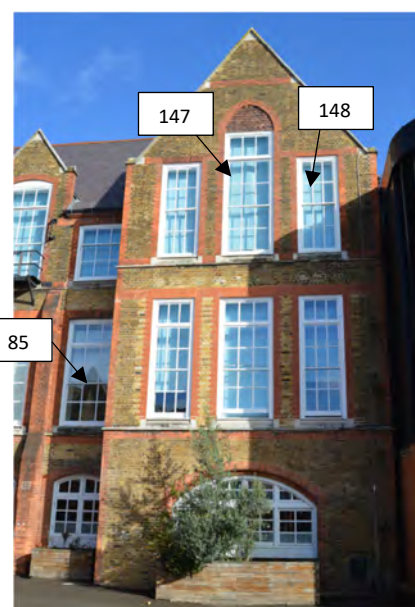
Type 2 sash windows to SW Elevation requiring urgent repairs

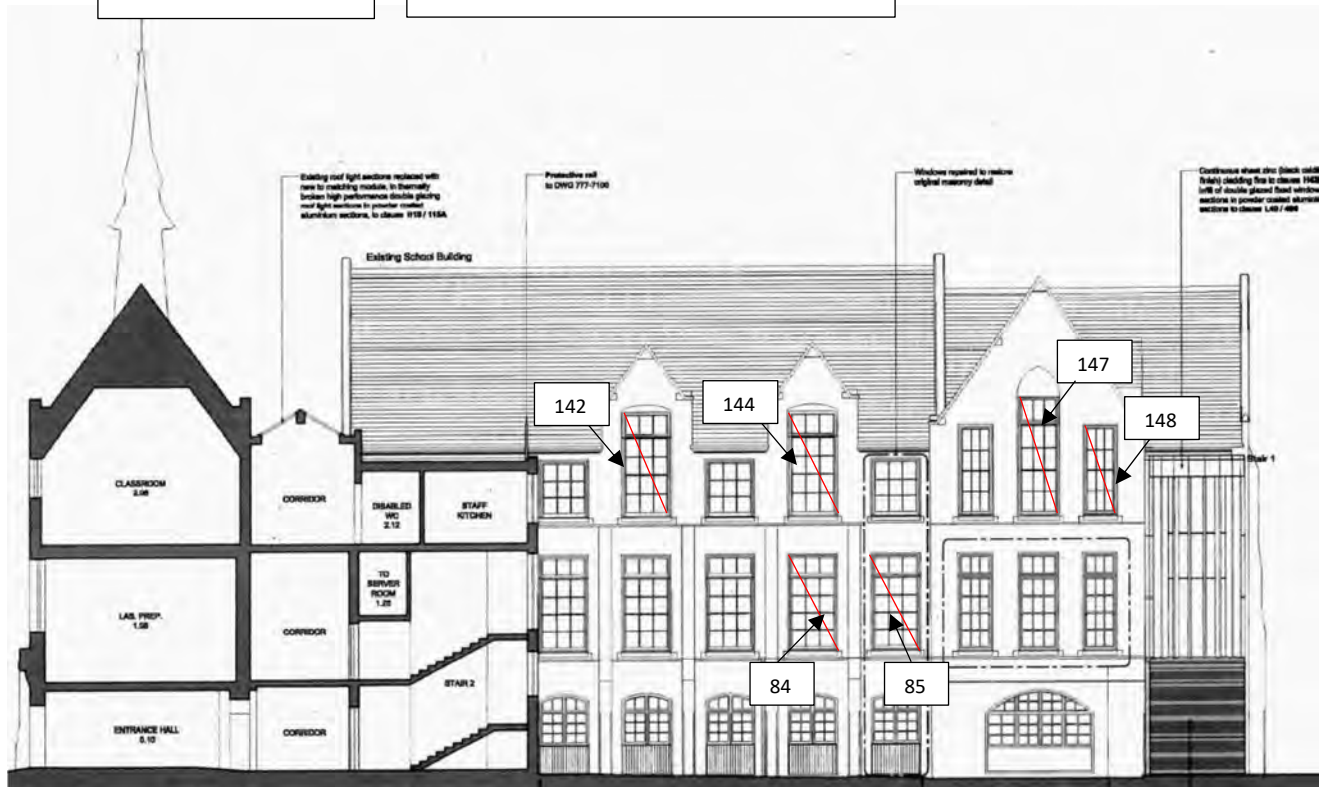
South West Elevation to playground

Type 2 sash windows to SW Elevation requiring urgent repairs

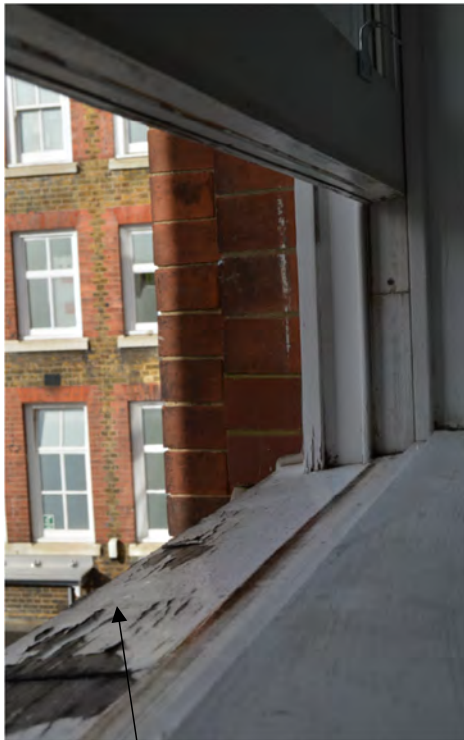
Cill failure to window when scarf repair has failed in South West Elevation

1. Remove existing damaged or rotten base window cill & replace it with new hardwood (oak) to match existing cill profile. It is assumed that the work will be carried out from within the building with the new cill to be fitted in situ without external scaffolding & primed & painted prior to the whole window being reinstated.
2. Repair/ scarf in any damaged or rotten sash boxes, rotten sash frames all to match the existing profiles.
3. Use 'Repair Care' CT1 www.repair-care.co.uk, resin fillers where necessary.

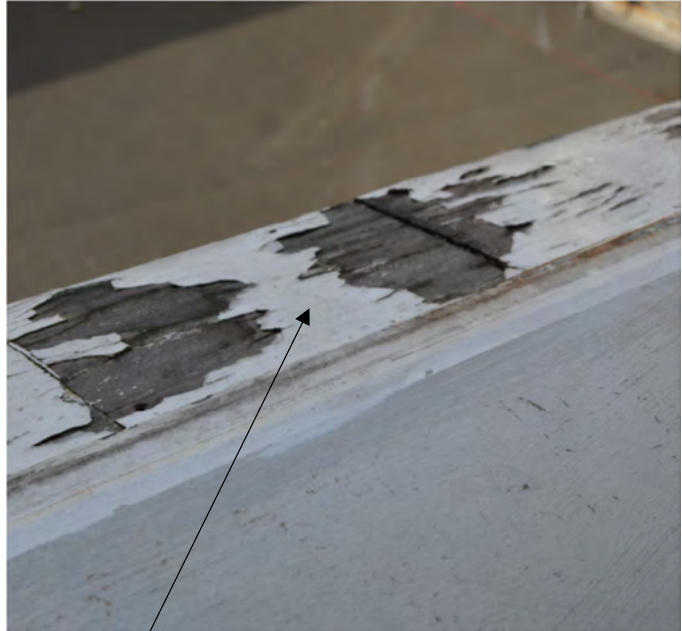
Detail of cill failure

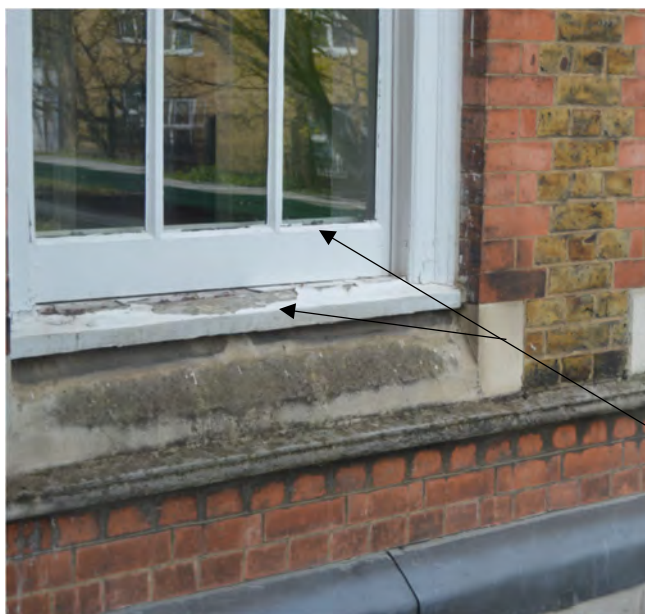
Peeling paint & damaged putties Window on South Gable Elevation

Redecoration - Painting Contractor will carry out all the external & internal redecoration of the windows after the repairs are completed i.e removing all peeling paint & cracking putties. Filling all cracks with suitable external filler. Apply 1 coat external wood primer, plus 3 coats Dulux Weathershield or similar breathable external paint to all parts of the window.

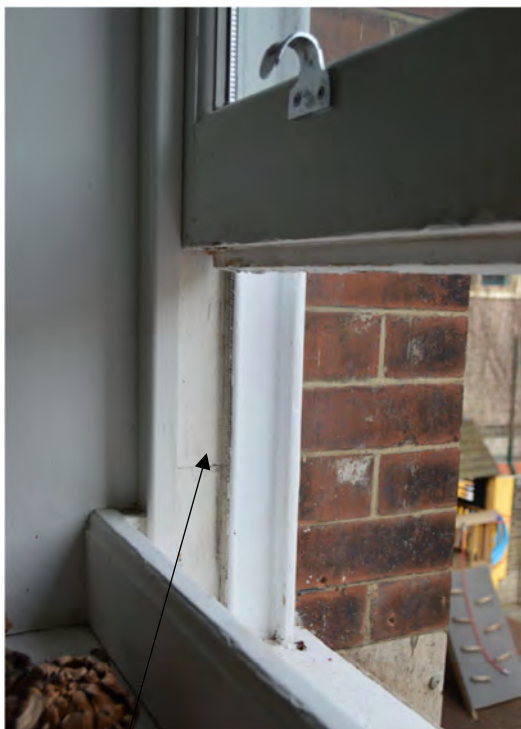
Draught seals to sashes to be replaced – all windows

1. Check all sash cords & re-cord where necessary. Replace damaged pulleys & ensure all opening sashes run smoothly & can be operated easily.
2. Replace any damaged or missing parting beads & stop beads.
3. Check & replace all damaged or missing draught seals.
4. Replace any damaged ironmongery with new fittings to match the existing.

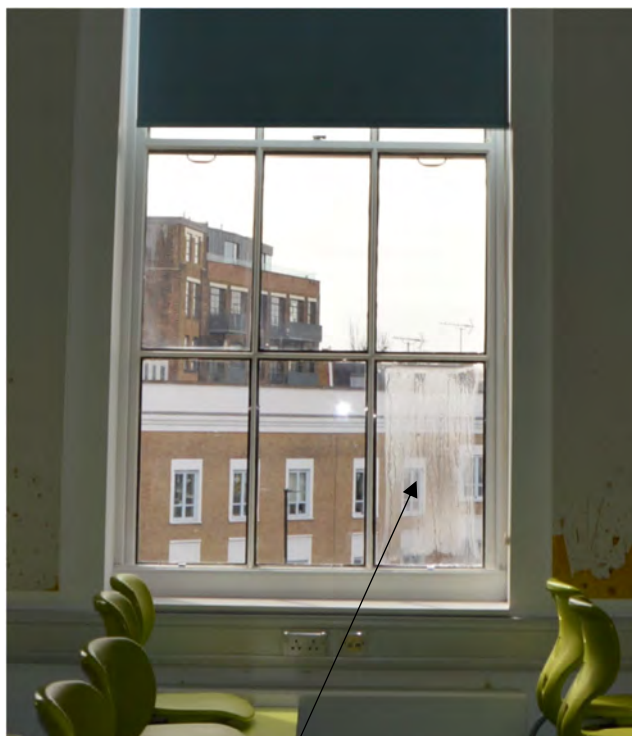
Failed Double Glazed sash to be replaced to South West Elevation

1. Replace any failed double-glazed units as scheduled above to match the sizes & specification of the present glazing units currently assumed* installed are;

*4mm float glass outer sheet / 4mm krypton gas / 4mm toughened float glass inner sheet – 12mm overall thickness. Weight 17kg/m². *(size subject to verification once existing double glazed unit is removed)*
2. New glazing units to be fitted into existing timber frames using 'Dry Flex' type or similar mastic putty.

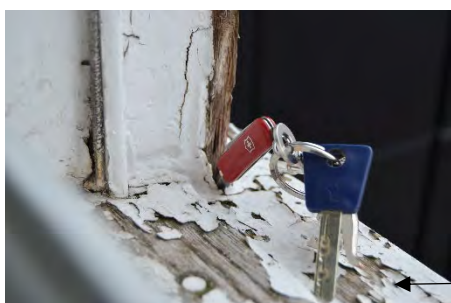
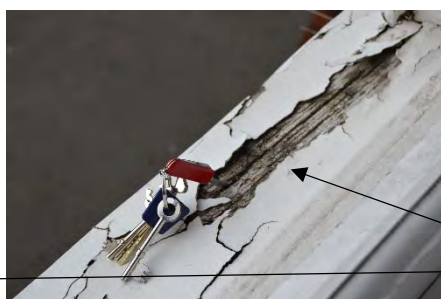
Rotten cills to be replaced in South West Elevation

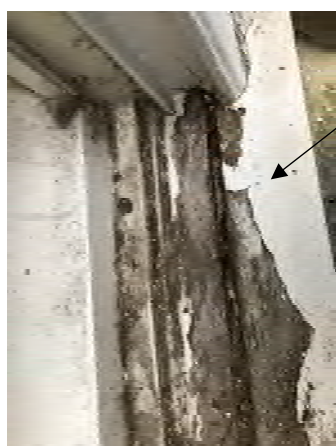
Base cill failure to window in South Gable Elevation

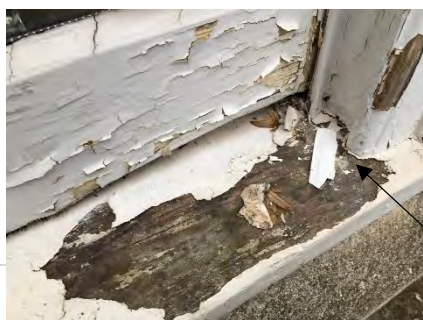
Rotten base of external sash box- scarf in new section. South Gable Elevation
