**Tree Survey &
Hazard Assessment Report**

7th May 2024

45 Highgate West Hill, London, N6

AS/MF/090/24

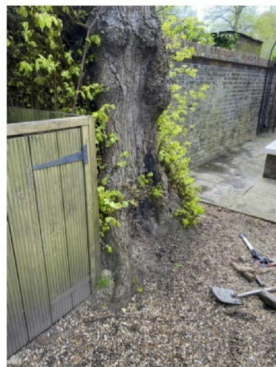
- Fungal fruiting bodies at base to north *Kretschmaria deusta* fruiting brackets extending to 1000mm height.
- Testing with sounding mallet confirms significant cavity at base to north
- Crown diminished via crown reduction - cyclical, lapsed 2 years approx

Base and initial stem of tree T1 showing fungal fruiting body to north of main stem

5.4 The identified fungus *Kretschmaria deusta* is a simultaneous 'soft rot' which in advanced stages, can as described within *Fungi on Trees*, Watson, G. & Green, T. (Arboricultural Association, 2011) leading to 'catastrophic brittle failure'. The advanced presence of the fungus where combined with location adjacent to the public highway provides clear evidence of the hazardous form of the tree in its current form.

6.1 The tree is proposed for removal to remove the current hazard. The removal of the tree for reasons of health and safety and to dispense with duty of care. A replacement planting is specified to provide replacement amenity value and canopy cover for the prominent location.

T1 -Common lime
Fell to ground level and grind out stump to minimum 300mm below ground level
Provide replacement planting of 1 no. *tree* - species to be confirmed from the following species selection:
Acer campestre
Betula pendula
Liquidambar styraciflua 'Worplesdon'

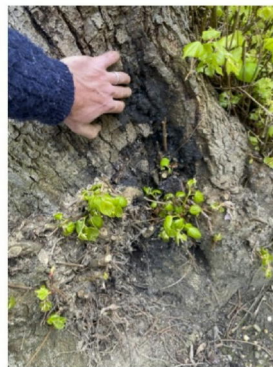
Fungal fruiting body to north of main stem
