18-20 Gower Street – Front Elevation (Gower Street Fronting)

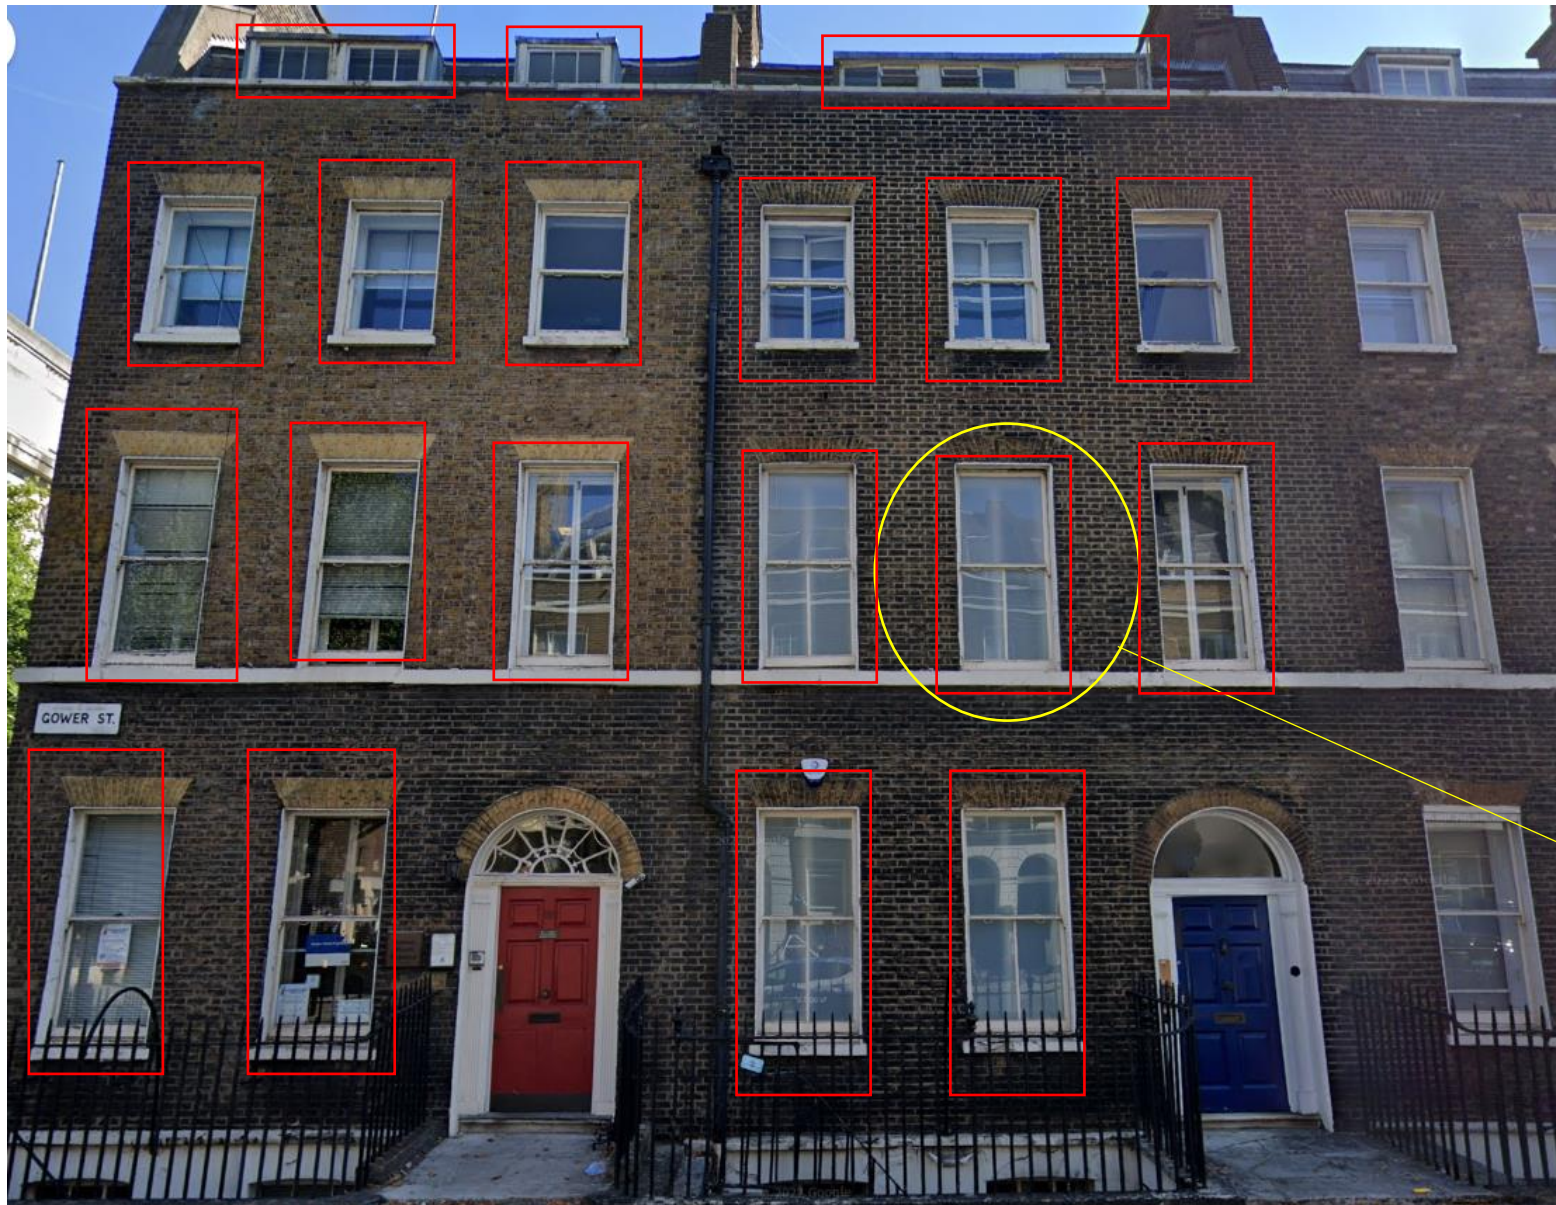
Location of bowed brickwork and deformed window.

Windows to be repaired/redecorated.
