## **Window Validation Condition Survey**

**London Borough of Camden  
Rhyl Community Primary School  
Rhyl Street,  
London,  
NW5 3HB**

### **Refurbishment Works**

**Job No: 35463  
Date: April 2024**

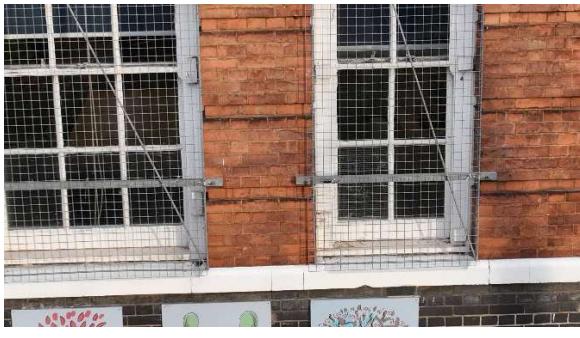
Defective timber cill & frame	Defective timber cill & frame

- 4.2.1 It is our recommendation to undertake timber repairs to all windows where required, which shall be ascertained by further high level inspections once access is available (i.e. scaffold). We would also recommend a repair method of Timbercare type system or equal (see appendix A).

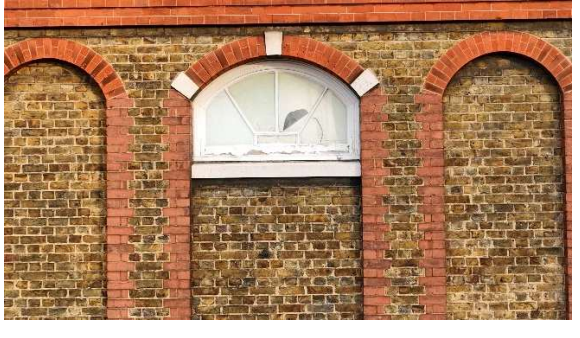
Defective timber cill & frame	Defective timber cill & frame

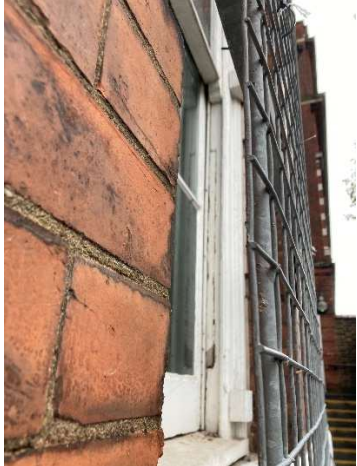
Defective timber cill & frame	Defective timber cill

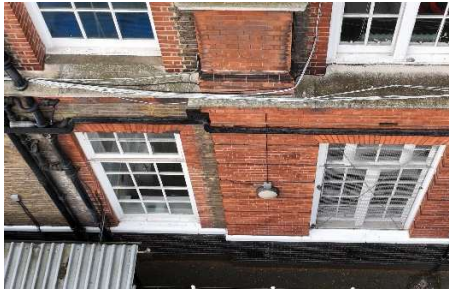
Defective timber cill	Defective timber cill & frame

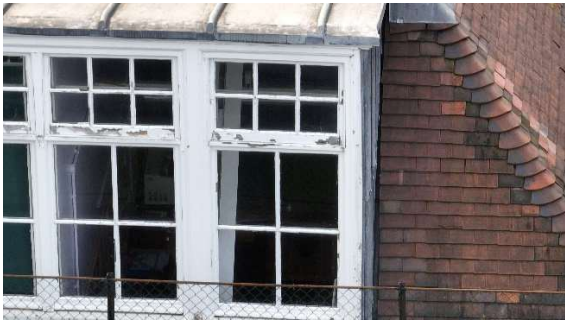
Defective timber frame	Defective timber frame
