**INSURANCE CLAIM: ENGINEERING APPRAISAL REPORT**

Address of Insured: 6 Dartmouth Park Avenue, LONDON, NW5 1JN

Date: 23/08/2021

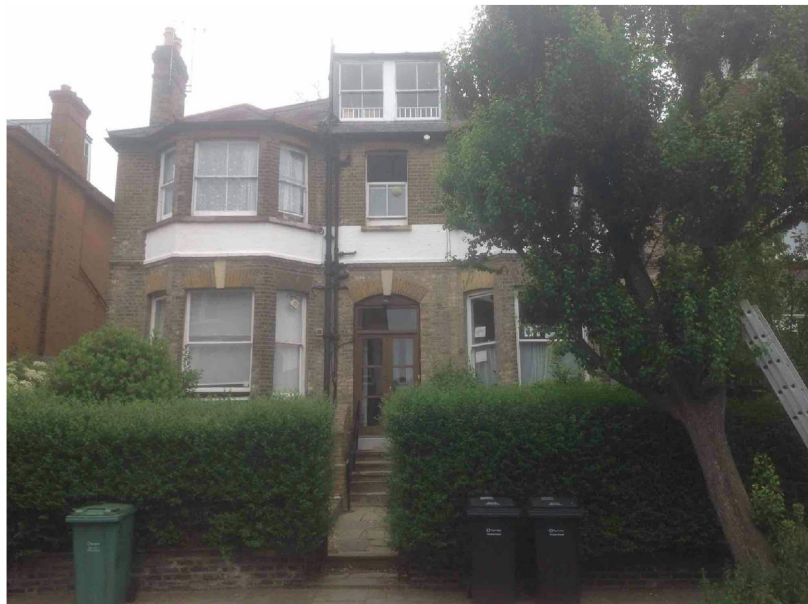
The claim is primarily concerned with damage to the front bay windows and the rear single storey extension. All references to the property are as observed facing the front of the building.

The principal damage takes the form of vertical and diagonal tapered cracking.

The indicated mechanism of movement is downward towards the front of the front bay windows and downward towards the rear of the rear single storey extension.

The level of damage is moderate, and is classified as category 3 in accordance with BRE Digest 251 - Assessment of damage in low-rise buildings.

Based on the information detailed above, we are of the opinion that damage has occurred due to clay shrinkage subsidence. This has been caused by moisture extraction by roots altering the moisture content of the clay subsoil, resulting in volume changes, which in turn have affected the foundations.

Our recommendation is that mitigation measures are undertaken to address the cause of damage and restore stability to the subsoil and building foundations. Consideration can then be given to the required building repairs.
