**INSURANCE CLAIM: ENGINEERING APPRAISAL REPORT**

Address of Insured: 6 Dartmouth Park Avenue, LONDON, NW5 1JN

Date: 23/08/2021

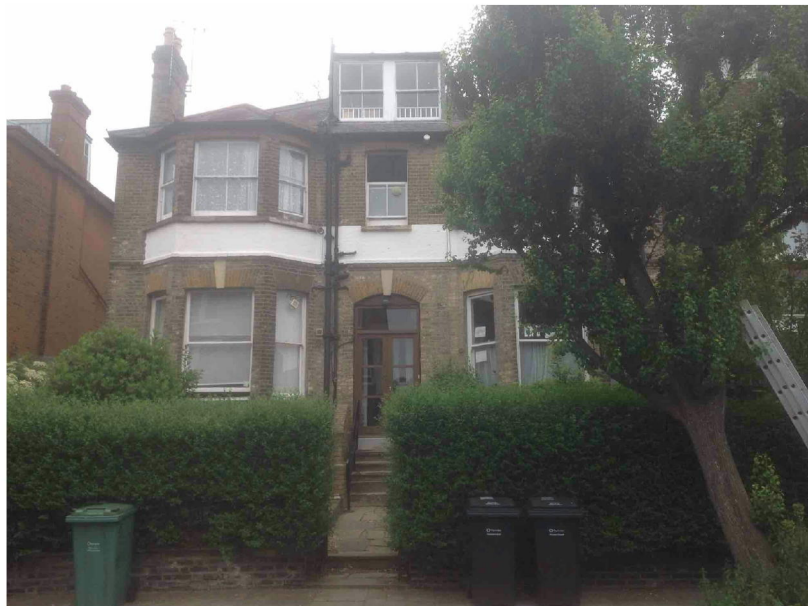
The claim is primarily concerned with damage to the front bay windows and the rear single storey extension. All references to the property are as observed facing the front of the building.

The principal damage takes the form of vertical and diagonal tapered cracking.

The indicated mechanism of movement is downward towards the front of the front bay windows and downward towards the rear of the rear single storey extension.

The level of damage is moderate, and is classified as category 3 in accordance with BRE Digest 251 - Assessment of damage in low-rise buildings.
