## ARBORICULTURAL ASSESSMENT REPORT

**Risk Address:** 63A Belsize Lane, London, NW3 5AU

**Survey Date:** 23/10/2023

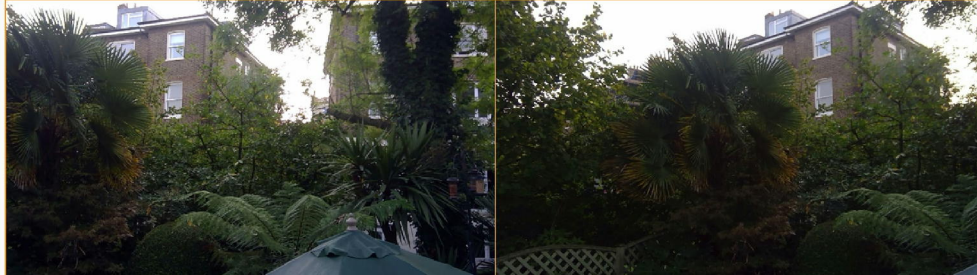
TG2 - Laurel

| Tree No | Common Name | Age Class | Condition | Height (m) | Crown Spread (m) | Stem diam. (mm) | Dist to bldg. (m) | Roots implicated | Pruning history | Recommendation | Tree work constraints | Notes | Owner address | Owner |
|---|---|---|---|---|---|---|---|---|---|---|---|---|---|---|
| TG2 | Laurel | Mature | Fair | 4.8* | 4* | 150* | 8.5* | N | Subject to past management. | No work required. | | | 30 Belsize Park London NW3 4DX | P3P |
