12 Park Village West

Arboricultural Impact Assessment

Report for Adam Richards Architects

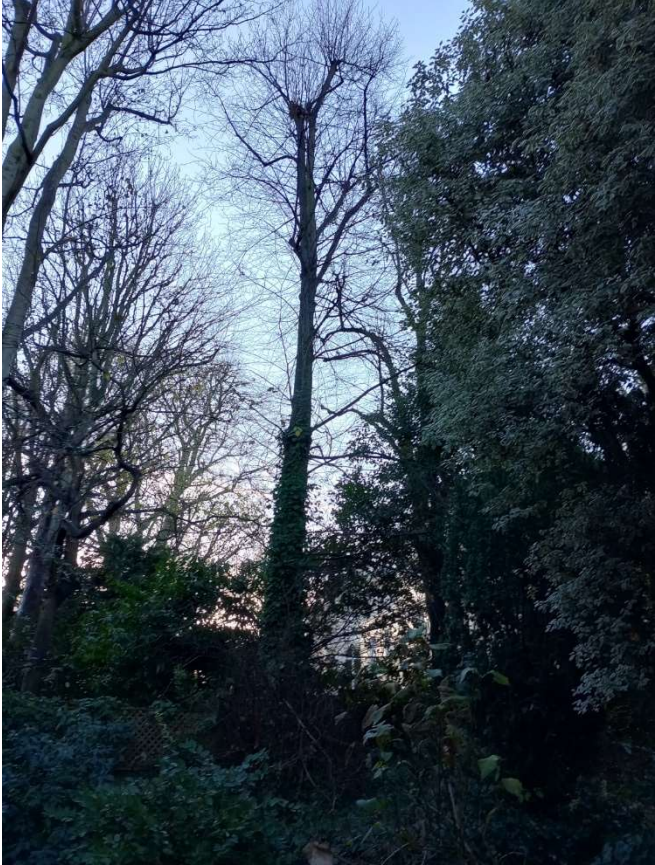
<p>Photograph 3</p> <p>View looking east towards lime tree T8</p>

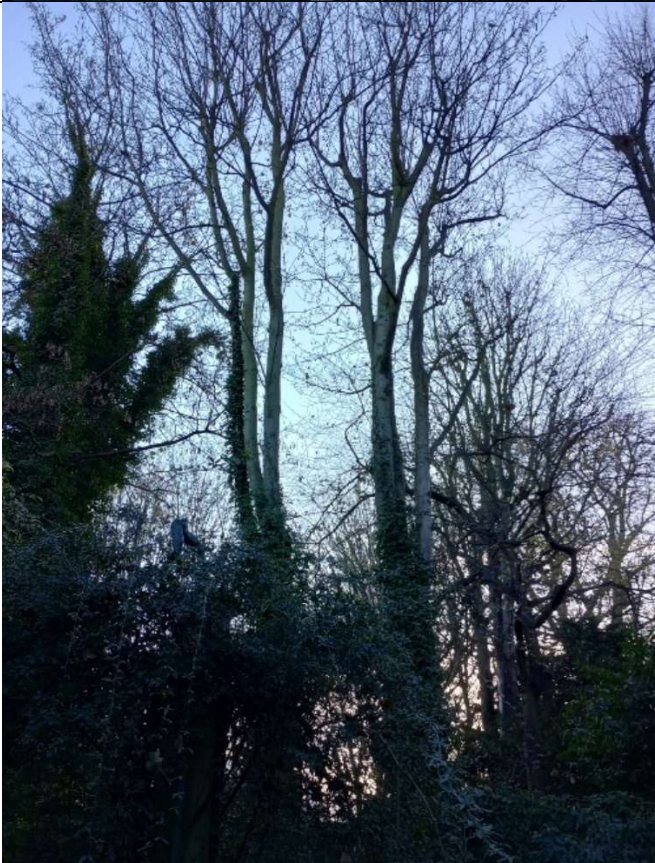
<p>Photograph 4</p> <p>View looking southeast towards sycamore trees T9 and T10</p>

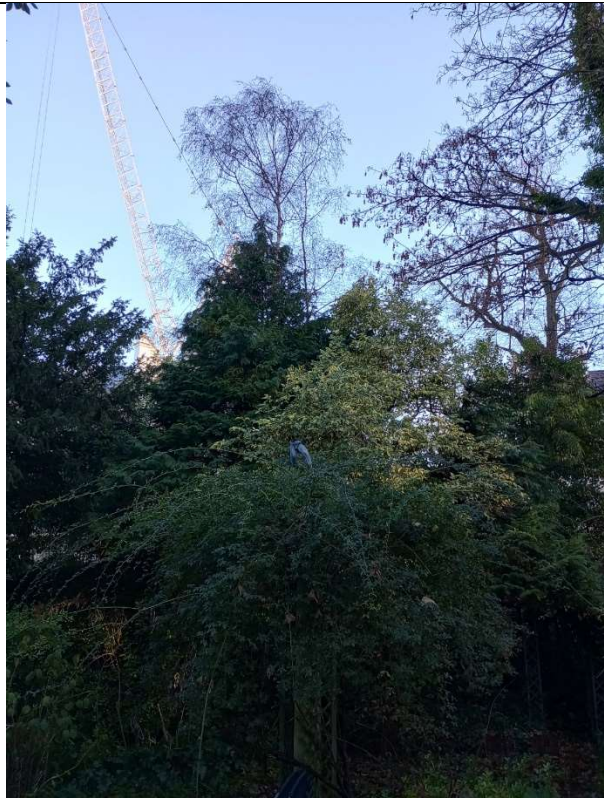
Photograph 5

View looking northeast towards
T11 and T14

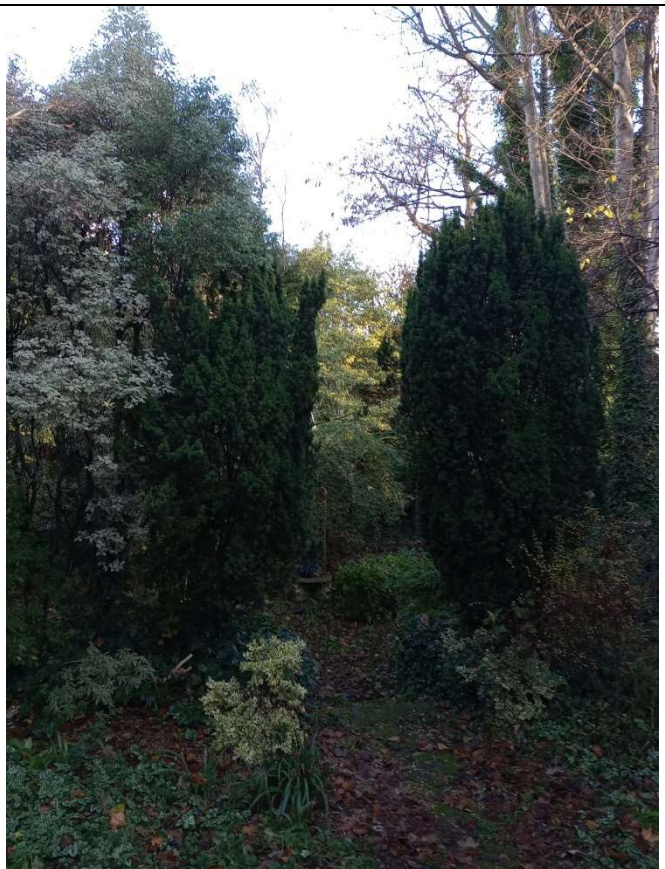
Photograph 6

View looking northeast towards
the stems of Irish yew T20 and
T21
