51 Great Ormond Street London WC1N

Structural Inspection Report

Prepared by:	Oladimeji Soleye MEng
Reviewed by:	George Reed MEng CEng MStructE
Job Number:	30343

Date	Revision	Notes/Amendments/Issue Purpose
May 2024	P1	For Information

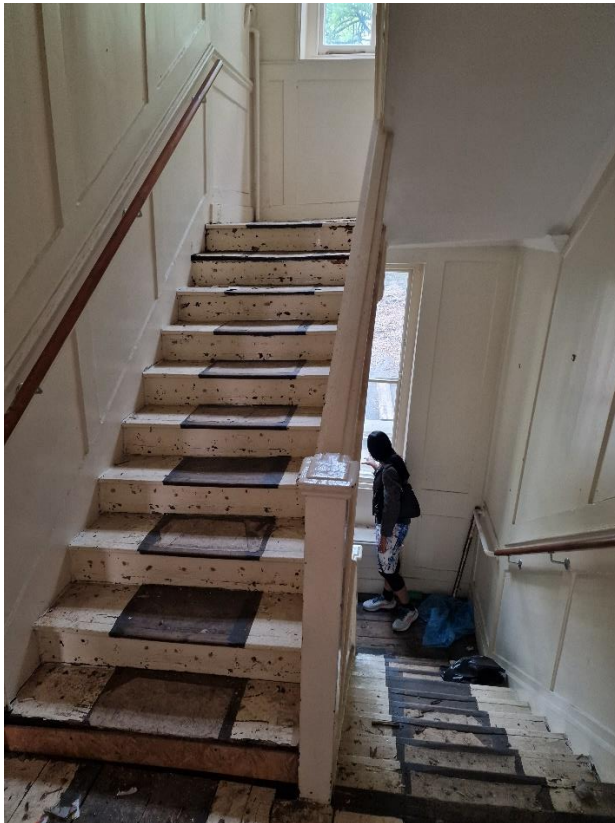
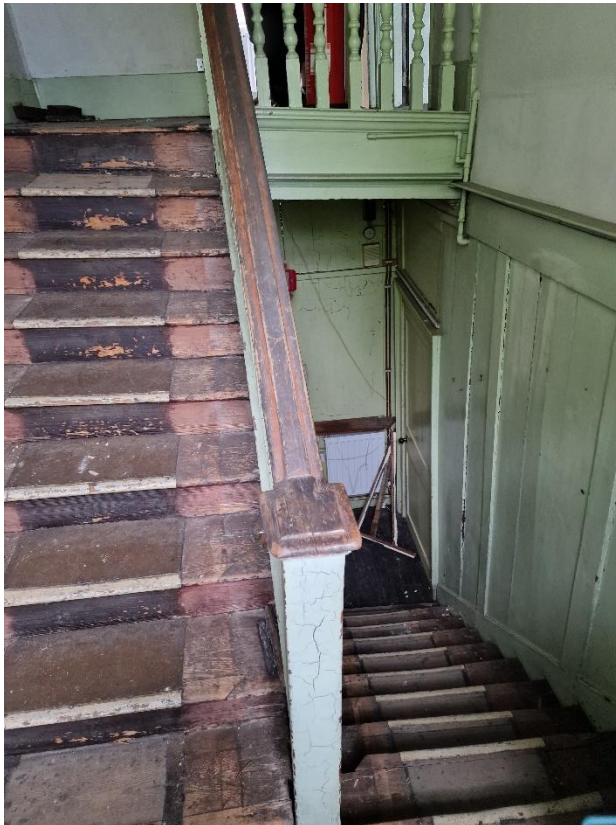
At 51 Great Ormond Street, there was some significant vertical and horizontal movement observed within the main stair in this building which was also progressively worse up the building with the worst instance of movement being observed at the topmost landing and half landing. This movement in the stairs could be due to faulty drainage which caused additional settlement in the ground, timber creep and shrinkage, historical building settlement, or a combination of two or more of the above. Such significant movement in the stair is likely to have compromised the entire stair structure, creating an unsafe structure.

Figure 2 - Stairs at 51 Great Ormond Street

Figure 3 - Stairs at 51 Great Ormond Street

- Straps and ties between existing floors and walls.
- Remedial works and strengthening to stairs following further investigation which may involve replacement of damaged treads and reinstatement of connections between timber members.

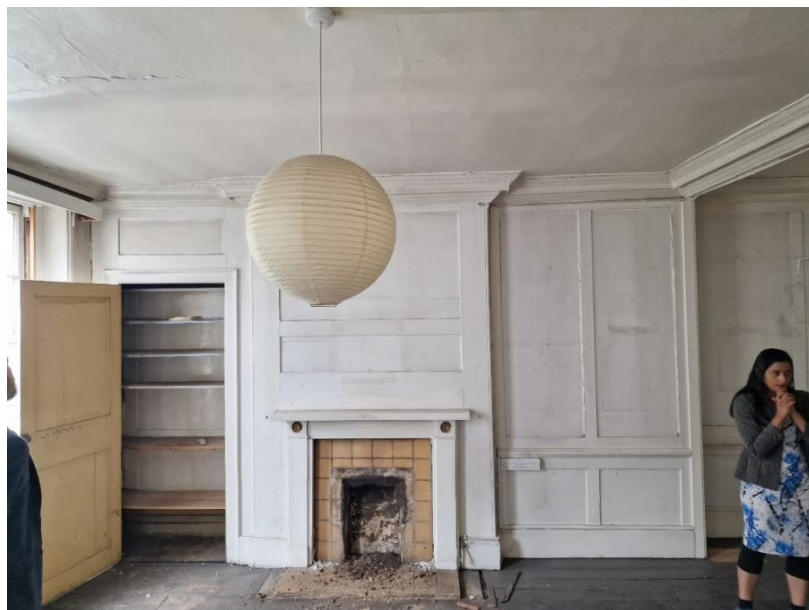
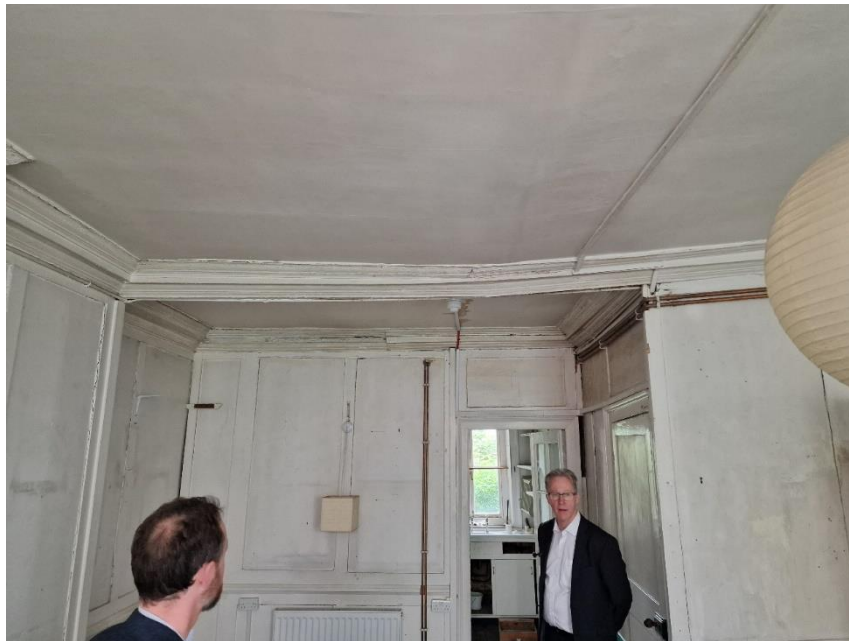
Figure 4 - Vertical movement in the ceiling/floor at 51 Great Ormond Street

Figure 5 - Vertical movement in the ceiling/floor at 51 Great Ormond Street

Internally, there was also some major settlement within the floors of the which could be attributed to a combination of timber creep and shrinkage, in combination with the observed settlement of the building. The floors slope and then level out at a consistent point on all levels. From figures 4 and 5, one of the internal spine walls has previously been removed which is also a very likely a cause for the movement in the structure.

- Investigation and remedial/strengthening works where previous alterations have taken place.
- Infill/replacement of notched joists to reinstate original structure following full strip-out and raise of floorboards.

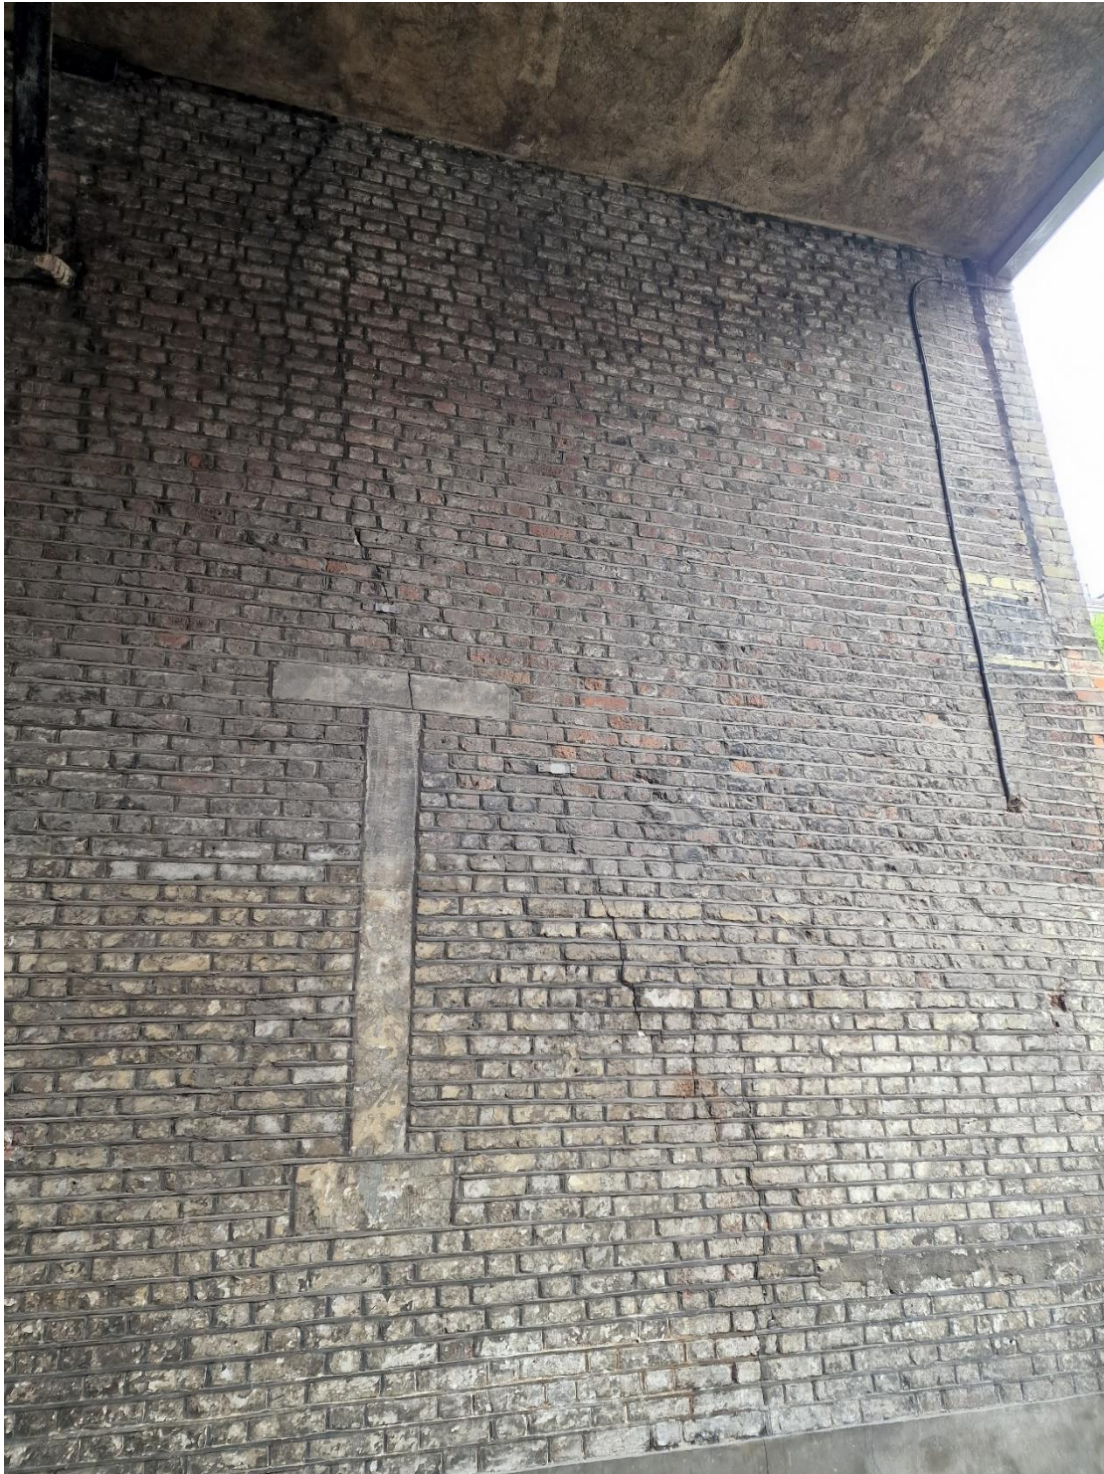
To the side of 51 Great Ormond Street, the external wall of the building which faces onto Barbon Close was observed to have been repointed/rebuilt at an unknown time, however, there was some large cracks observed on the wall that run from the top of the visible portion of the wall to the bottom. This area is near to the chimney of the building and the cracking is likely due to water in the chimney.

On the cracked external wall, two tell-tail crack monitors were observed on one of the larger cracks which suggests that the movement is active, however this will be confirmed during the works.

Figure 6 - Crack in External wall at Barbon Close

- Crack repairs to external brick wall to Barbon Close.
- Additional steelwork/strengthening to the rear extension roof for plant.
