45 Great Ormond Street London WC1N

Structural Inspection Report

Prepared by:	Oladimeji Soleye MEng
Reviewed by:	George Reed Meng Ceng MStructE
Job Number:	30343

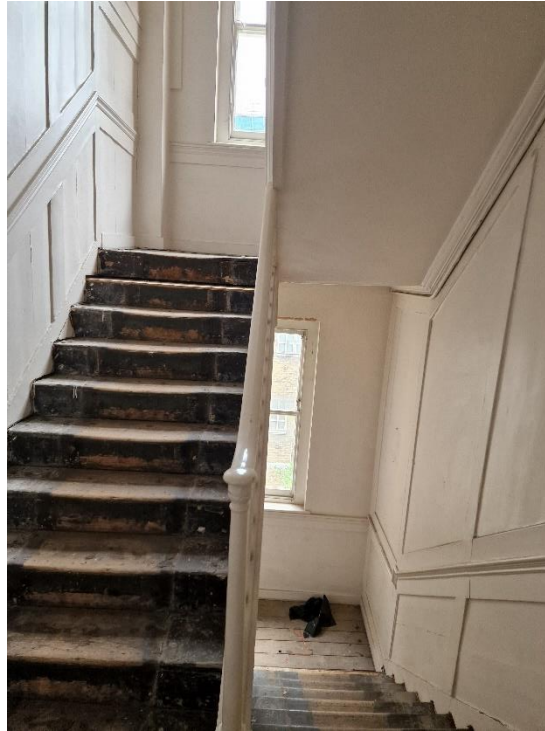
Figure 2 - Stairs at 45 Great Ormond Street

At 45 Great Ormond Street, there was some vertical movement observed with the main circulation stair in this property which was progressively worse up the building. This movement in the stair could be due to faulty drainage which caused additional settlement in the ground, timber creep and shrinkage, historical building settlement, or a combination of two or more of the above.

- Crack repairs to existing masonry walls following removal of finishes.
- Replacement of rotten/damaged lintels to window and doors.
- Replacement of rotten/damaged floor joists and beams.
- Straps and ties between existing floors and walls.
- Remedial works and strengthening to stairs further investigation which may involve replacement of damaged treads and reinstatement of connections between timber members.
- Remedial works to timber rafters, ceiling joists, and wall plates to the roof structure. Allow for additional remedial works and possible partial rebuild of the parapet.
- Investigation and remedial/strengthening works where previous alterations have taken place.
- Infill/replacement of notched joists to reinstate original structure following full strip-out and raise of floorboards.

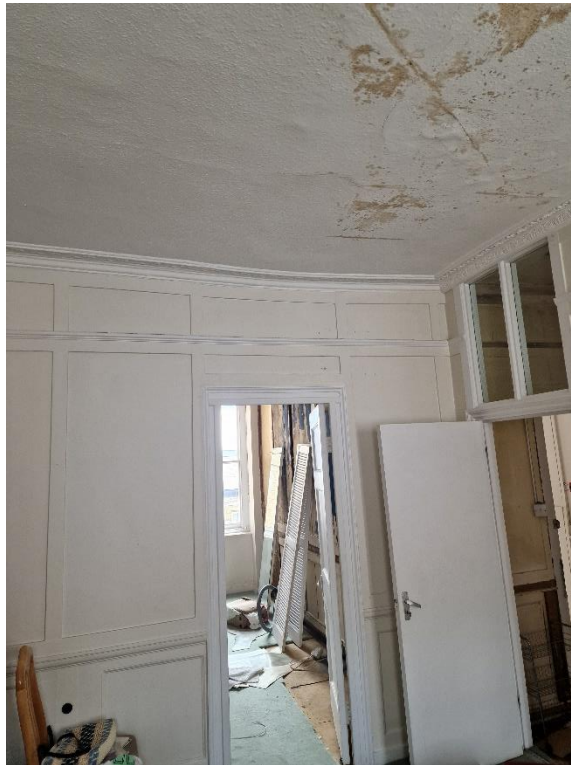
Figure 4 - Vertical movement in the ceiling/floor at 45 Great Ormond Street

There was also some settlement/movement observed within the floors of the building which could be attributed to the use of the building over time, in combination with timber creep and shrinkage.

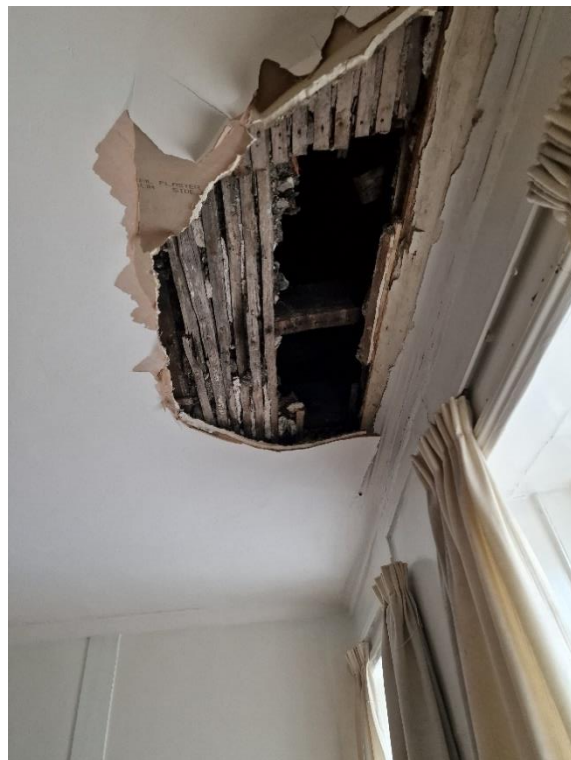
Figure 3 - Caved-in Ceiling at 45 Great Ormond Street

In the upper floors within the building, there are a few instances where the ceilings have caved in, likely due to a water leak in the roof/plumbing.

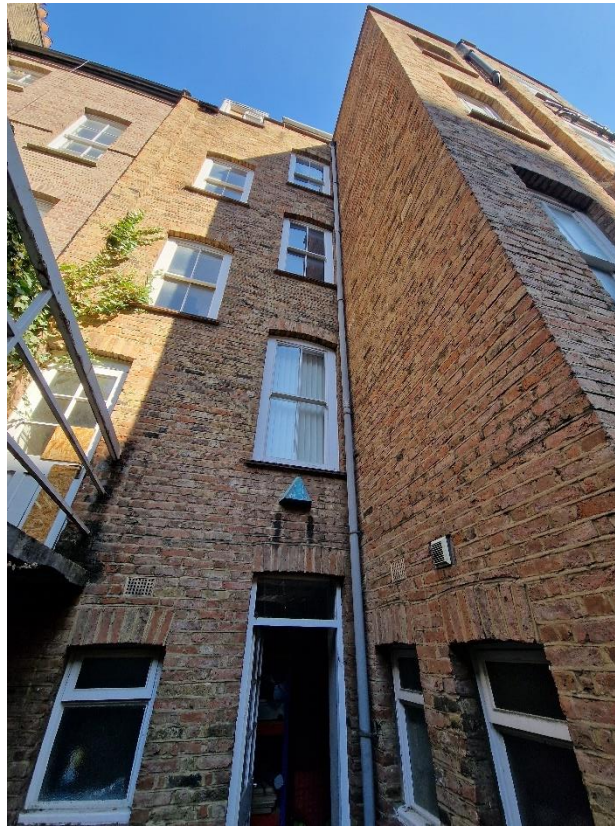
Figure 5 - Rear Elevation of 45 Great Ormond Street

It was also observed that that the external walls to the rear of the building had been rebuilt/repointed at an unknown time, ridding any visual evidence of the wall having settled at any point in the past.
