Client  
Victor & Apolline Luggier

Project Title  
Church Row

Sheet Title  
Existing Floor Plans - Lower Ground & Ground

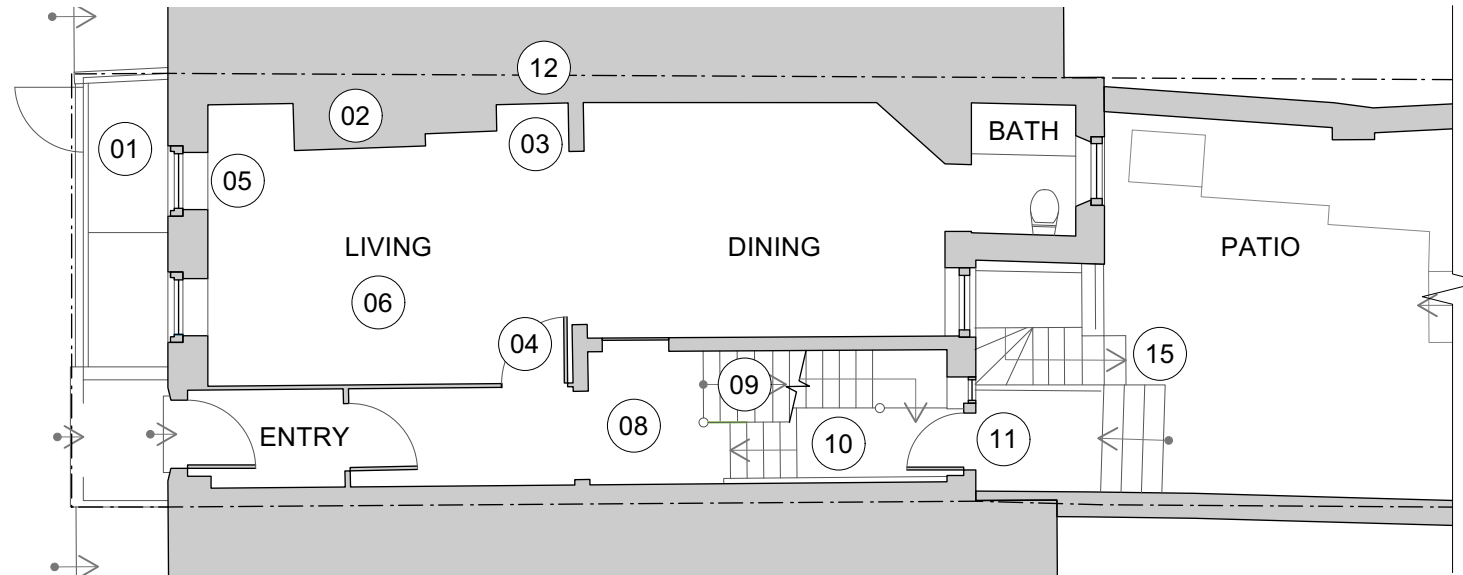
**G** Existing Ground Floor Plan  
Scale: 1:100

- 01 1960's concrete bin store
- 02 1940's tiled fireplace
- 03 Damage to timber wall paneling and floor (holes cut and paneling removed)
- 04 Damage to door (holes cut)
- 05 Cracked window panes
- 06 Disintegrating vinyl floor finish
- 07 Damage to floor
- 08 Patchwork plywood floor finish
- 09 Structural damage to staircase, including badly reinforced newel posts and balusters
- 10 Plastic stair nosing and vinyl floor
- 11 1960's metal bars installed over glazing
- 12 Exposed lead pipes

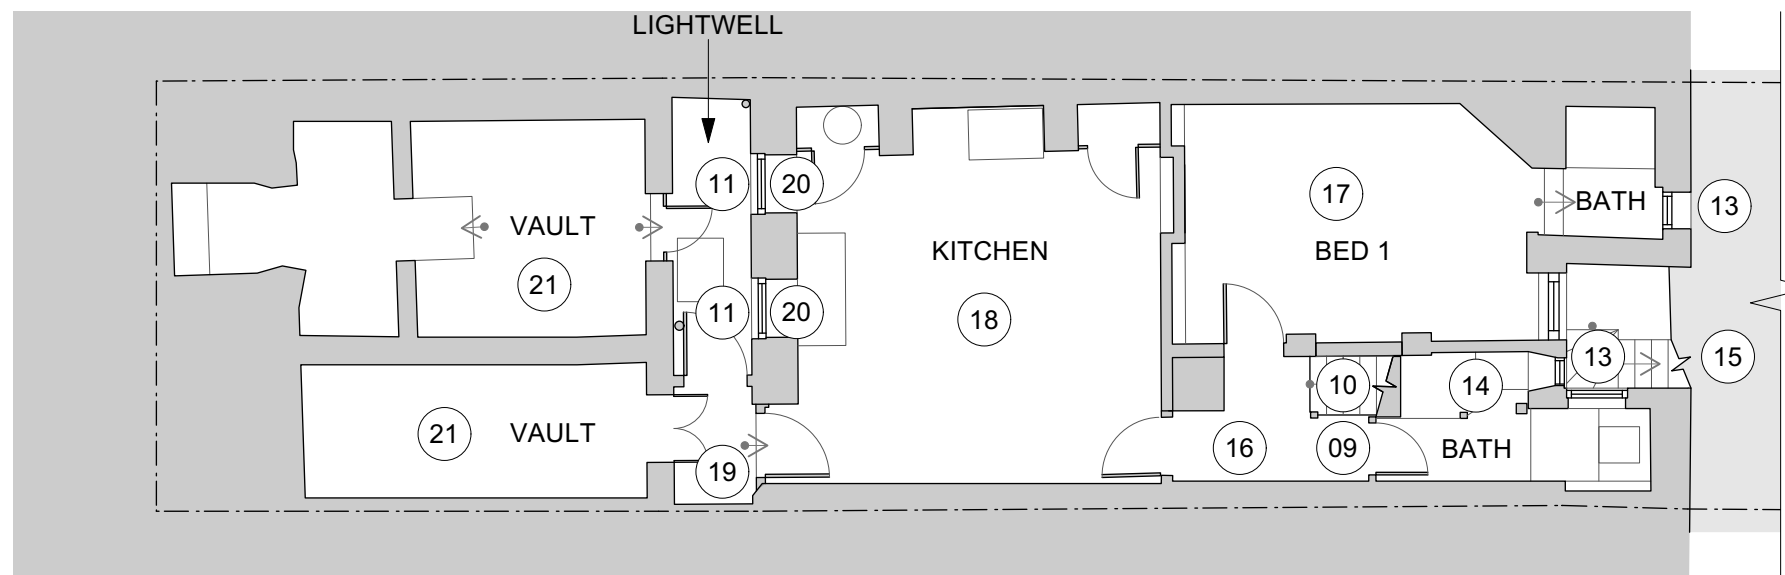
**LG** Existing Lower Ground Floor Plan  
Scale: 1:100

- 13 1960's UPVC windows
- 14 1960's bathroom with exposed stone ceiling and damp issues - unfit for purpose
- 15 Non original concrete stairs
- 16 Walls and cupboards with rustic style 1960's timber cladding
- 17 1960's fit out with inappropriate profiled mouldings and wood block floor
- 18 Early 19th century kitchen fit out with tiled floor, exposed services, damaged fittings
- 19 Exposed services and wiring
- 20 Non original timber windows
- 21 Coal cellar ceiling disintegrating - damp conditions unsuitable for use

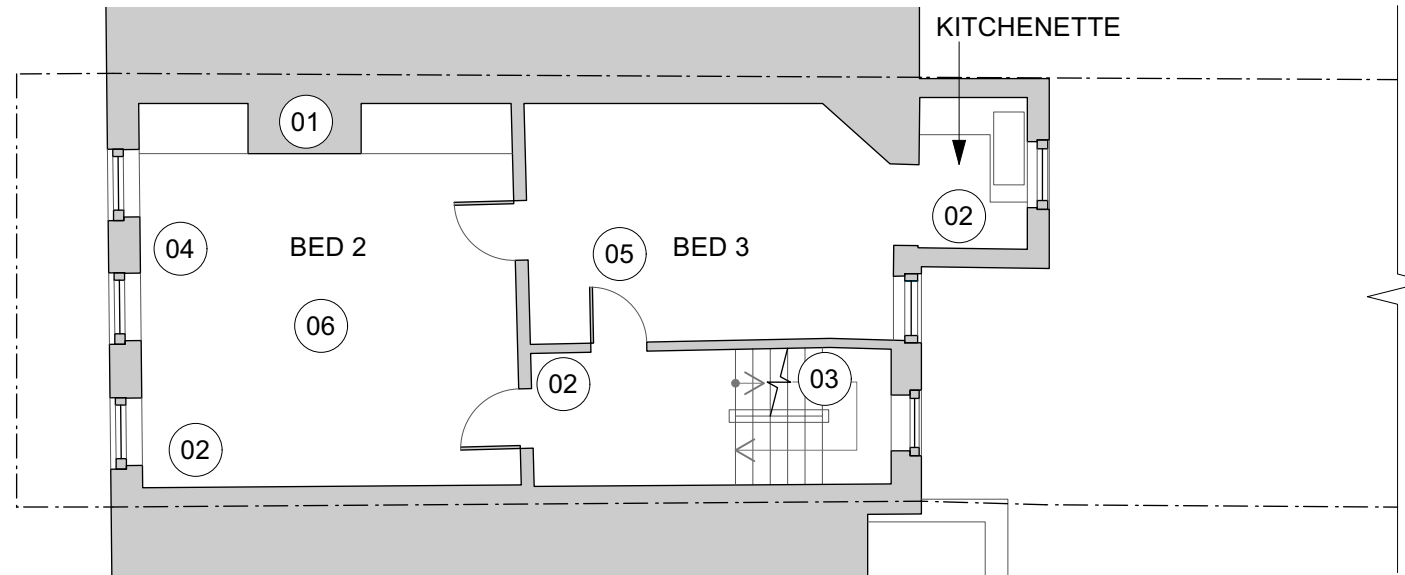
2 Existing Second Floor Plan  
Scale: 1:100

- 01 Fireplace blocked and decorated with 1950's tiles
- 02 Exposed fuseboxes, plumbing and electrical wiring
- 03 Surface mounted boxing obstructs head height on stair
- 04 Damage to timber panelling
- 05 Damage to door (holes cut)
- 06 Damage to ceiling
- 07 Blocked up doorway
- 08 Substantial water damage to ceiling
- 09 Sash windows painted shut
- 10 Rotten timber window frames

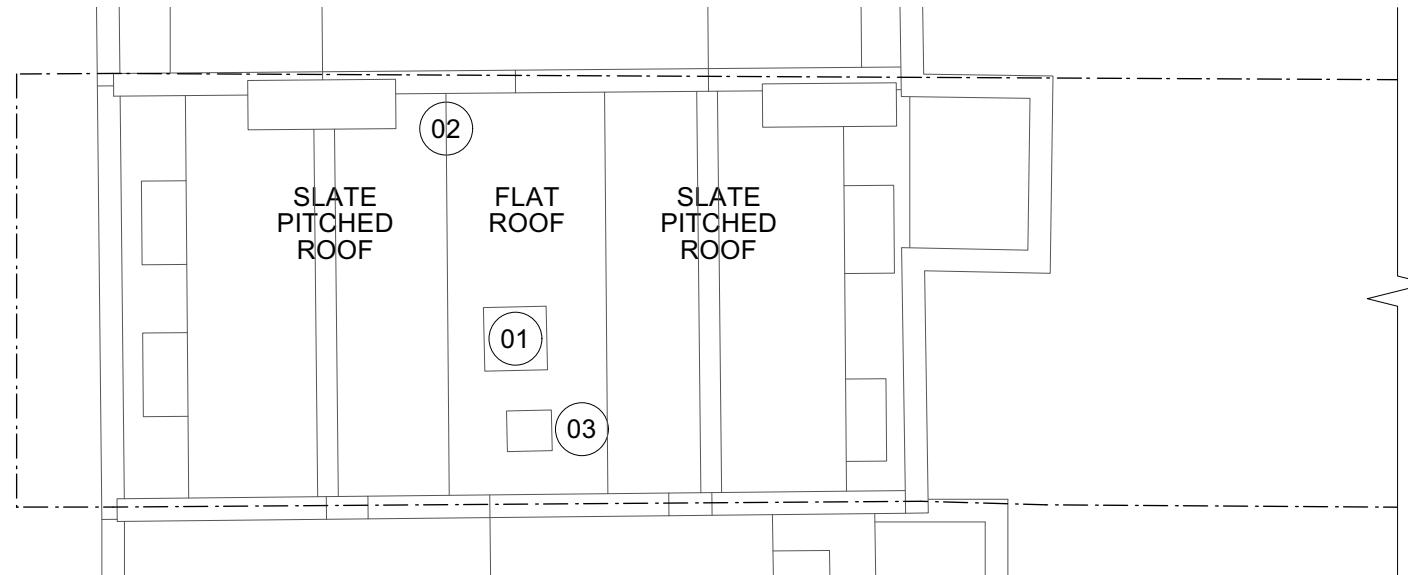
R Existing Roof Plan  
Scale: 1:100

- 01 1960's plastic dome skylight
- 02 Satellite dish
- 03 Decaying timber roof access hatch
- 04 Water tank
- 05 Damaged, uneven floor throughout
- 06 WC space too small for use
- 07 1960's electric fire
- 08 1960's inbuilt wardrobe
- 09 Threadbare carpet floor finish
- 10 Water damage to party wall
- 11 1960's casement window

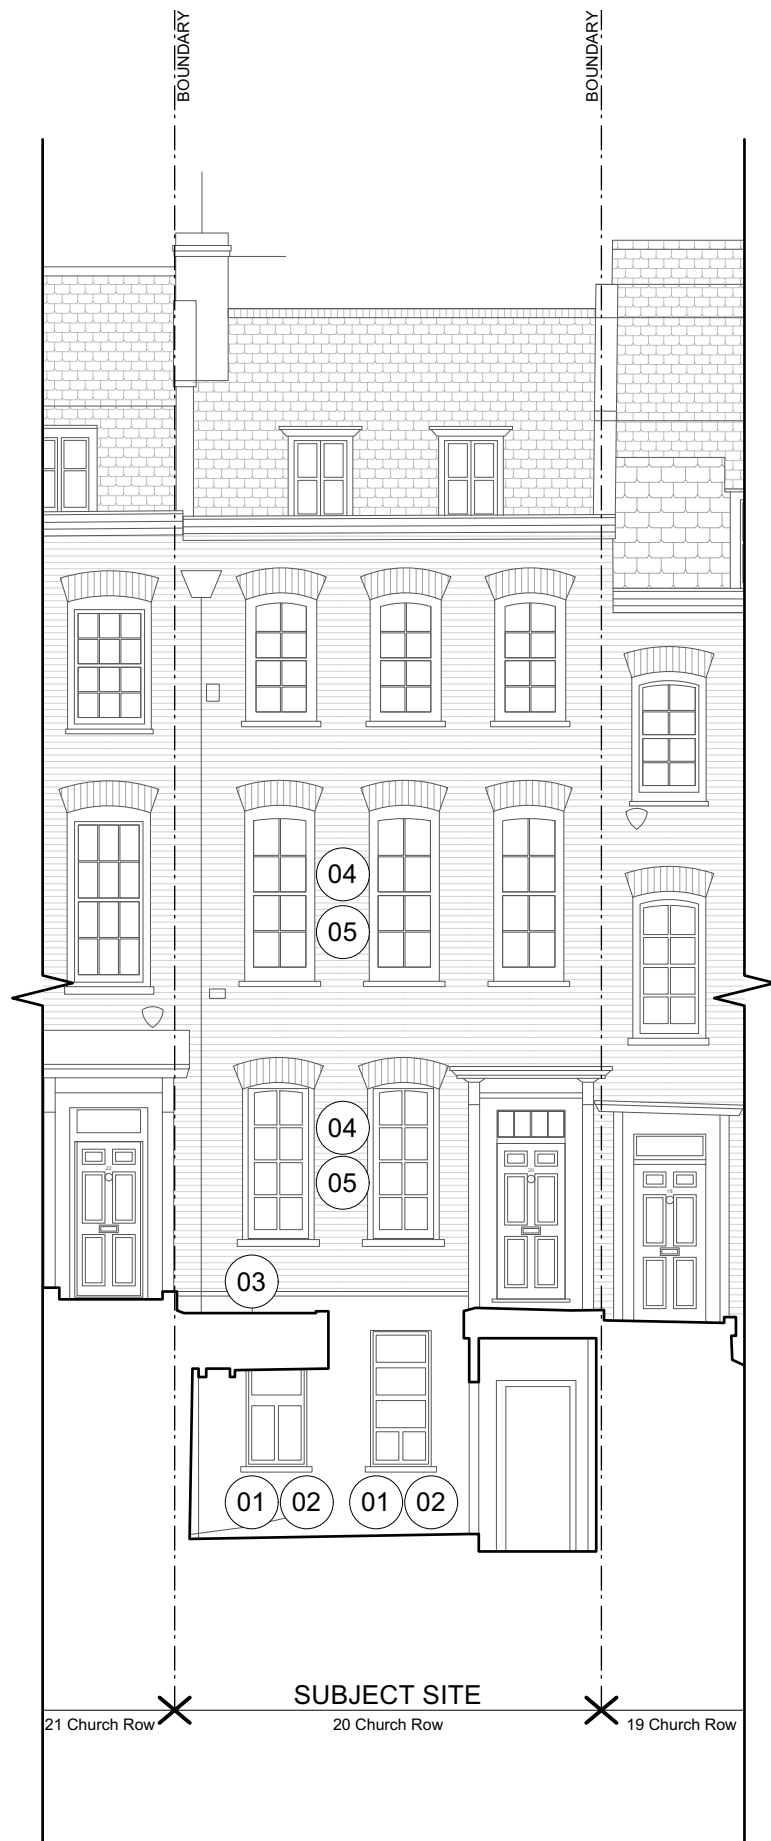
1 Existing Front Elevation  
Scale: 1:100

- 01 Non original timber windows
- 02 1960's metal bars over windows
- 03 1960's concrete bin store
- 04 Sash windows painted shut
- 05 Cracked window panes
- 06 1960's UPVC windows
- 07 1960's casement window
- 08 1960's infill brickwork
- 09 Pre 1960's infill brickwork
- 10 Non original concrete stairs
- 11 Asbestos pipework
