H+R French drain
 General detail for adaption to use
 September 2010 - Indicative Only - Not for Construction
 Hutton + Rostron Environmental Investigations Ltd, Nettle House, Gomshall, Surrey, GU15 9QA
 Tel: 01483 203221 Fax: 01483 202911 Standard Details | Ground © Copyright Hutton+Rostron, 2019

Rev.	Date	Description
LBC01	18.05.2024	Listed Building Consent
project 131_9 Wedderburn Road		
site address 9 Wedderburn Road London NW3 5QS		
client Private Client		
drawing title Bay Window Section Detail		
project number_drawing number_revision 131_408_LBC01		
date 18.05.2024		
designed / drawn by 4H Architecture 0751572458 info@4harchitecture.co.uk		
scale

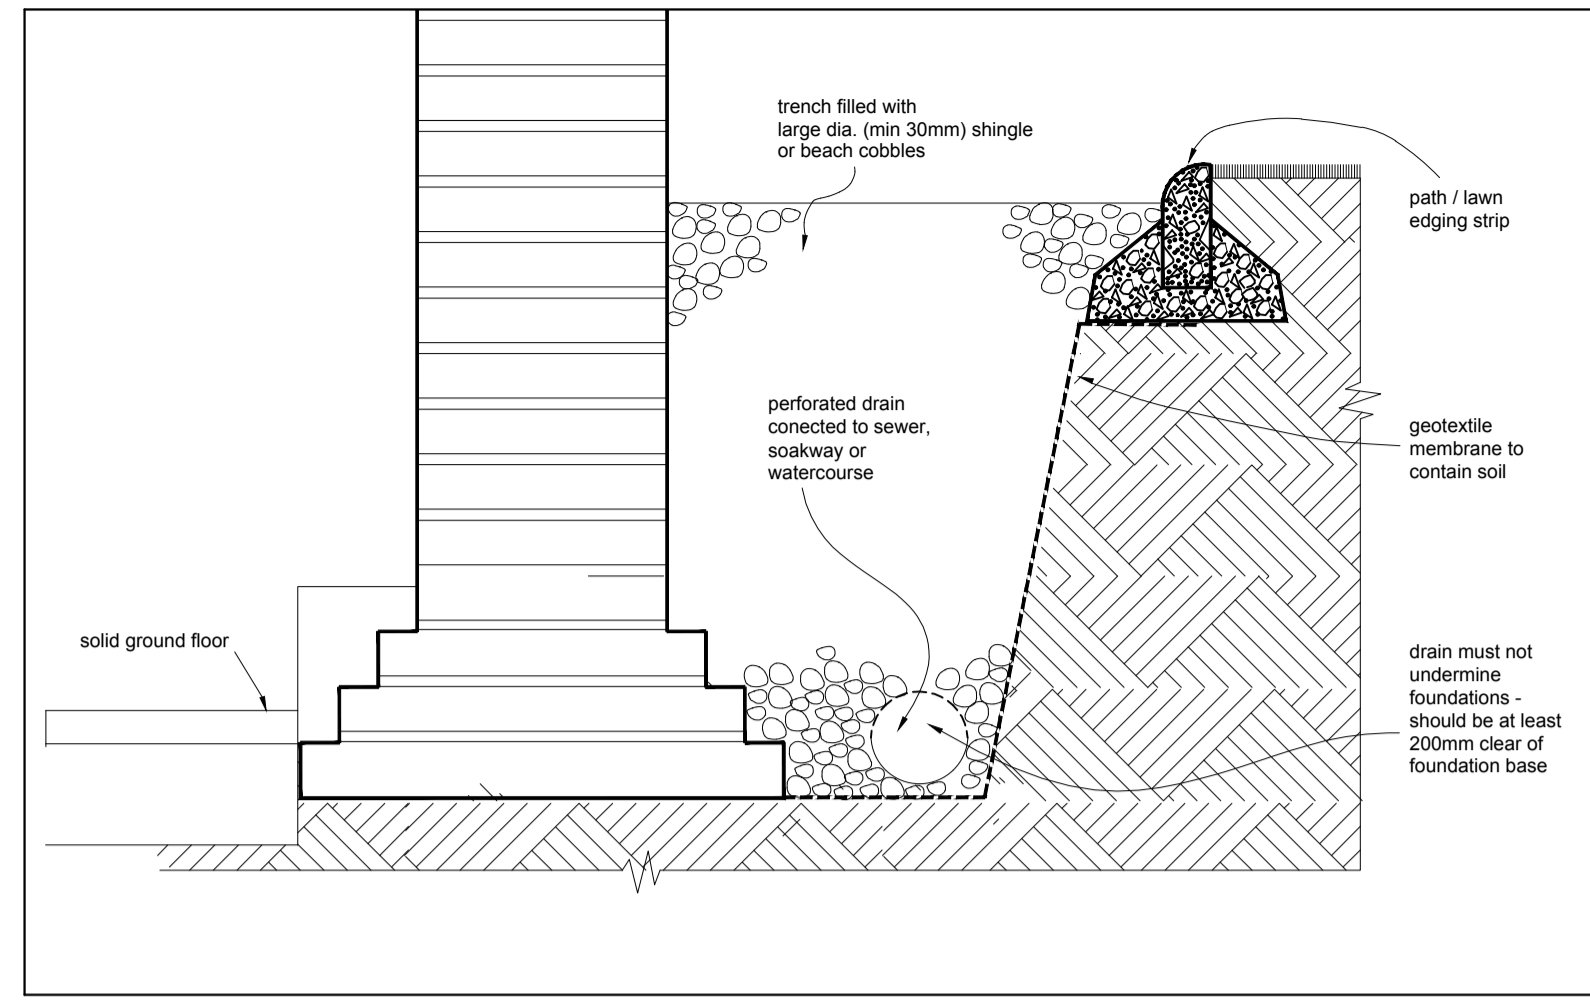
NOT TO SCALE
 SD-401E

To the east there was an excavated trench around the bay window. H+R were informed that this was to be backfilled. Some signs of a retrofit injected DPC were observed. It should be noted that these are rarely effective, as was certainly the case with the building given masonry samples were saturated above DPC level

All areas where external ground levels are above internal ground levels and finished floor levels are intended to remain that way would be deemed below ground structures and would require protection in line with BS8102: 2022. No injected DPCs are required. An air drain could be installed within the trench around the bay window. An alternative could be a French drain, although these tend to get blocked by silt and therefore should comprise of a perforated pipe, geotextile membrane and inspection chambers

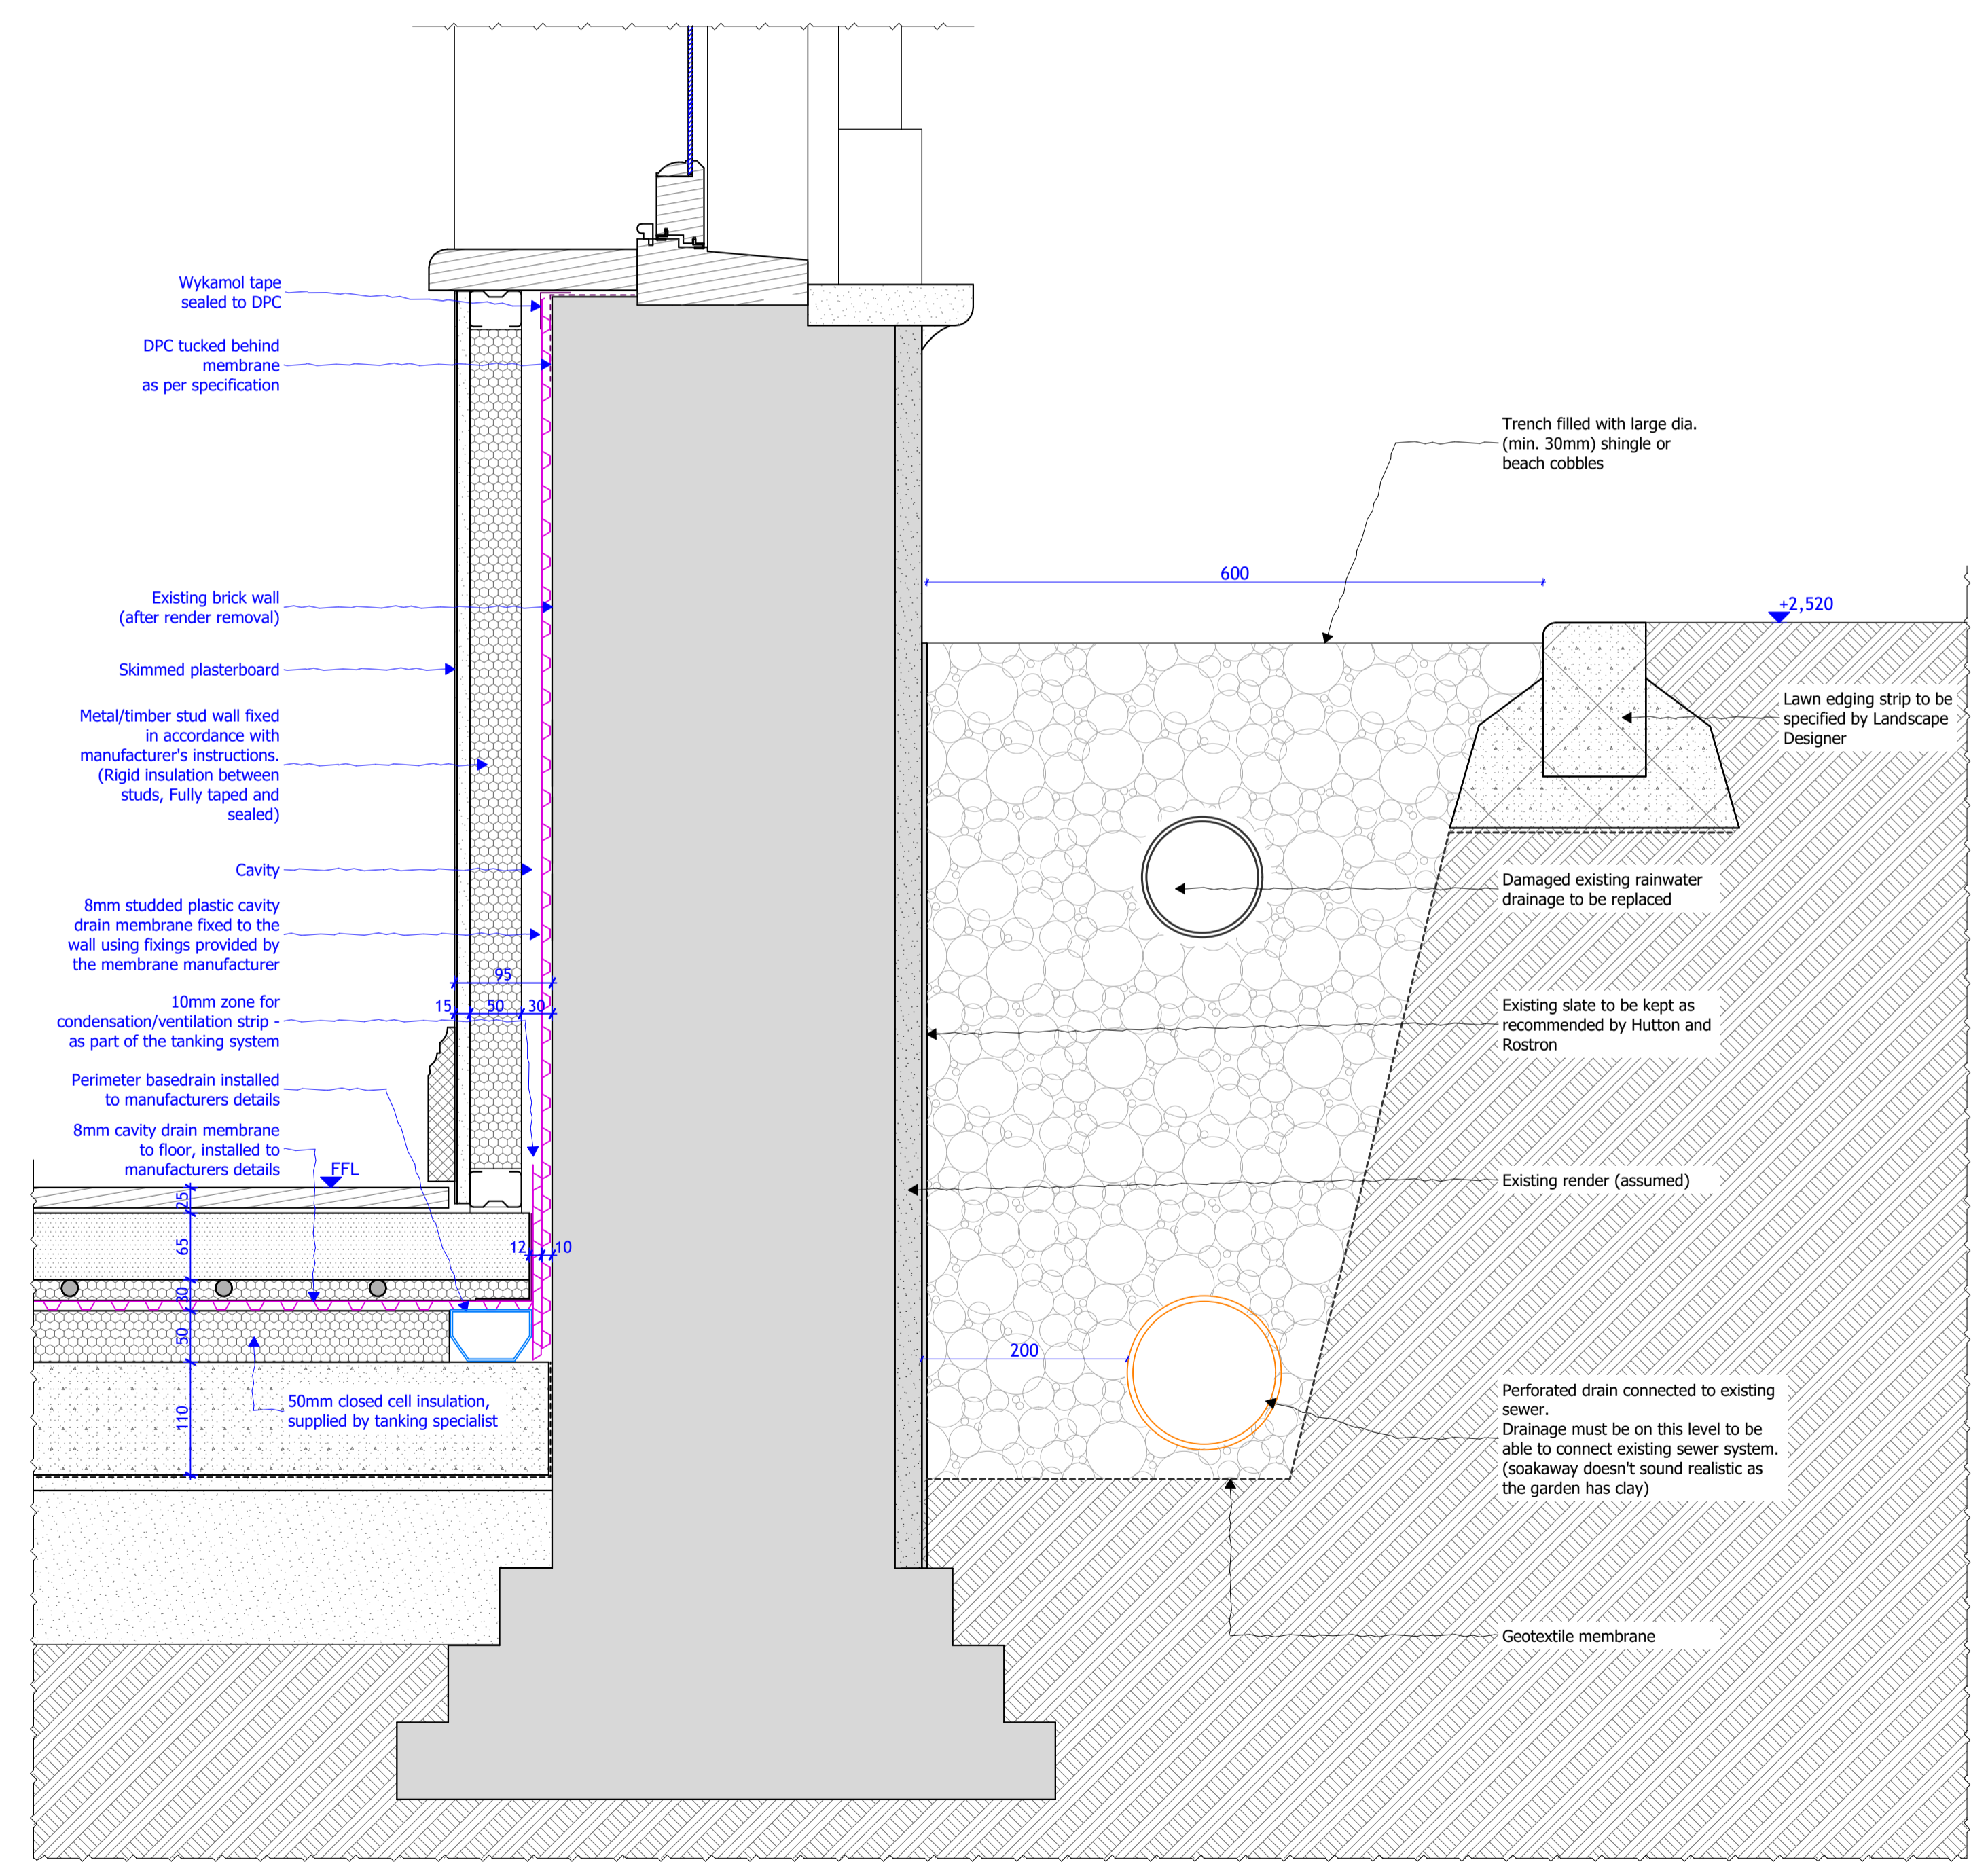
3 Trench Detail with French Drain - Section

External walls: The external walls were not inspected in detail. At the rear elevation, the walls were generally of similar construction to the front elevation. To the bay window, the walls below ground level had been applied with a vertical course of slate. This was cracked and spalled in areas. This was not acting effectively as a barrier to dampness, however, would reduce the dampness penetrating into the walls. Given the relative flexibility and capacity for movement of the walls, a more rigid material was bound to crack. Given the perched water table rainwater and likely build up of water within the earth against the bay, moisture was always likely to penetrate into the property

The slate could be retained. It will be providing some protection against groundwater and acting as a type A tanking system albeit with defects, allowing moisture to trickle rather than freely flow through. This would require additional protection internally in the form of a CDM system as mentioned later within the report
