TECHNICAL REPORT ON A SUBSIDENCE CLAIM

49 & 49A Gloucester Crescent
London
NW1 7EG

SUBSIDENCE CLAIM

5 March 2024

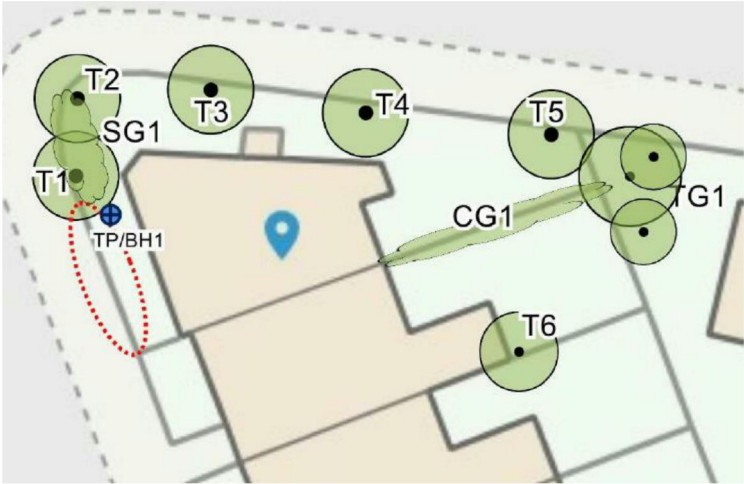
See sketch.

There are several trees and shrubs nearby, some with roots that may extend beneath the house foundations. The following are of particular interest:-

Tree No.	Species	Ht (m)	Dia (mm)	Crown Spread (m)	Dist. to building (m)	Age Classification	Ownership
T1	Lime	12.0	440	5.0	1.4	Younger than Property	Policy Holder
Management history		Subject to past management/pruning - previously pollarded at approx. 3.0m and since crown reduced.					
Recommendation		Re-pollard to original points at approx. 3.0m and thereafter re-pollard on a triennial cycle to maintain at broadly reduced dimensions. Subject to review if movement persist.					
T2	Lime	10.5	440	4.5	3.1	Younger than Property	Policy Holder
Management history		Subject to past management/pruning - previously pollarded at approx. 3.0m and since crown reduced.					
Recommendation		Re-pollard to original points at approx. 3.0m and thereafter re-pollard on a triennial cycle to maintain at broadly reduced dimensions. Subject to review if movement persist.

As per the recommendations of the Arboricultural Report the T1 and T2 Limes are to be pollarded at smaller dimensions to allow the property to stabilise.
