Arboricultural Appraisal Report

Subsidence Damage Investigation at:

49 and 49A Gloucester Crescent
London
NW1 7EG

CLIENT:	Crawford & Company
CLIENT REF:	[REDACTED]
MWA REF:	[REDACTED]
MWA CONSULTANT:	Andy Clark
REPORT DATE:	01/02/2024

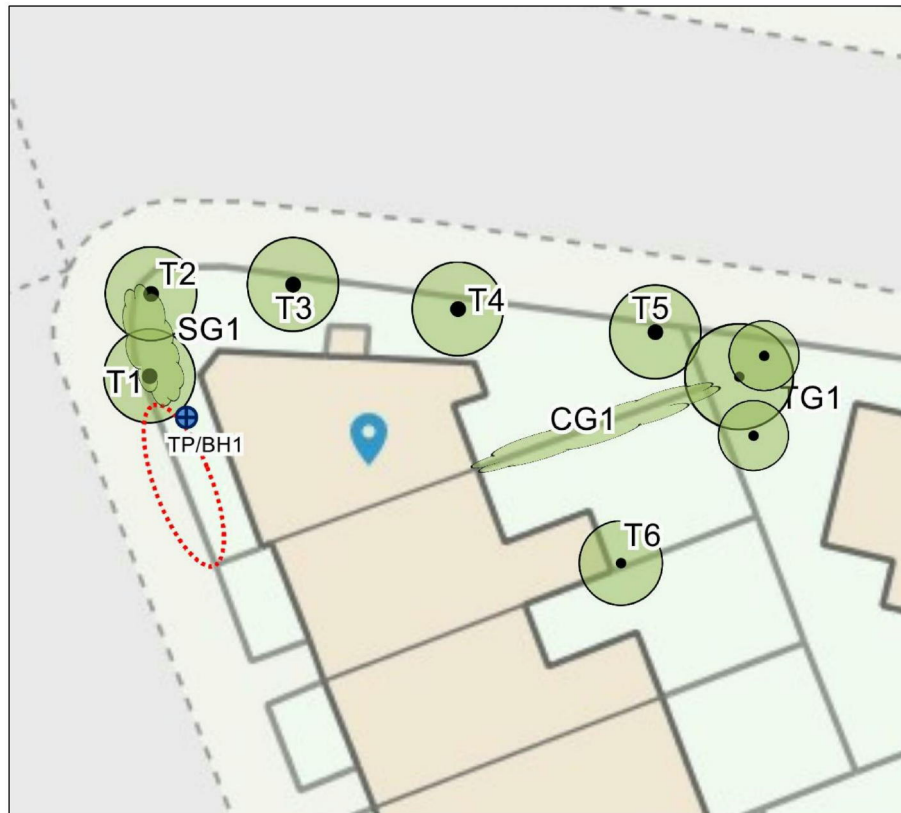
Site Plan

Approximate areas of damage

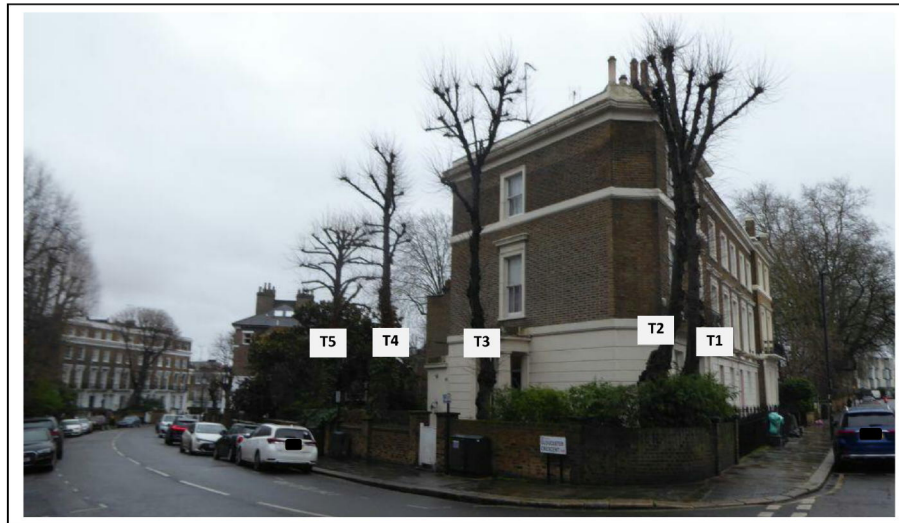
Roots were observed to a depth of 1.2m bgl in TP/BH1, and recovered samples have been positively identified (using anatomical analysis) as *Tilia* spp., and possibly either *Pomoideae* gp. or *Prunus* spp. [Poor sample]; the most significant of which are the *Tilia* spp. roots which will originate from the nearby Lime trees [T1 and T2 being the closest].

Overview of T1 to T5 Limes

If an arboricultural solution is to be implemented to mitigate the influence of the implicated trees/vegetation we recommend that T1 and T2 Limes are pollarded at smaller dimensions. Other vegetation recorded presents a potential future risk to building stability and management is therefore recommended. Recommended tree works may however be subject to change upon receipt of additional information.

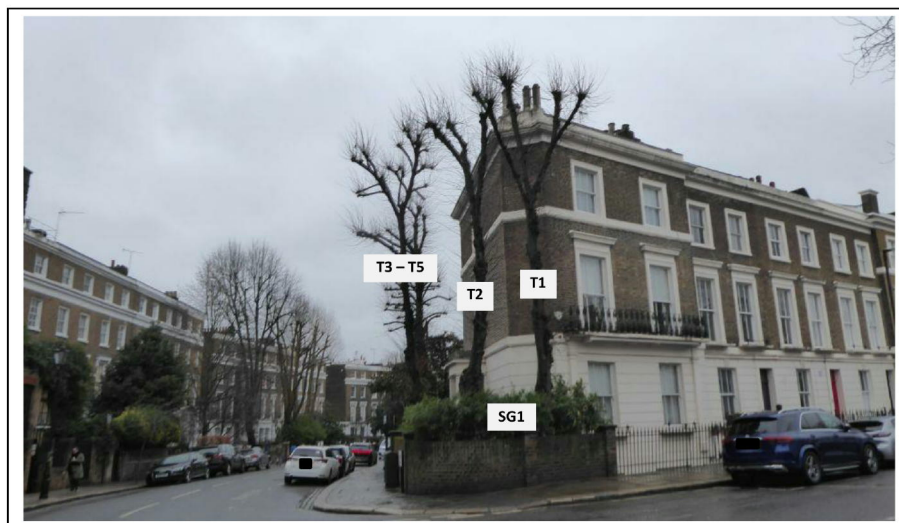
View of T1 and T2 Limes, with SG1 Bamboo below and T3 to T5 Limes visible beyond

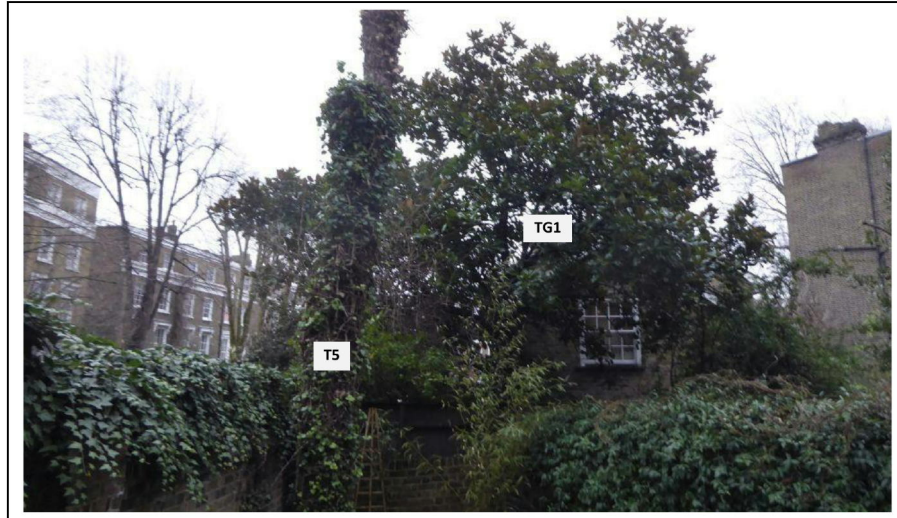
View of TG1 group with T5 Lime stem visible to foreground

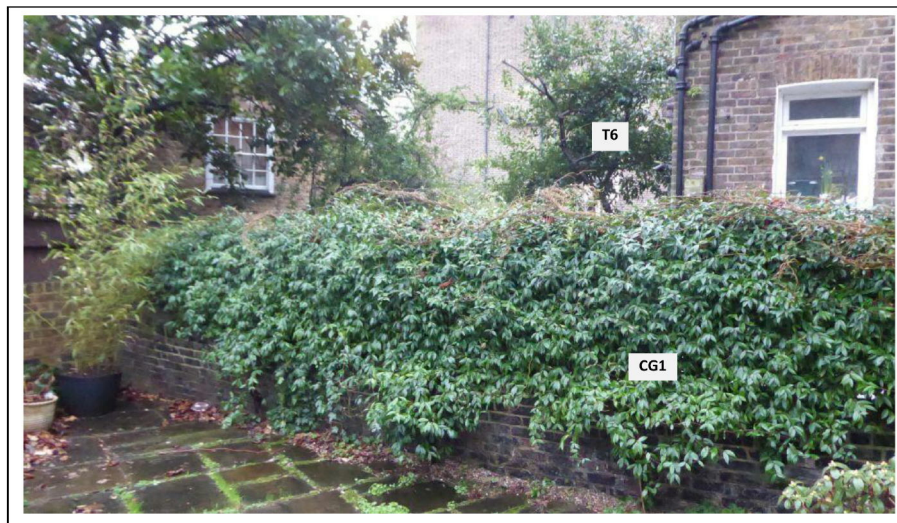
View of CG1 Jasmine with T6 Bay visible beyond
