S1281-J1-R1

REPORT

on trees in relation to
62A Savernake Road, London, NW3 2JR

For Redbourne Consultants (ref: RC 2088/23)

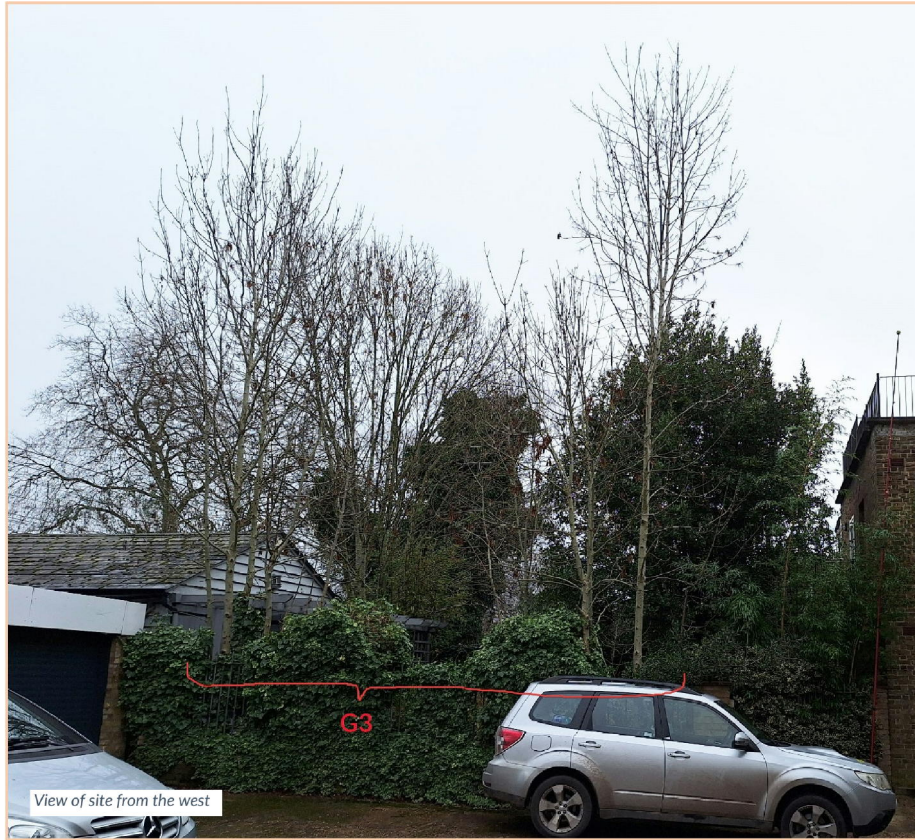
4 Photo

The root identification indicates that vegetation (bay 2 and likely, certain bamboo in G1) near the property has developed roots close to or under the footings. Questions therefore arise over how such vegetation could be managed in order to reduce soil drying near the footings.

The main influence on soil drying is likely the bay tree 2. That having been said bay as a species is typically not very often involved in vegetation-related subsidence damage cases. They responds well to pruning and can be fairly straightforwardly maintained as topiary. As far as the clump of bamboo is concerned, these appear to consist of *Phyllostachys aurea* and *P. nigra*, black bamboo. The latter is probably not involved in the soil drying in my view (they are much smaller than the former) but the larger golden bamboo probably is. It could be practically difficult to extract the golden bamboo from the black.

Tree number	Tree type	Height (m)	Stem diameters (mm)	Proximity (m)	Comments	Cost - £
G1	golden and black bamboo	7.5	<40, <40, <40, <40, <40	1	Phyllostachys aurea and P.nigra. Remove the former.	
2	bay	9	No access	3	Reduce to and maintain at 5m in height as a topiarised item.	
G3	common ash	10	<150	6	Poorly sited for growth to maturity. I recommend they are removed, the stumps ground out to 250mm below ground level and something more suitable planted for example, say three <i>small</i> trees arranged along the left boundary.
