### Tree & Landscape Report

The Garden House  
Vale of Health  
London  
NW3 1AN

12th December 2017

AR/MF/053/17

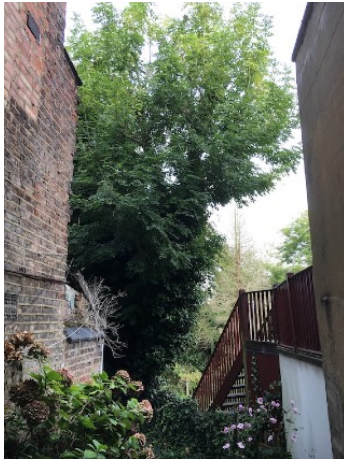
4.3 Sited within a raised retainer tree T1 is a developing young to early mature Ash tree. Although generally structurally sound and with compact and columnar form, T1 is inappropriately placed and will be problematic for the long term with the following information relevant:

4.3.1 The 800mm height x 1500mm width raised retainer is insufficient for the mature development of an Ash tree, a species with an expansive and significant root system

4.3.2 The historic boundary wall to the west - approximate height 4m - is likely to be damaged with the development of a large and mature tree due to the very close proximity

4.3.3 The canopy growth will for the long term become expansive both in height and spread for the location close to Heath Villas and The Garden House also

Tree T1 - Ash - as viewed in an easterly direction from within The Garden House access pathway

T1 Ash

Fell to ground level and grind out stump

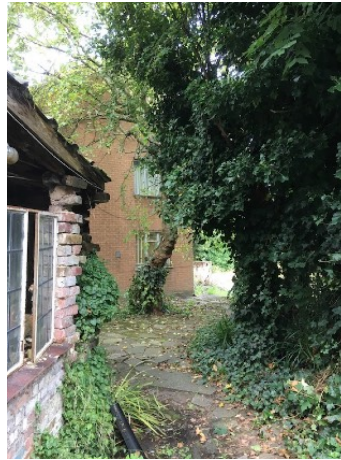
4.9 Tree T5 is proposed for removal as highlighted within the *Arboricultural Impact Assessment Report - AIA/MF/052/17*. The tree is unsuitable in relation to the property in its current condition and therefore as proposed also for the following reasons:

4.9.1 Very close proximity of medium sized tree with dense habit and large leaf size

4.9.2 Tendency to lean with age particularly on sites where preferred dry / well drained soil is not present

4.9.3 Poor aesthetics further to pruning works required cyclically for tree in its current location and compromised form for the long term

Tree T5 - Mulberry - as viewed in a northerly direction with Berberis trees / shrubs adjacent to the south on boundary

T5 Mulberry

Fell to ground level and grind out stump

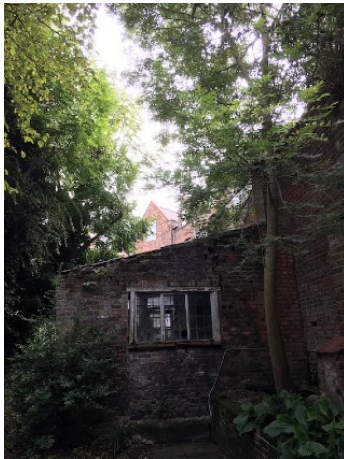
Tree T1 - Ash - located within raised border on western boundary as viewed in a southerly direction

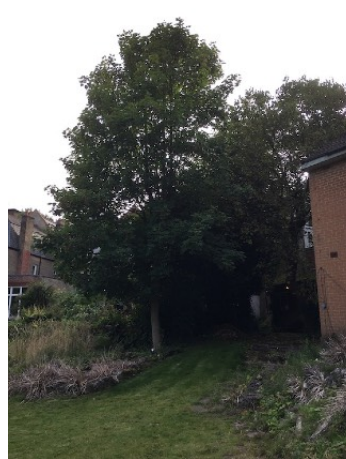
4.11 Tree T6, the early mature to mature Sycamore tree is proposed for retention and as discussed above will be complimented by the proposed replacement planting scheme on the south western boundary between The Garden House and No. 13 Heath Villas

Tree T6 - Sycamore - and upper canopy of T5 - Mulberry - as viewed in a south westerly direction from main lawn area

T6 Sycamore

Crown lift to 4m

Remove any major deadwood

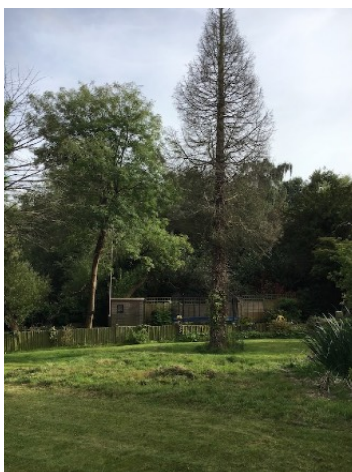
4.12 The Cypress tree (T7) within the main lawn area has died and requires removal as in its current condition it is hazardous being unstable. The tree has likely died due to excessive wet conditions with the ground consistently wet underfoot (late summer at time of inspection - August 2017)

Tree T7 - Cypress - tree is dead within main lawn area as viewed in a southerly direction

T7 Cypress (dead)

Fell to ground level and grind out stump

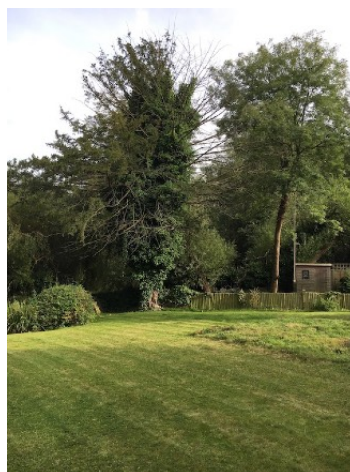
T8	Yew	13	720	N: 6 E: 3 S: 4 W:4	M/OM	P	F/P	C.2	Less than 10 years	Tree has significant dead sections throughout but is an old tree with wildlife habitat directly adjacent to the pond / heath. To the west the tree is completely dead; to the north 25% live growth; to east very limited growth; to south 10% live growth ; upper canopy 50% live growth. Dieback likely due to tree's permanently waterlogged ground condition, not preferred by species	Option 1: Fell to ground level to implement improved landscape scheme for boundary in accordance with all restrictive covenants  Option 2: Crown reduce height 40% / Spread 25% to retain for habitat whilst removing hazards	8.6m
T9	Willow	10	600 (e)	N: 5 E: 3 S: 3 W:3	M/OM	P	F	C.2	10-20 years	Tree is a heavily leaning specimen to the north east over the adjacent pond. Not able to fully inspect due to this location but in latter stages of life offering important wildlife habitat	No action required at present	7.1m

Tree T8 - Yew - as viewed in a southerly direction

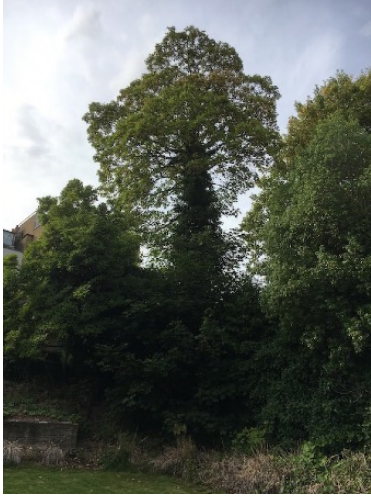
4.22 The mature Magnolia tree (*Magnolia x soulangeana*) currently suppressed beneath tree T11 adjacent appears generally structurally sound. The form is compromised by suppression mainly to the south and west from the adjacent Sycamore tree. Proposed for retention in the scheme, the tree will require protection where formalisation of the garden topography is required within the landscape scheme.

Tree T11 - Sycamore - and T12 - Magnolia - as viewed from within main lawn area in a north westerly direction

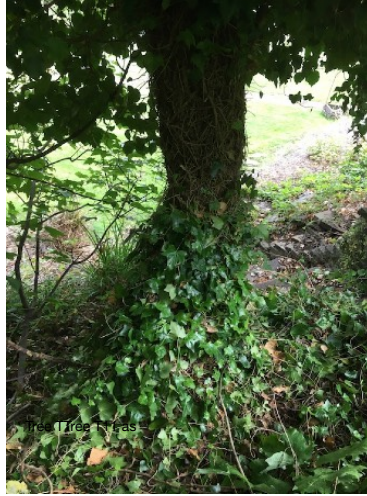
4.20 Tree T11 is a mature Sycamore tree which is sited on the northern boundary of the site on steeply sloping topography (north to south). The tree is sited 0.3m from the historic low retaining wall which at 1200mm height full retains the land to the north within the rear gardens of Athenaeum Hall. The survey of this tree was carried out with the tree being significantly ivy clad and therefore not all structural features could be identified. However the main characteristics of the single stemmed tree include:

- Base appears generally structurally sound
- Significant compensatory growth at 1.6-1.8m on west side likely due to removal of large stem growing towards property originally
- Excessively crown lifted thereafter to crown break at 7-8m
- Overall crown limited relative to age of species with majority
- Low to moderate vigour in upper crown / moderate vigour in mid crown

Base of tree T11- Sycamore, as viewed in a easterly direction

T11 Sycamore

Remove ivy and inspect main stem

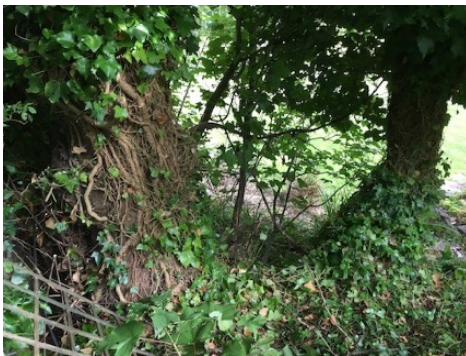
Base of tree T11 - Sycamore - and T12 - Magnolia - as viewed in a south easterly direction showing sloping topography of ite

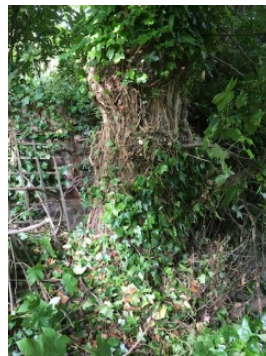
Base of tree T11 - Sycamore - with parial ivy removal
