**TREE SURVEY & CONSTRAINTS PLAN
IN ACCORDANCE WITH BS 5837:2012**

Proj. No 10986	6 Redington Road, London, NW3 7RG	
Client:	Simon Firth	
Date of Report:	24/06/2024

Hayden's Arboricultural Consultants Ltd, Units 3-5 Moseley's Farm Business Centre
Fornham All Saints, Bury St Edmunds Suffolk. IP28 6JY

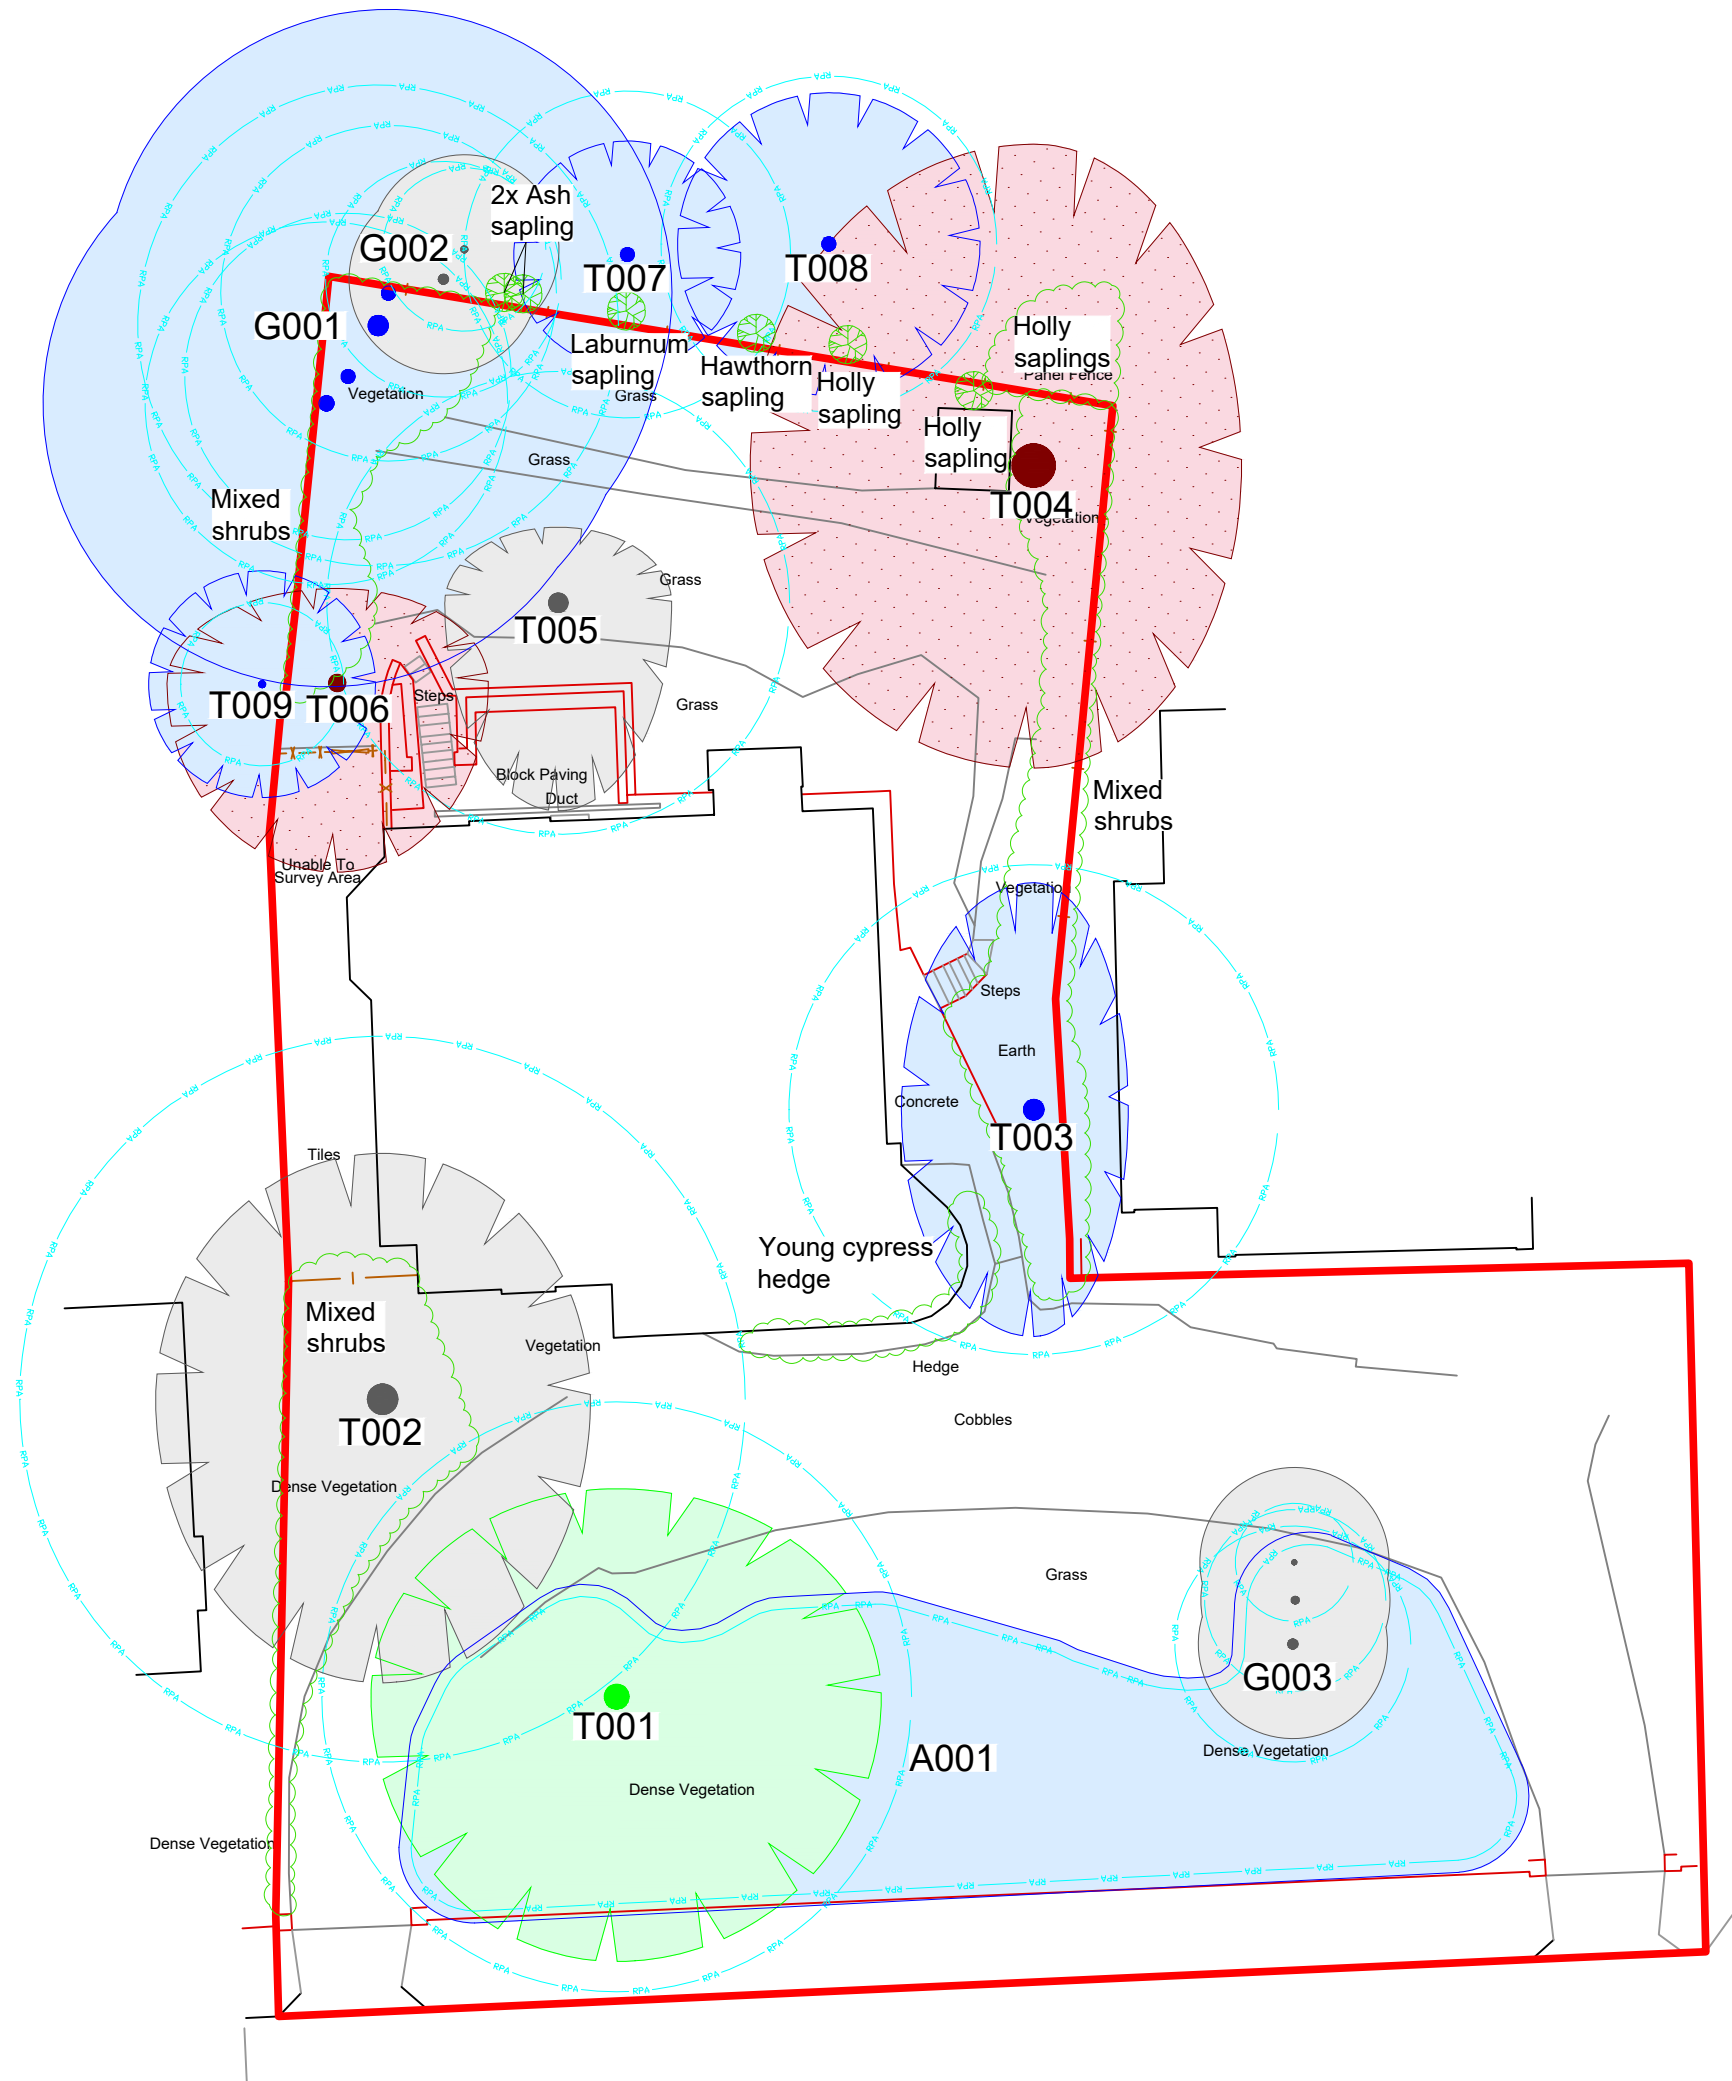
Existing Site Plan

Hayden's contacted London Borough of Camden Council on 12/06/2024. We were informed that:

- TPO's are present on site
- The site is located within a conservation area
