## REFURBISHMENT DEMOLITION ASBESTOS SURVEY

50 Torbay Court London NW1 8HW

9 Apr 2024

J829

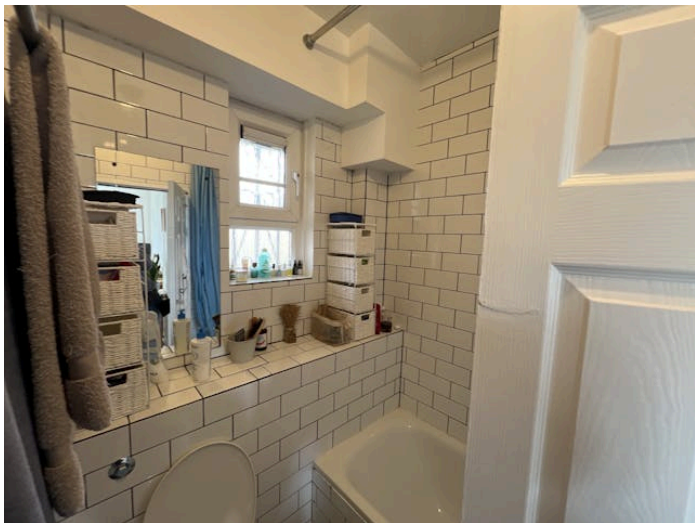
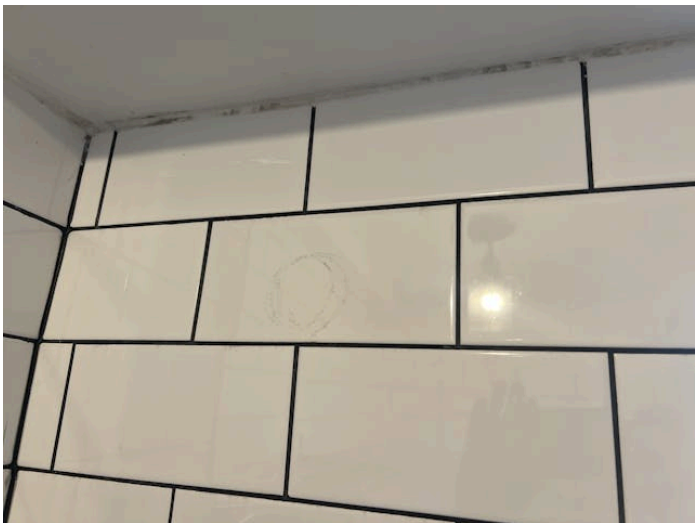
Main Building > 5 > Bathroom > Location Notes

Location Notes	Concrete ceiling, ceramic tiled walls, brick and plaster walls where walls are to be core drilled, fitted ceramic tiled floor.

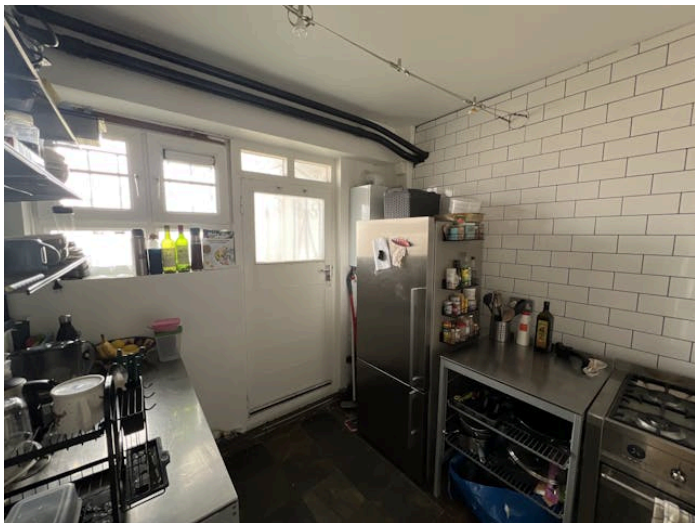
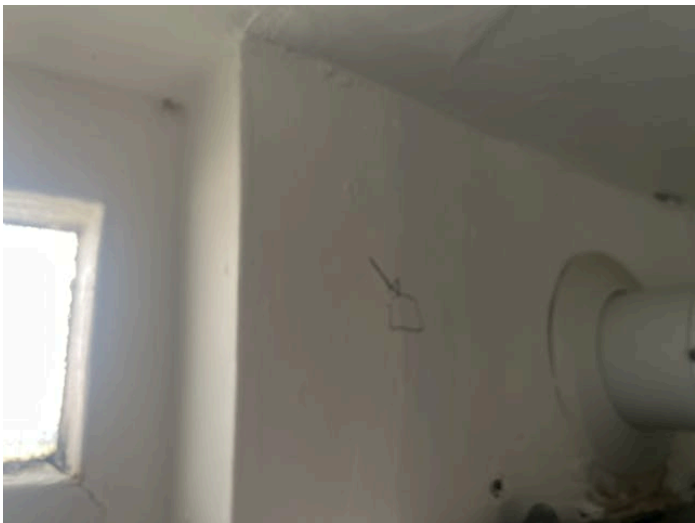
Main Building > 5 > Kitchen > Location Notes

Location Notes	Concrete ceiling, brick and plaster walls, modern boiler, timber external door and glass infill with no mastic, fitted ceramic tiled floor.

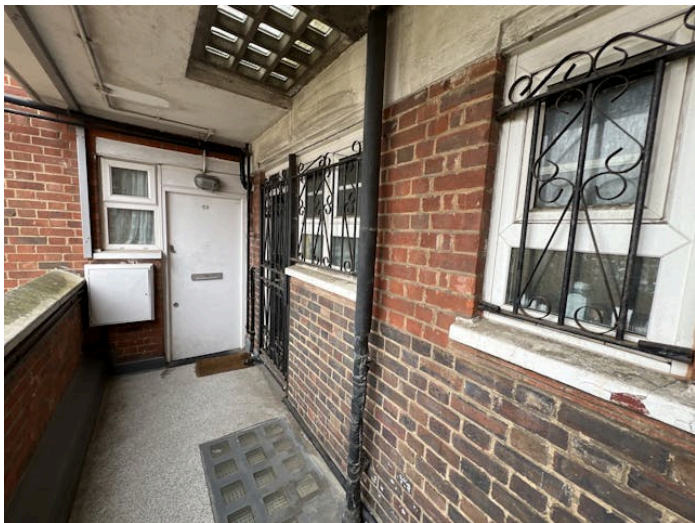
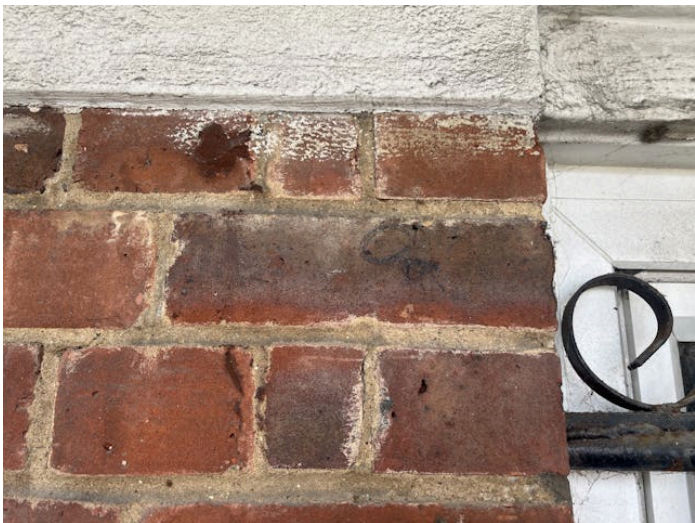
Main Building > External > External walls > Location Notes

Location Notes	Brick walls where cored wholes are to be made.
