Terracotta Balcony Replacement Design, Access, and Heritage Statement

UCL Student Union Building, 25 Gordon Street, London WC1H 0AY

Prepared for Stonewest Limited, on behalf of University College London

July 2024

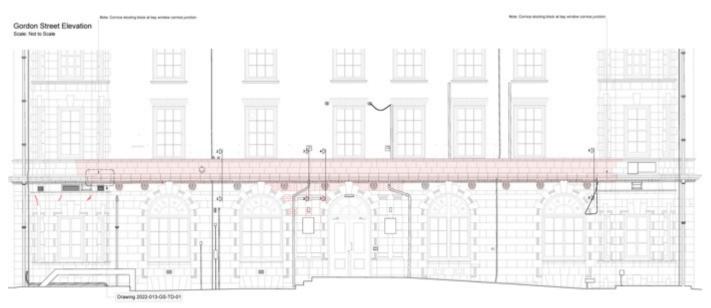
Figure 1. The Gordon Street elevation. The rebuilt balcony is shown by the red hatching

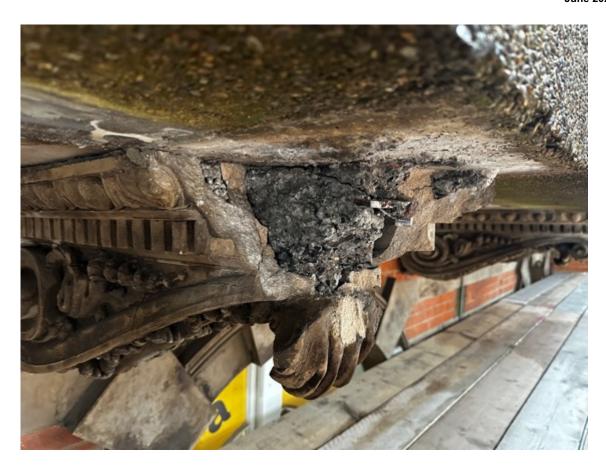
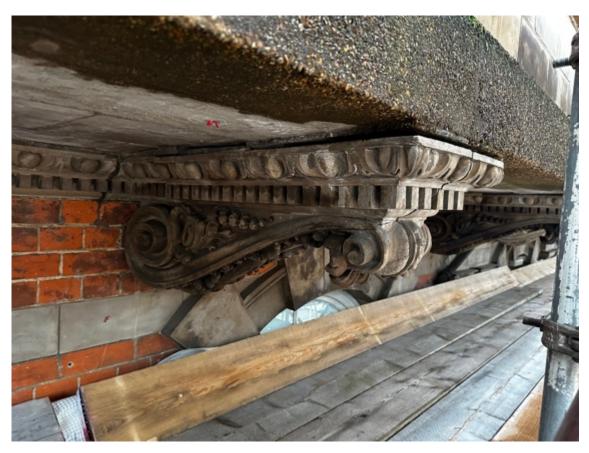
Figures 3 and **4**. Expansive corrosion of the steel balcony support and expansion of the saturated clinker concrete within the terracotta console has caused extensive cracking and failure. The image below shows the missing terracotta cornice which has been replaced with a crude exposed aggregate concrete repair.

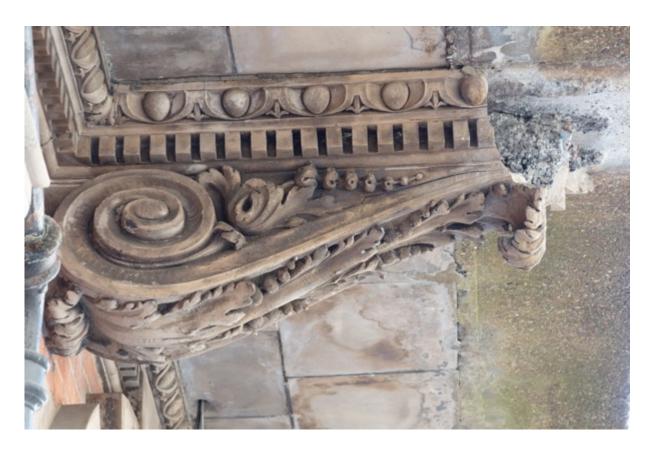
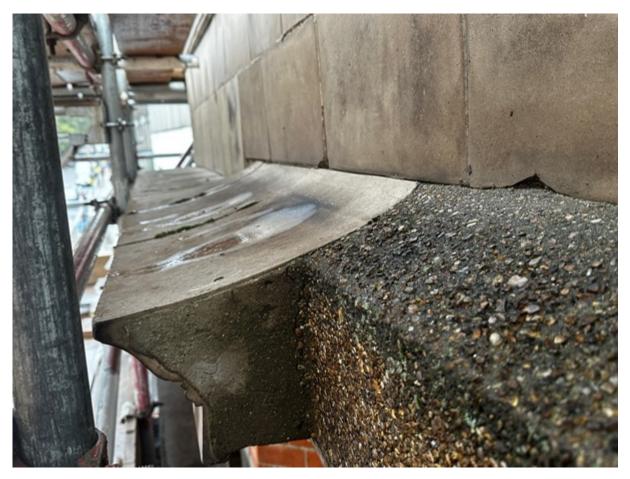
Figures 5 and **6**. A view of a terracotta console where the front section has broken away. Cracking extends across the full length of the console. Note, terracotta soffit tiles at the front of the balcony have been replaced with a cement render. The image below shows a section of original terracotta cornice surviving at the left hand (south) end.

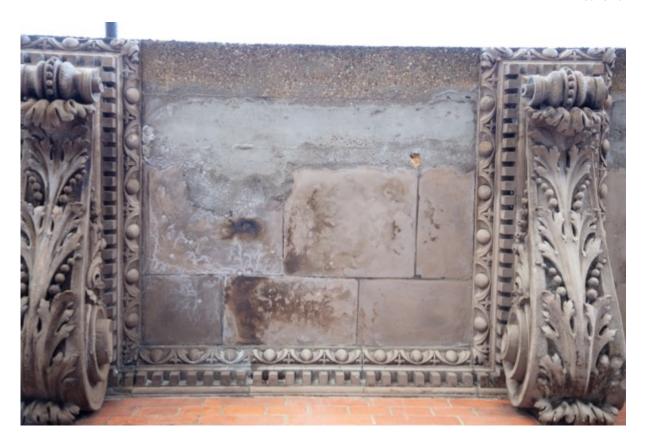
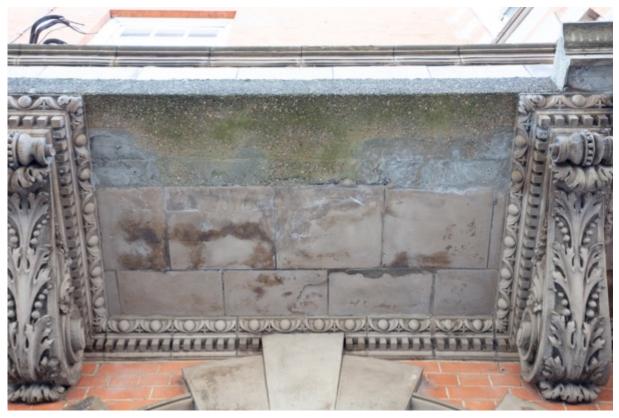
Figures 7 and **8**. Two sections of the balcony soffit illustrating missing tiles along the front edge and remaining tiles with extensive damage. This condition applies to the entire soffit.

- **Terracotta soffit tiles** the balcony soffit is clad with 50mm thick terracotta tiles. These will be replaced with minor modification to accommodate new stainless steel restraint fixings. The tile size, format and appearance will match the original design.

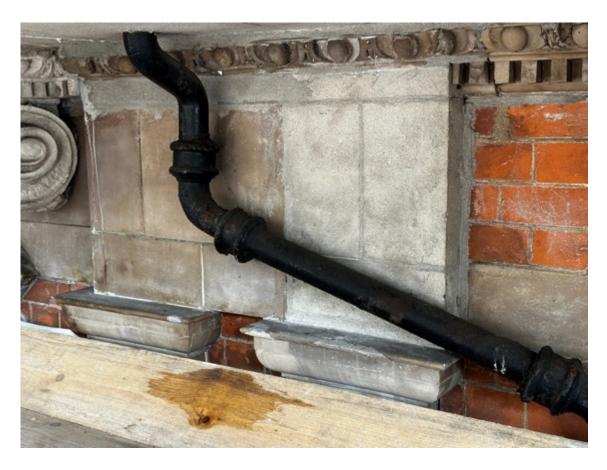
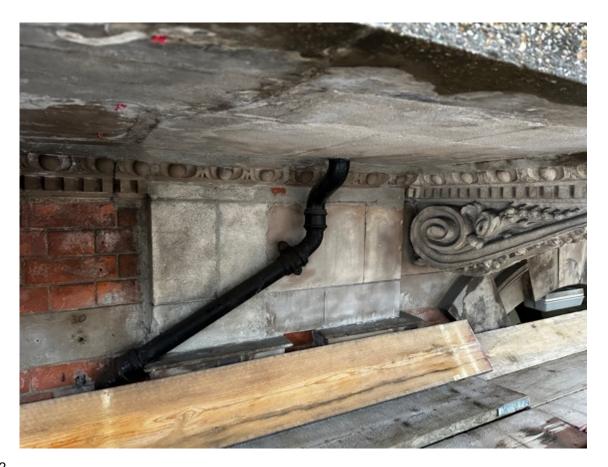
Figures 9 and **10**. Two areas of ashlar terracotta below the balcony which have been crudely replaced with cement render. This work appears to relate to alterations to the rainwater drainage.

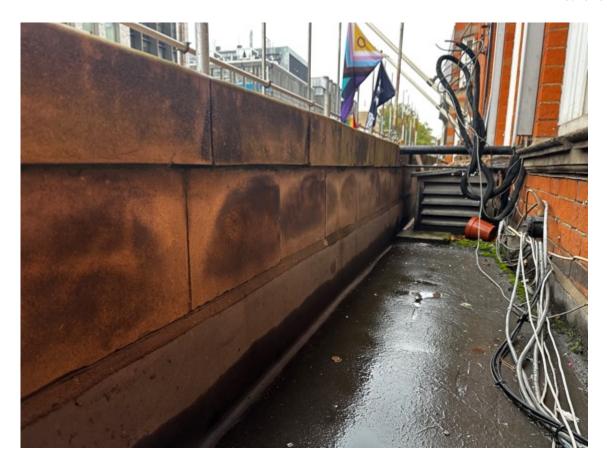
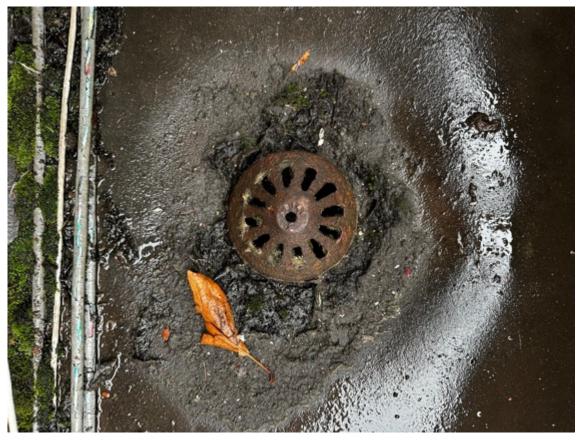
Figures 11 and **12**. The existing mastic asphalt. Cracks, splits and bulges are present. One of the two existing cast iron rainwater outlets. The internal dimension is only 44mm and there is very little drainage fall towards the outlets

- 2.10 The existing cast iron outlets are too small for current rainfall volumes. The outlets will be replaced with slightly larger cast iron outlets which meet existing rainfall demands plus a further 20% increase in peak rainfall with predicted climate change impact. If the existing cast iron downpipes below the balcony can be separated from the existing outlets they will be reused, however it may be necessary to replace the downpipes with new cast iron. If the downpipes are replaced, new traditional cast iron downpipes will be used in a slightly larger size to accommodate increased rainfall.
- 2.11 The pipes will be painted black to match the existing.
