**Asbestos Refurbishment/Demolition Survey for**  
**Circle East Ltd**  
**at**  
**35A Broadhurst Gardens**  
**London**  
**NW6 3QT**

Project Number: 20180525-AR01-REFURB

This survey was carried out by Andy Robson on the 25th May 2018.

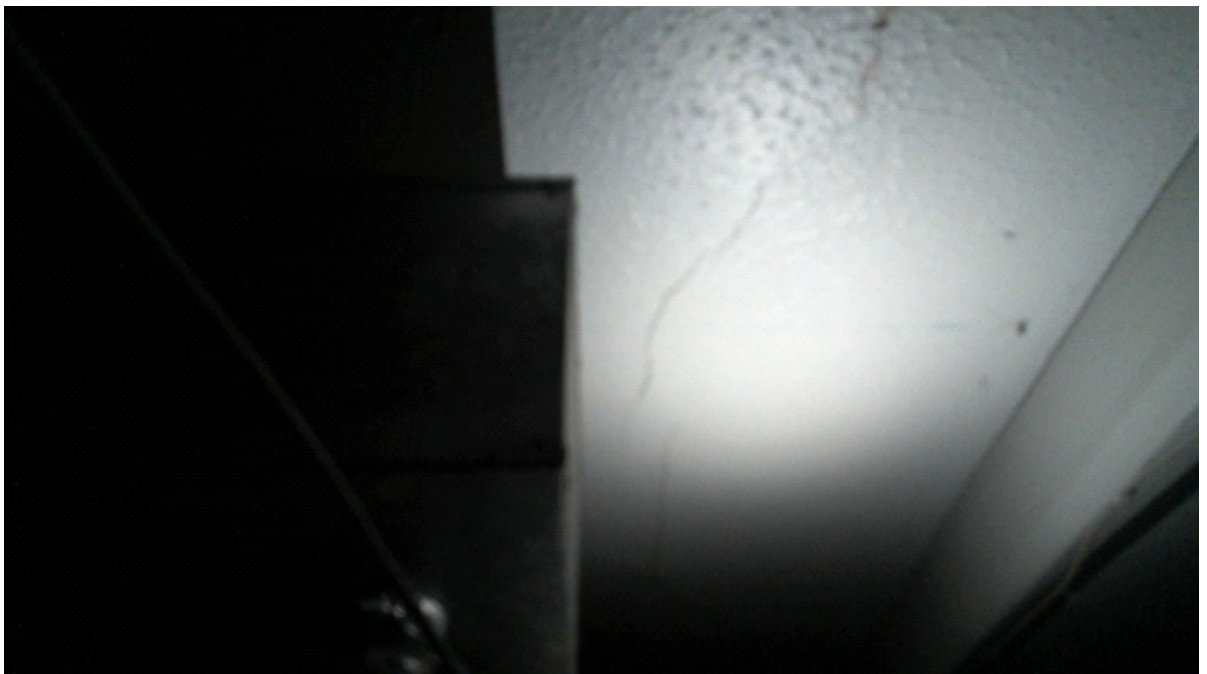
| Area: | Main Building | Damage: | No Asbestos Detected |

Material Comments: Non Asbestos Textured Coating (ceiling - above ceiling tiles - Also travels above ceiling of room 3 (recording studio))

Action: No Further Action Required

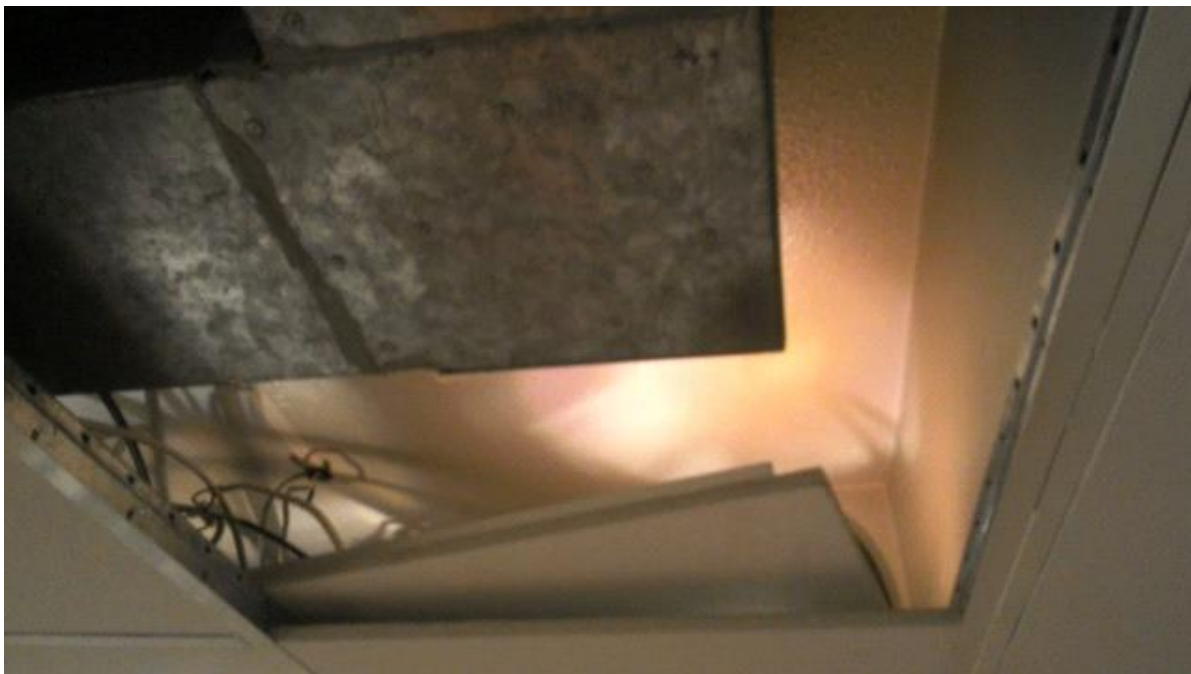
| Area: | Main Building | Damage: | No Asbestos Detected |

Material Comments: Non Asbestos Textured Coating (ceiling - above ceiling tiles)

Action: No Further Action Required
