Tree Condition Survey 2023

University of London

Gavin Jones Ref: MSURV/JV/UOL/2023

Survey work undertaken: 20th - 23rd November 2023

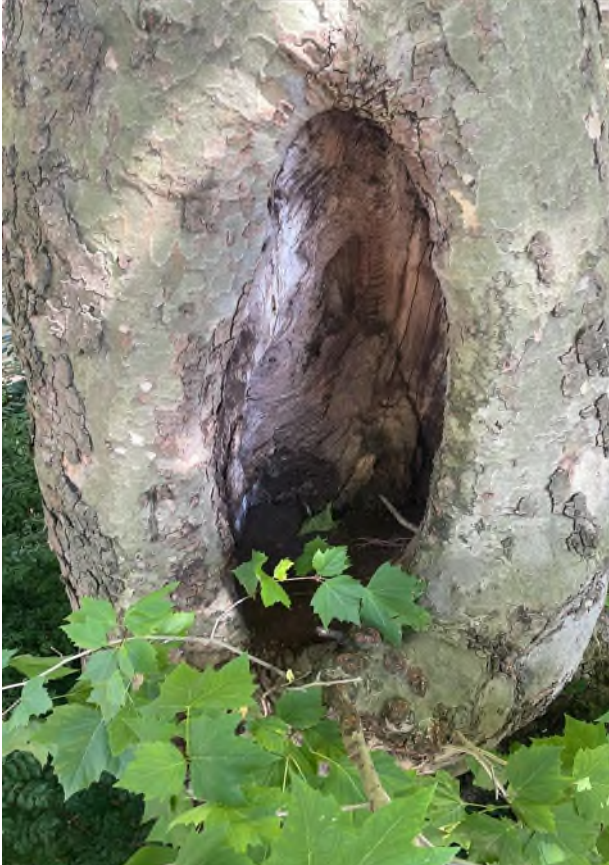
It is strongly recommended to carry out an internal decay evaluation on the stem of T103, a large, mature London plane. The large cavity on the stem was highlighted during the aerial *Massaria* inspections last year and although the tree is producing well-formed wound wood, given the size of the tree and its location, it would be prudent to have the stem assessed for

extent and severity of any internal decay. This will reveal the structural integrity of the residual wood which will, in turn, inform what the level of risk of potential failure there is and if any mitigating remedial works are required (see figure 1).

<p>Figure 1: Showing the cavity on T103, a large London plane. Although the cavity seems stable it will be prudent to check the condition of the residual wood by conducting a decay evaluation.</p>

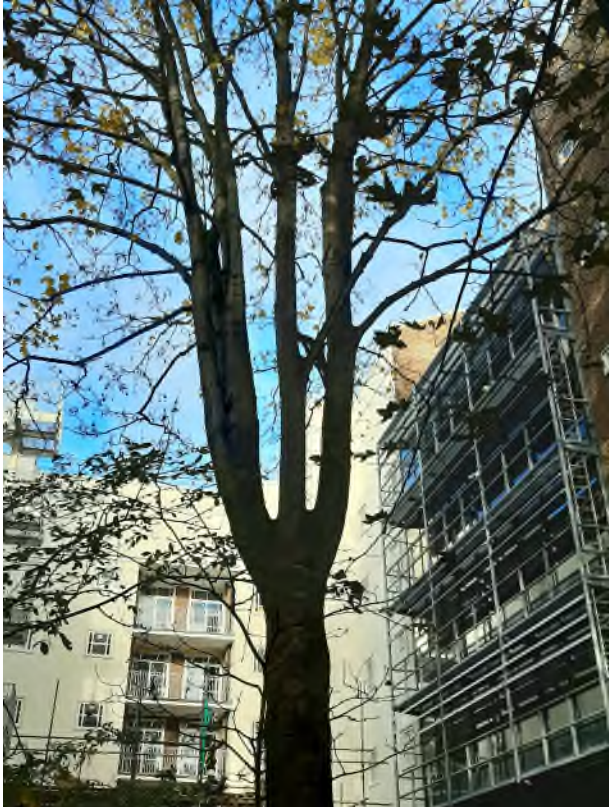
There is one tree which has been recommended for re-pollarding – T281, a sycamore classed as a lapsed pollard (see figure 2). This tree was heavily pollarded at least 20 years ago and has substantial growth above the old pollard points. Due to the extent/height of regrowth and the tree's close proximity to surrounding buildings, these works are recommended as a precautionary measure but are strongly advised.

<p>Figure 2: Showing T281, a 'lapsed pollard' sycamore. This will require pollarding to significantly reduce the risk of stem failure.</p>
