Method Statement and Scope of Repair

Boundary Wall, 34 Belsize Lane,
London

June 2024

Project Ref. 00567

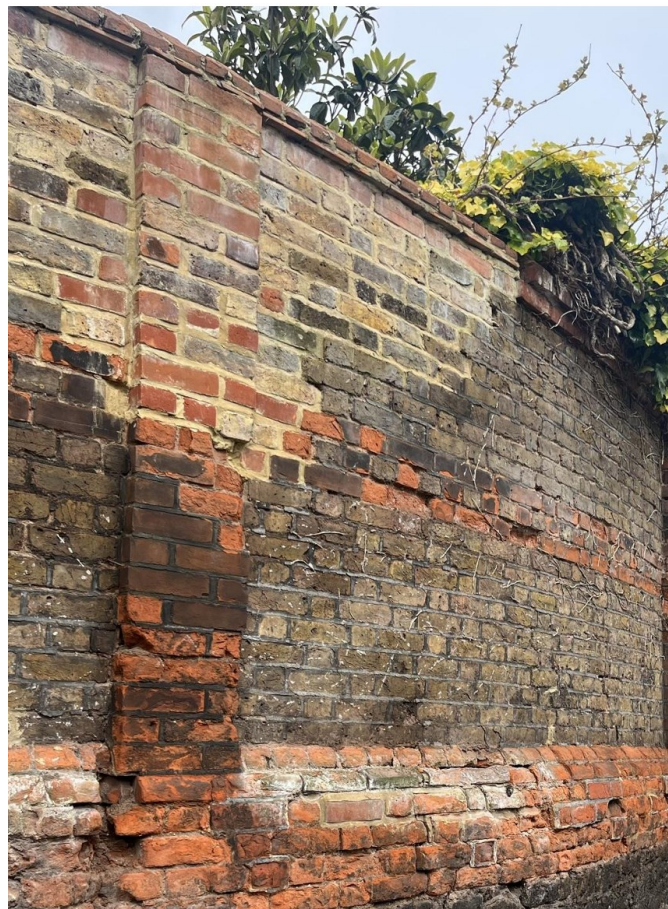
15. A large central section of rebuilt wall has omitted the stepped courses in favour of a tile course. This section also neglects strict adherence to the separation of yellow stocks and red facing brick. These poor quality works deviate from the intended design and are not contributory to the aesthetic interest of the wall.

Section of rebuilt wall of low quality

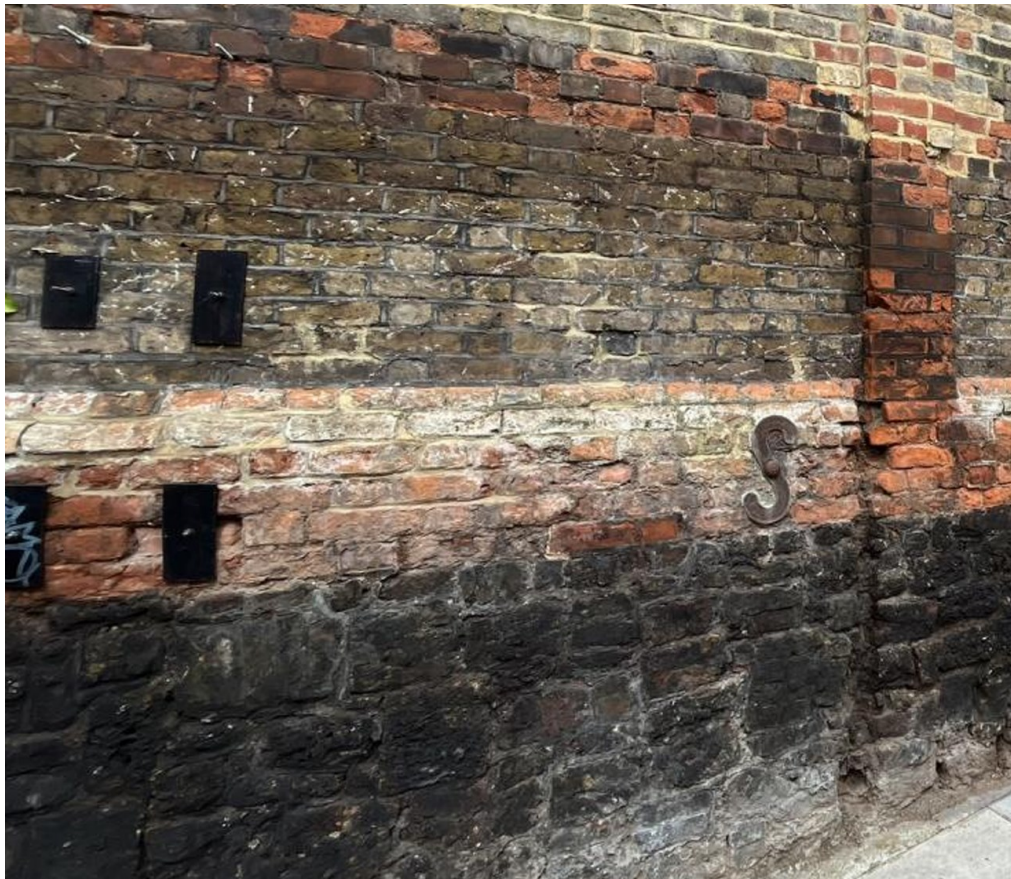
Wall has been previously been pinned.

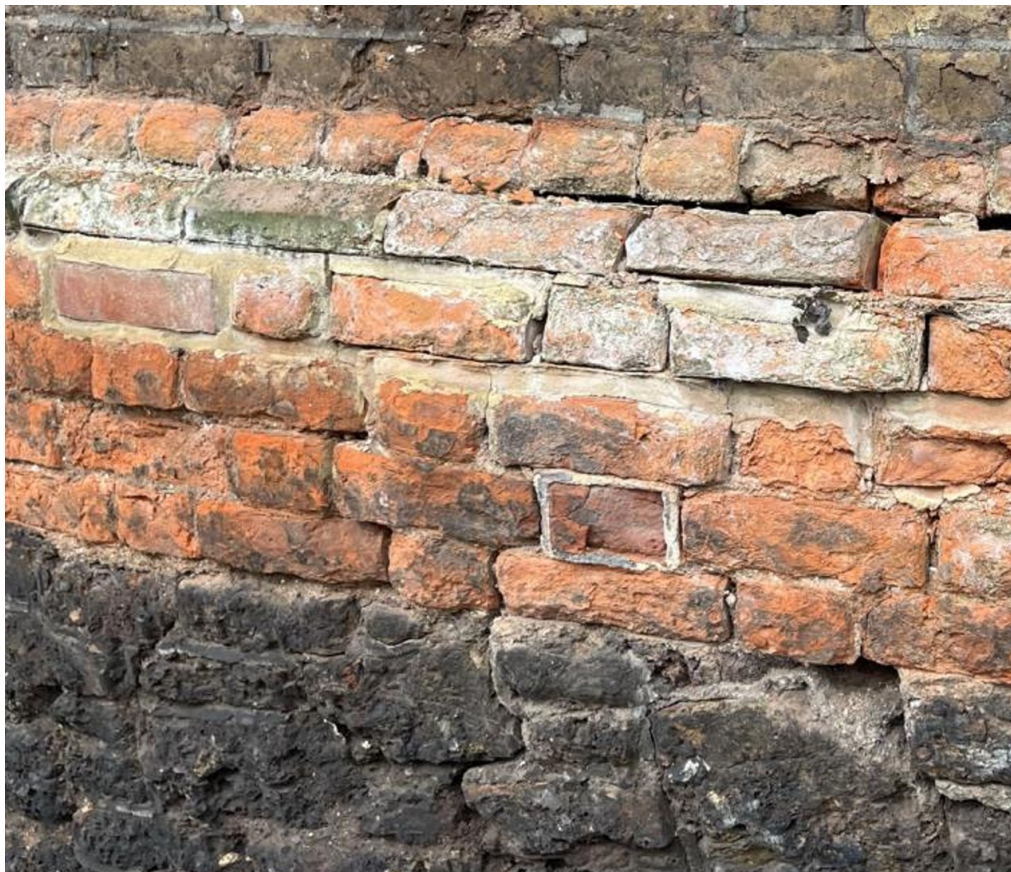
16. The red facing brick is evidently very soft with historic erosion of facings and arises. The erosion, in conjunction with the loss of the original lime mortar. Results in an uneven and irregular surface that will present challenges to repointing.

Example of eroded soft red brick, washed joints and low quality cement pointing.

- 25. Pointing repair styles, to match existing historic finishes. Sample panel to be presented for approval prior to executing full scope of works.
- 26. Inappropriate cement pointing of previous repairs should be removed, the joints raked and prepped for a lime pointing replacement. Due to the softness of the red brick it may be appropriate for careful use cutting discs if it aided removal of cement pointing without further loss or any damage to existing brick. Any mechanical cutting should only be attempted by experienced masons familiar with historic fabric and follow demonstrable trials.
