## ARBORICULTURAL ASSESSMENT REPORT

63A Belsize Lane, London, NW3 5AU

Survey Date: 23/10/2023

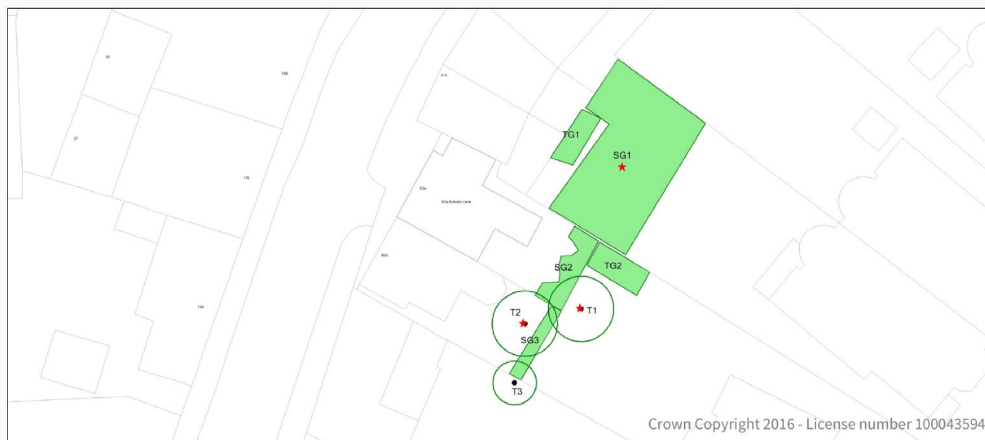
Location: 63A Belsize Lane, London, NW3 5AU

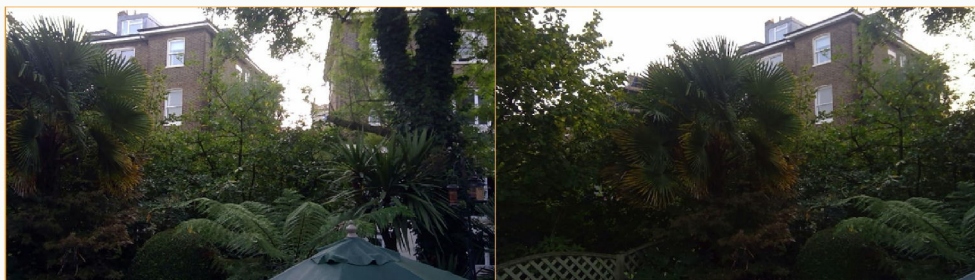
TG2 - Laurel

| Tree No | Common Name | Age Class | Condition | Height (m) | Crown Spread (m) | Stem diam. (mm) | Dist to bldg. (m) | Roots implicated | Pruning history | Recommendation | Tree work constraints | Notes | Owner address | Owner |
|---|---|---|---|---|---|---|---|---|---|---|---|---|---|---|
| TG2 | Laurel | Mature | Fair | 4.8* | 4* | 150* | 8.5* | N | Subject to past management. | No work required. | | | 30 Belsize Park London NW3 4DX | P3P |
