Appendix 2: Structural Engineer Report and Drawings / Price & Myers

University of London Lansdowne Terrace & Guilford Street Townhouses

Structural Engineering
RIBA Stage 3 Report

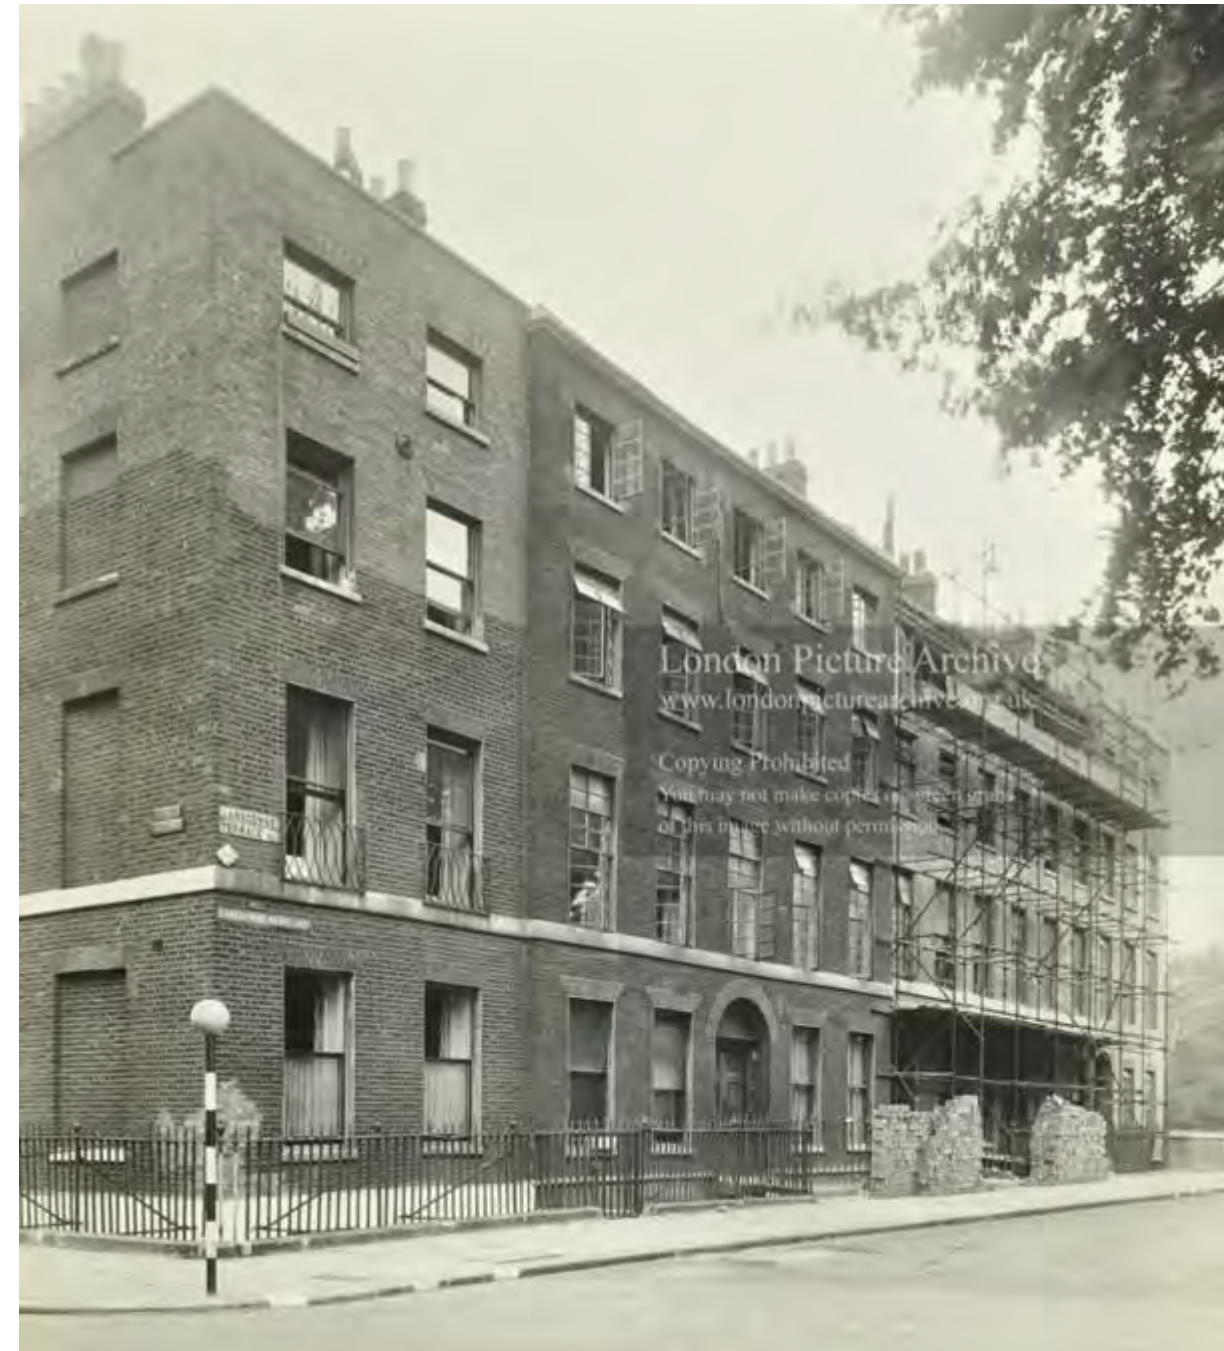
Figure 2 - 1940's photograph of Lansdowne Terrace showing rebuilding in progress.

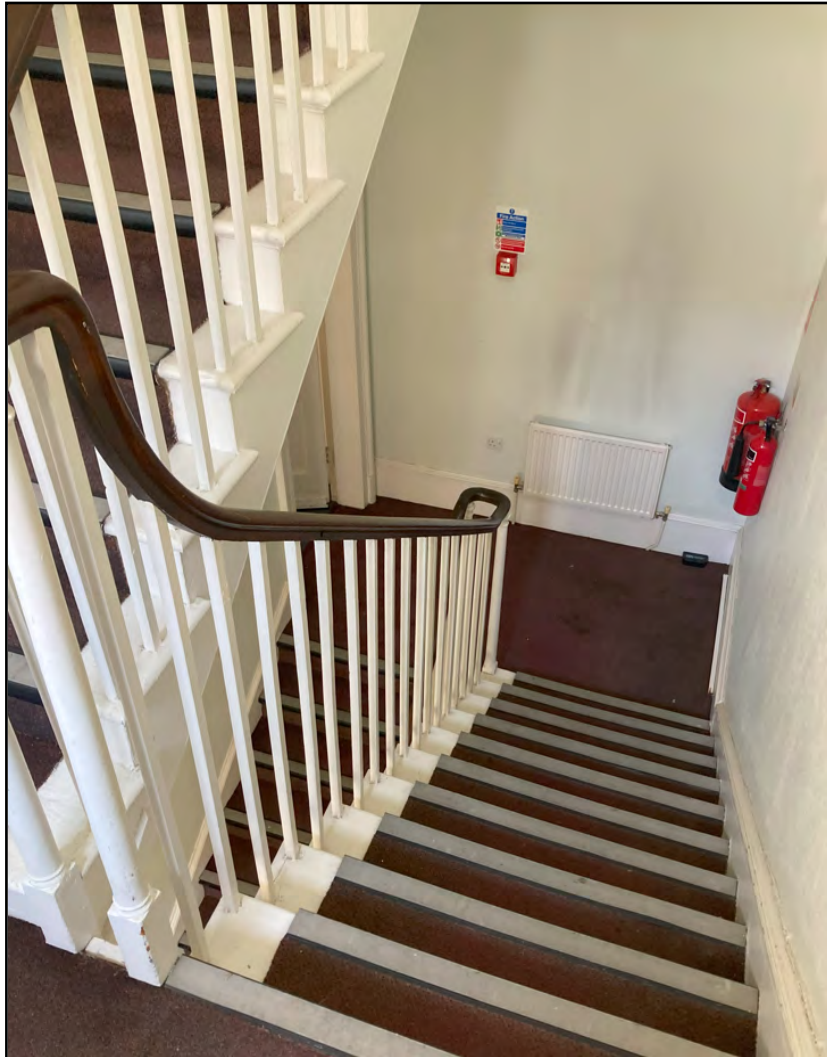
Typical Type 1 Stair (Suspected historic timber)

- Timber treads, risers and stringers
- Profiled 50mmx50mm timber handrail
- 20mmx20mm timber spindles at 120mm crs
- Pairs of 40mm round newel posts at some landings
- Generally loose and infective balustrade
- Handrail height to be confirmed

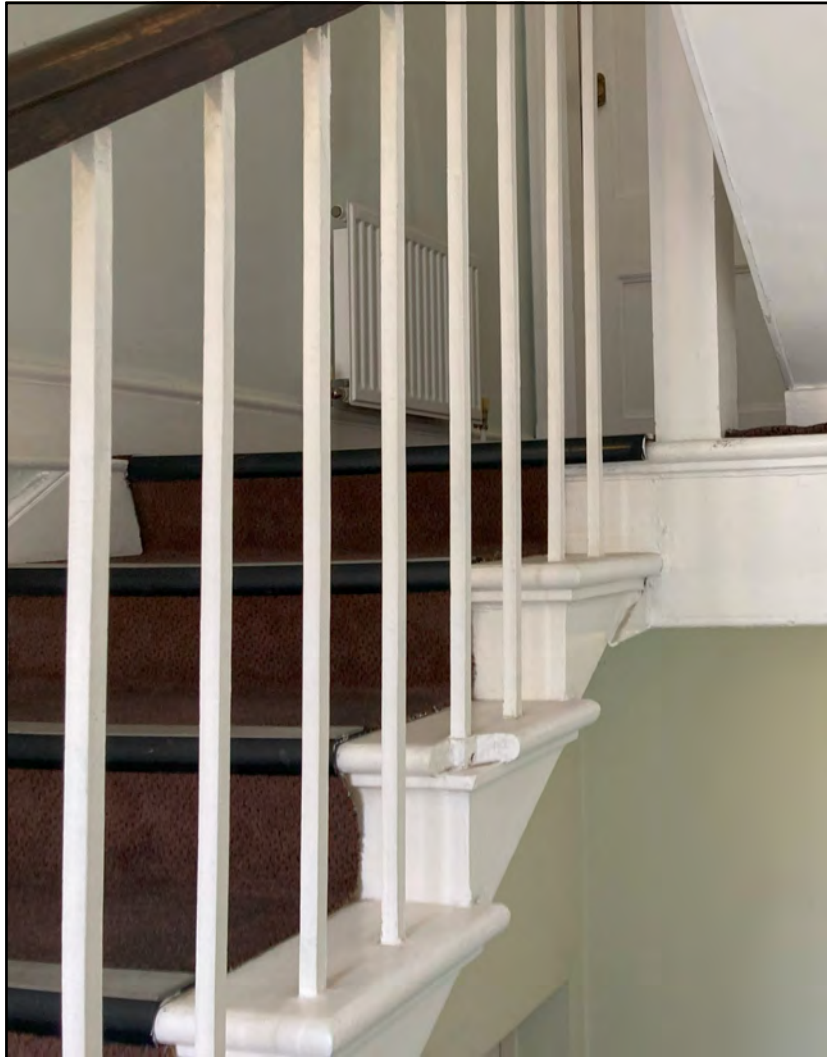
Typical Type 3 Stair (Suspected historic stone cantilever)

- Cantilever stone treads
- Profiled 50mmx50mm timber handrail
- 12mmx12mm iron spindles at 120mm crs
- Generally loose and infestive balustrade
- Handrail height to be confirmed

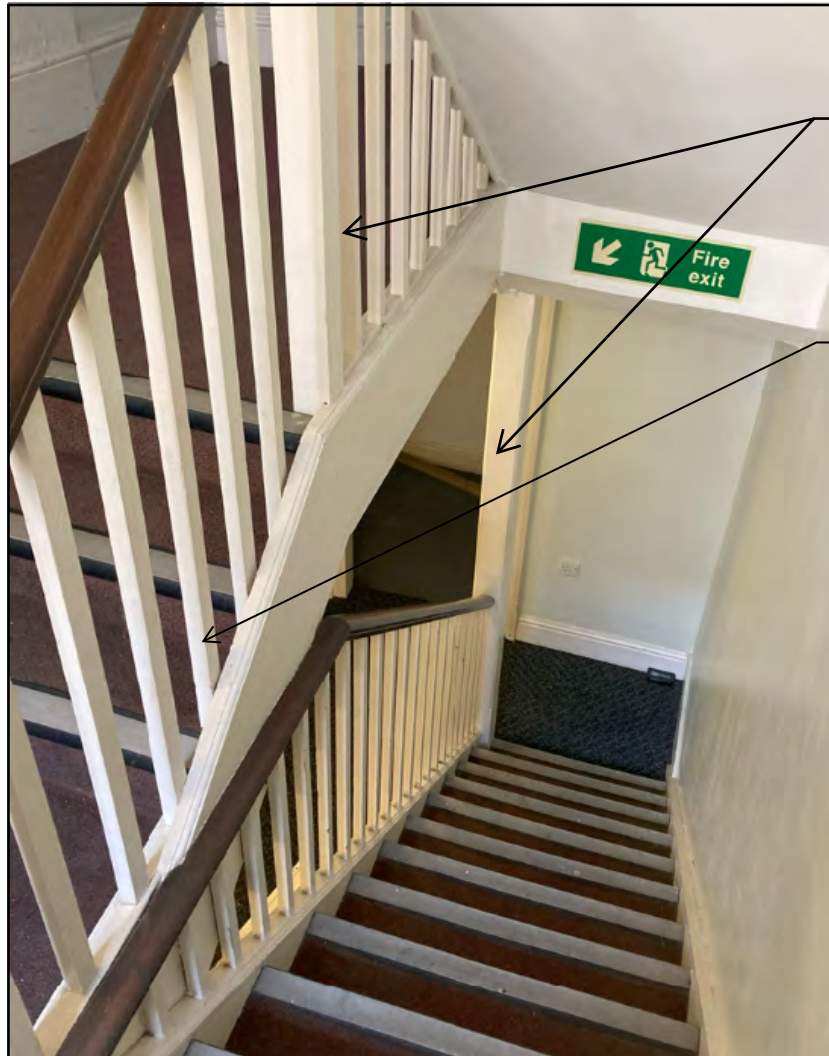
Stair 4LT at Lower Ground - Ground

Note posts providing stiffness to railings

Note thicker spindles provided at type 4 stair

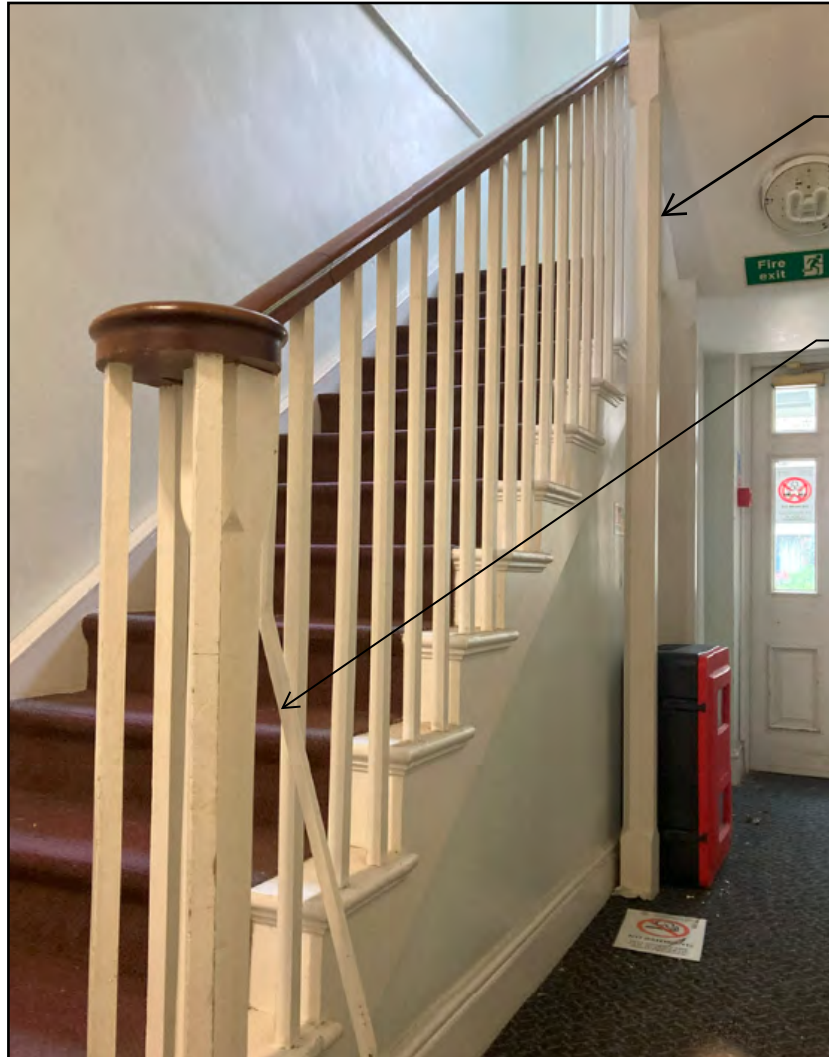
Stair 3LT at Lower Ground - Ground

Note posts providing stiffness to railings

Note ineffective retrofit bracket

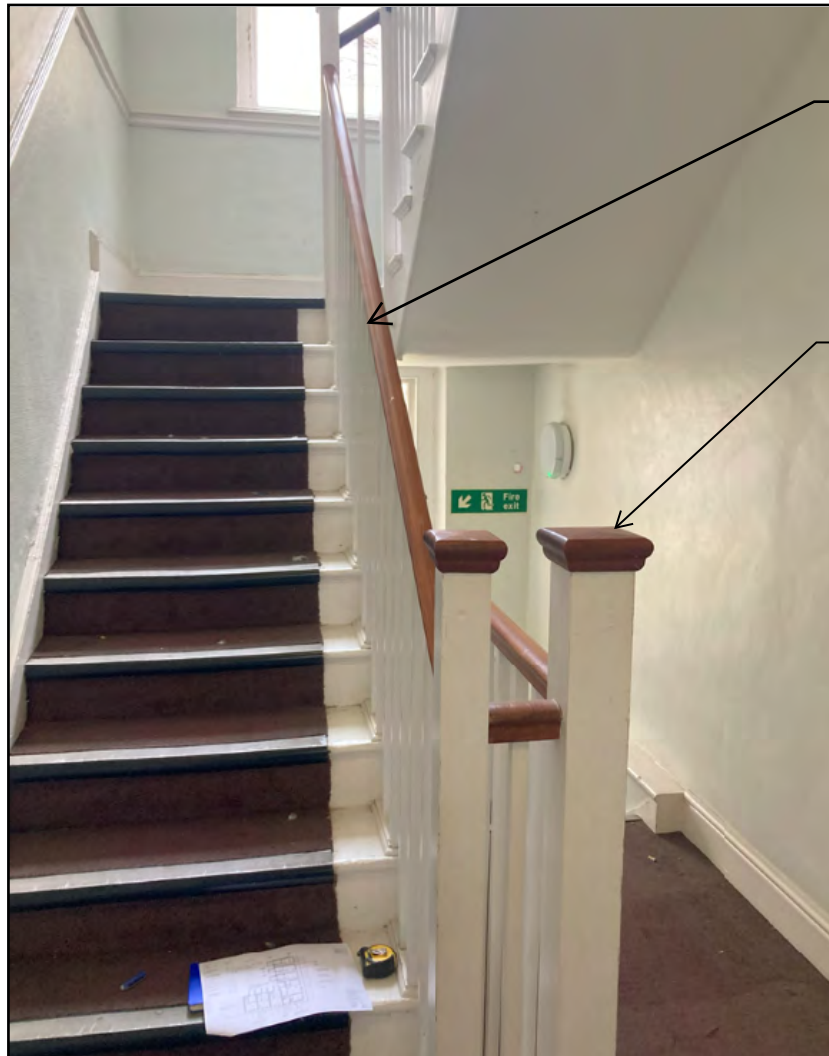
Stair 3LT at Ground - First Floor

Loose and ineffective balustrade

Newel posts at landings providing some rigidity

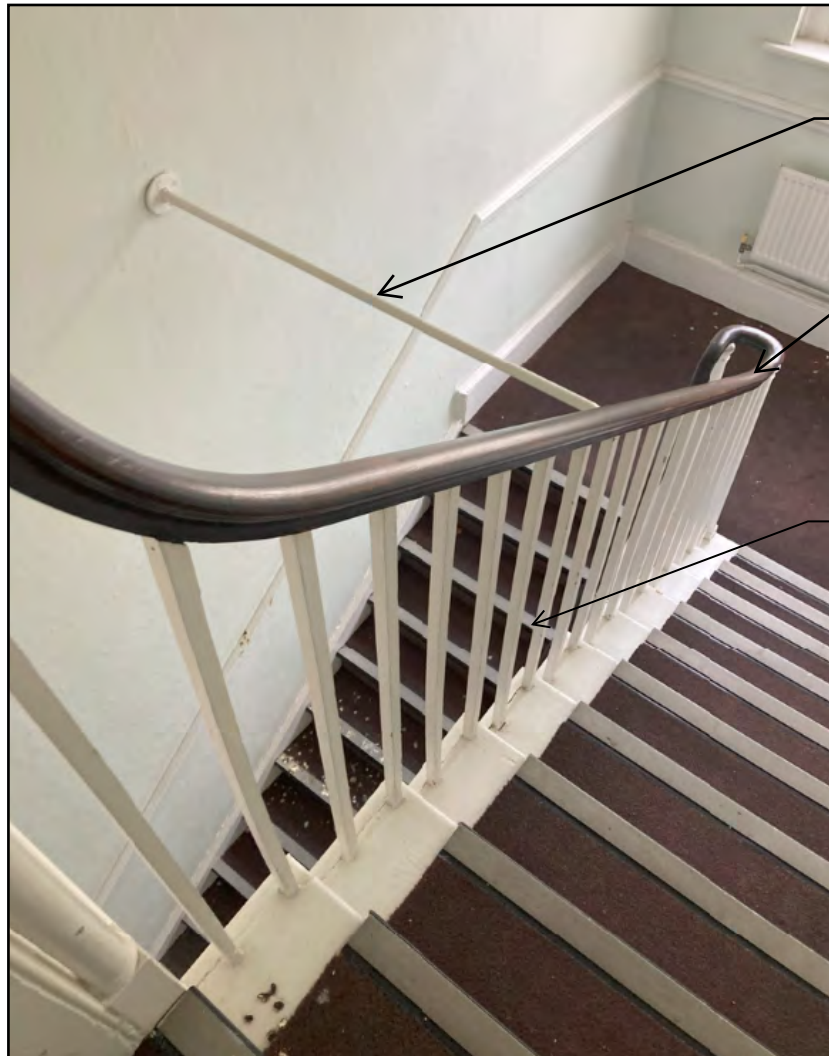
Stair 3LT at First Floor - Second Floor

Retrofit
balustrade
restraints into
party wall

No newel post
at landing

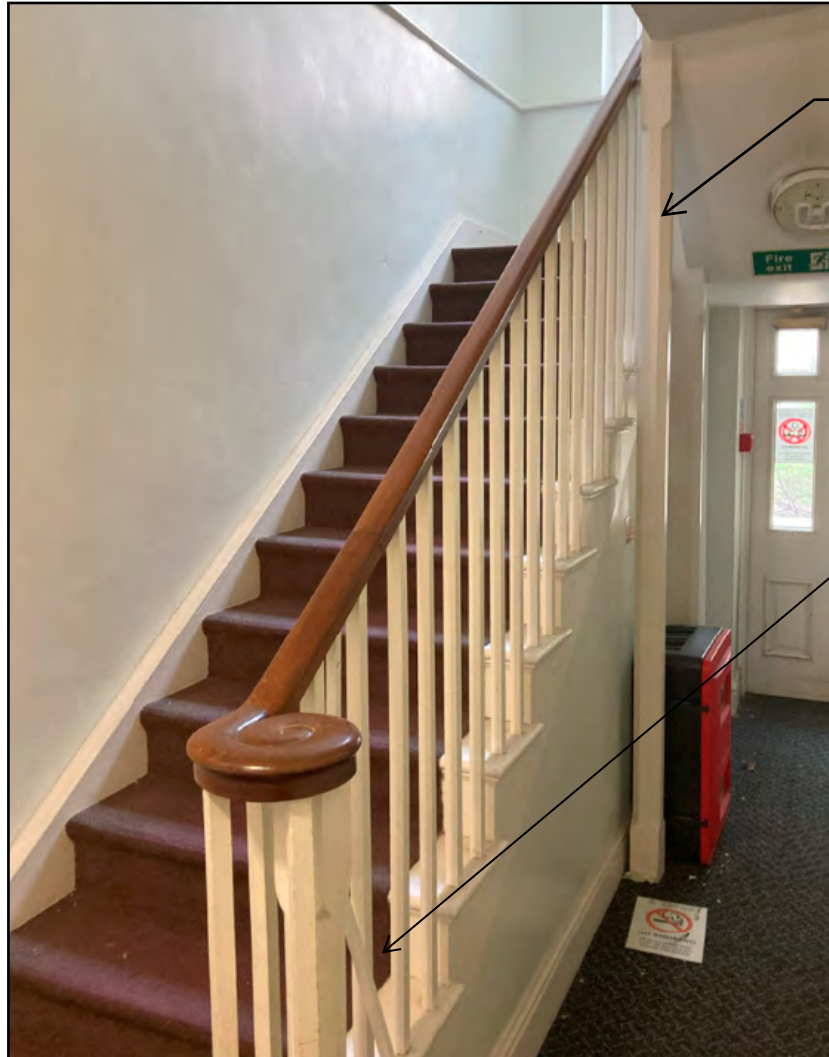
Stair 2LT at Lower Ground - Ground

Posts providing stiffness to railings

Note ineffective retrofit bracket

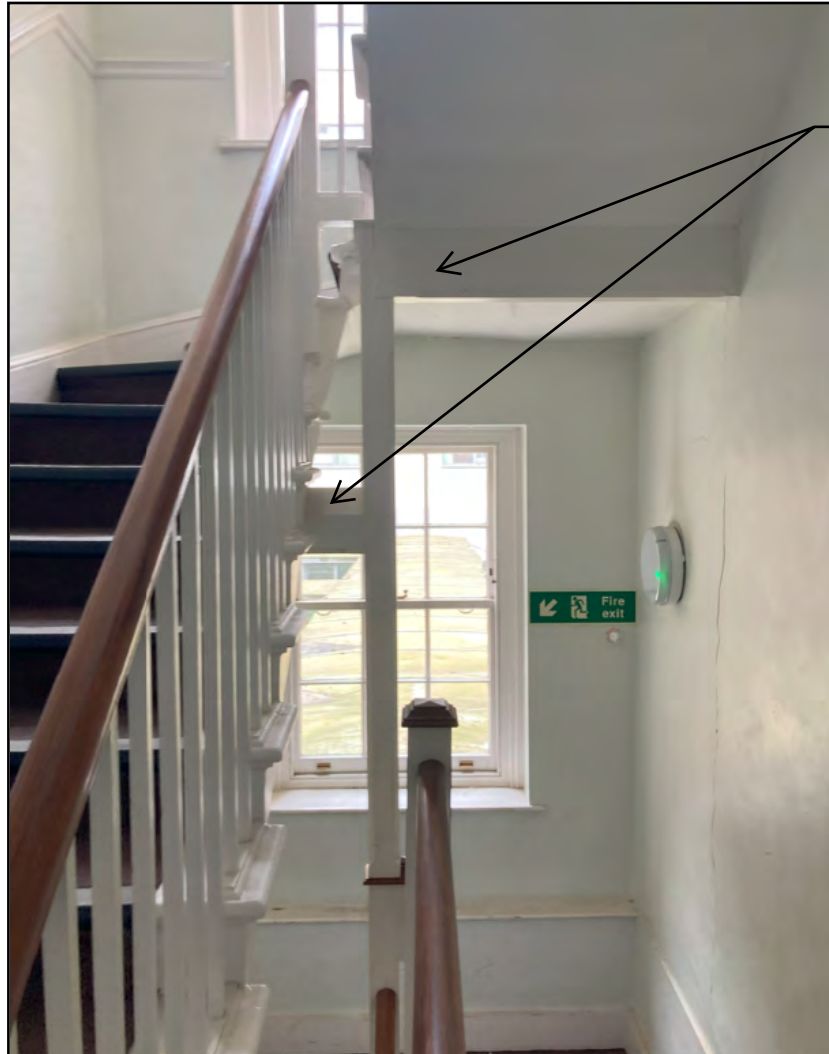
Stair 2LT at Ground - First Floor

Retrofit timber posts and beams supporting stone treads

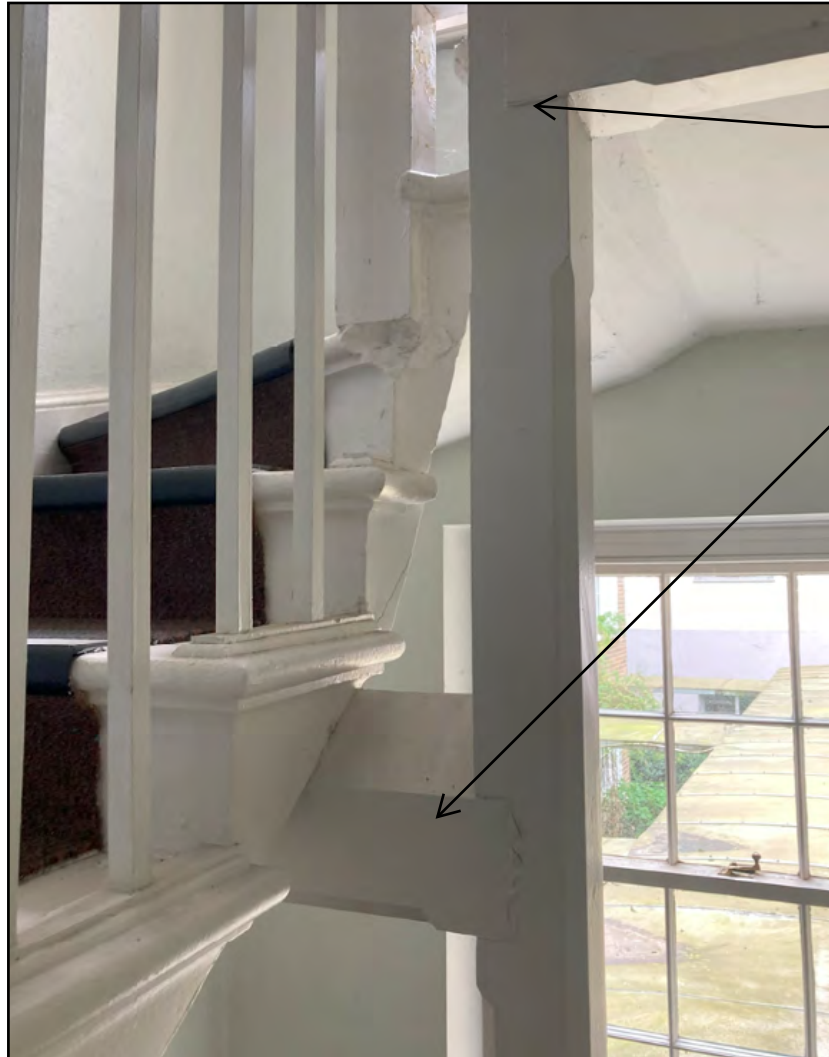
Stair 2LT at Ground - First Floor

Retrofit timber posts and beams supporting stone treads

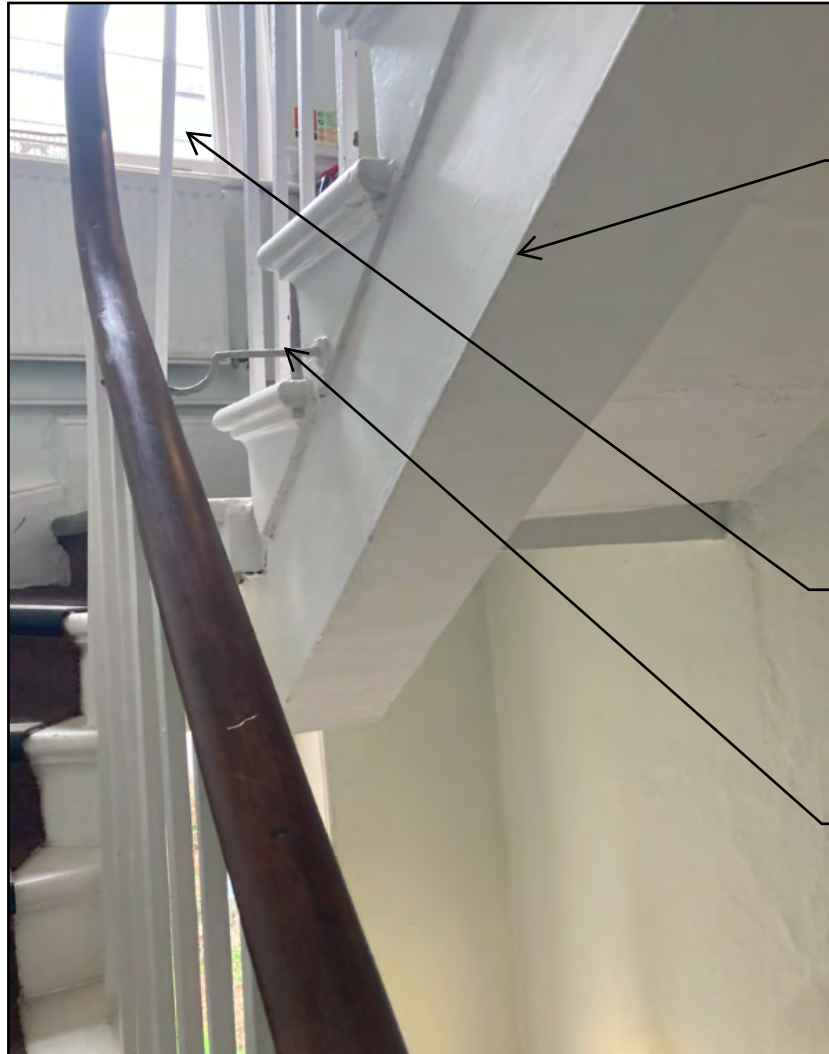
Stair 2LT at First floor - Second Floor

Note retrofit beam, possibly steel concealed within timber linings supporting stone treads

Note thin iron spindles typical of type 3 stair leaning over

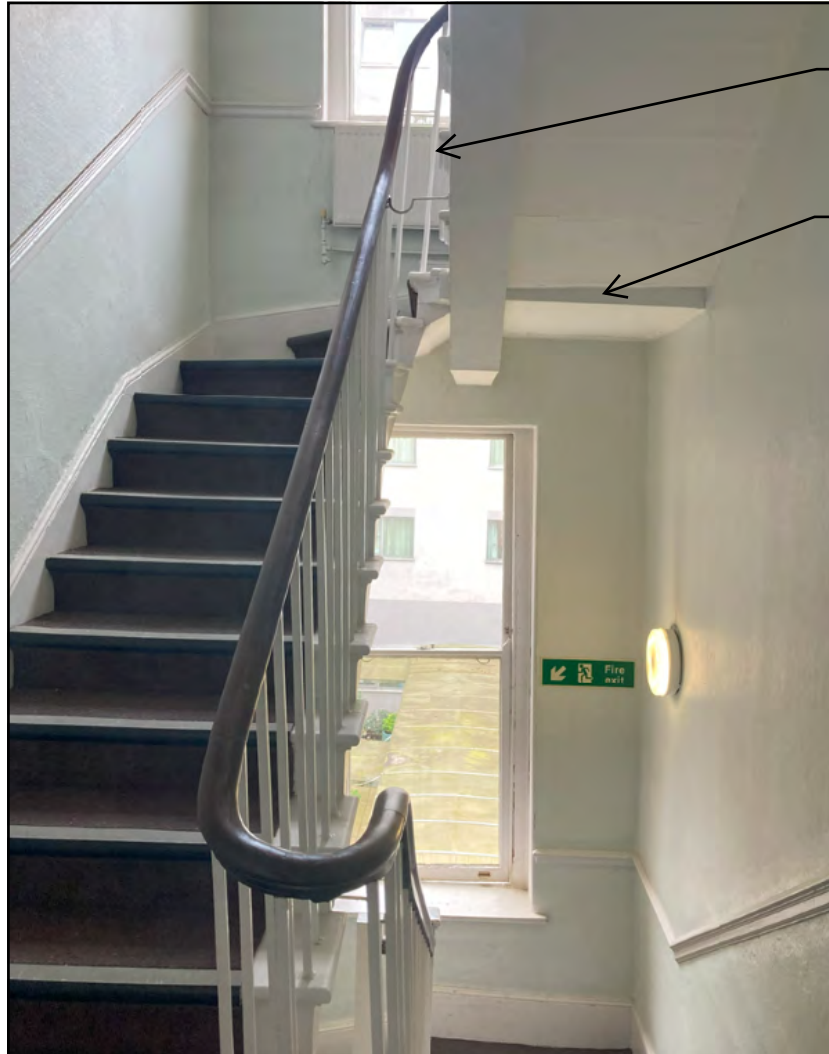
Stair 2LT at First Floor - Second Floor

Note Lean of balustrade spindles

Note distortion of flights

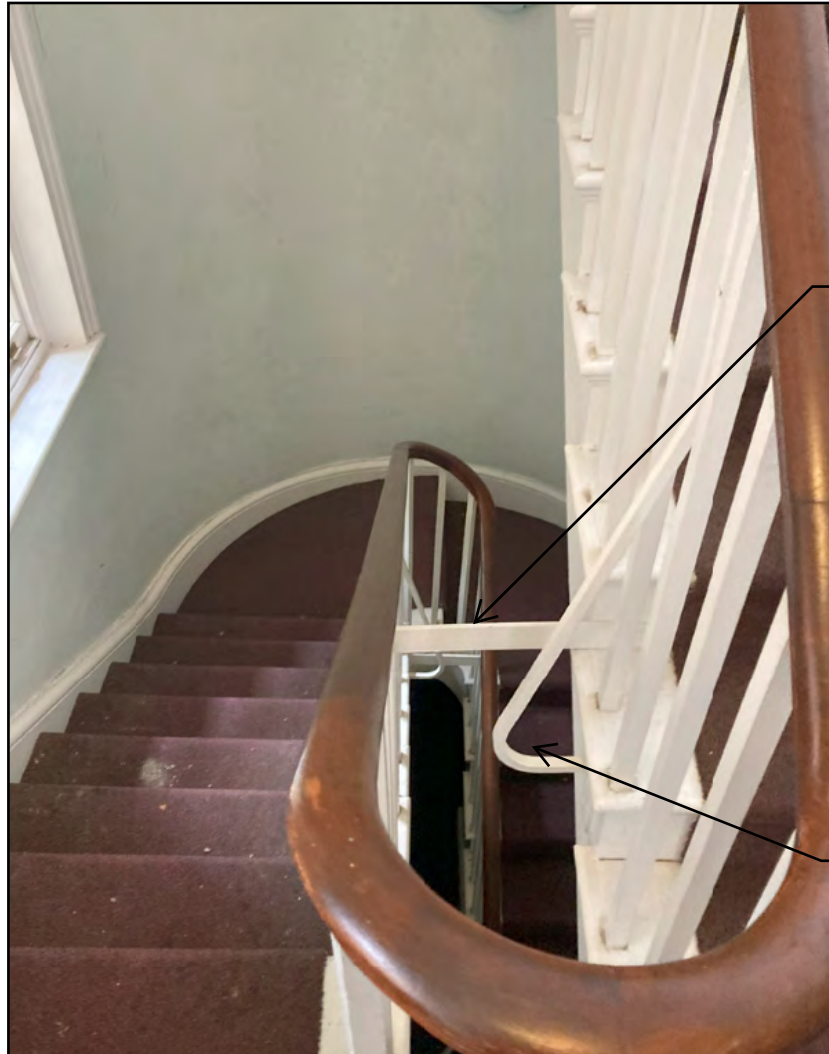
Stair 1LT at - Ground - First Floor

Note multiple retrofit brackets to attempt to strengthen balustrade

Note Ineffective bracket in attempt to provide stiffness to balustrade

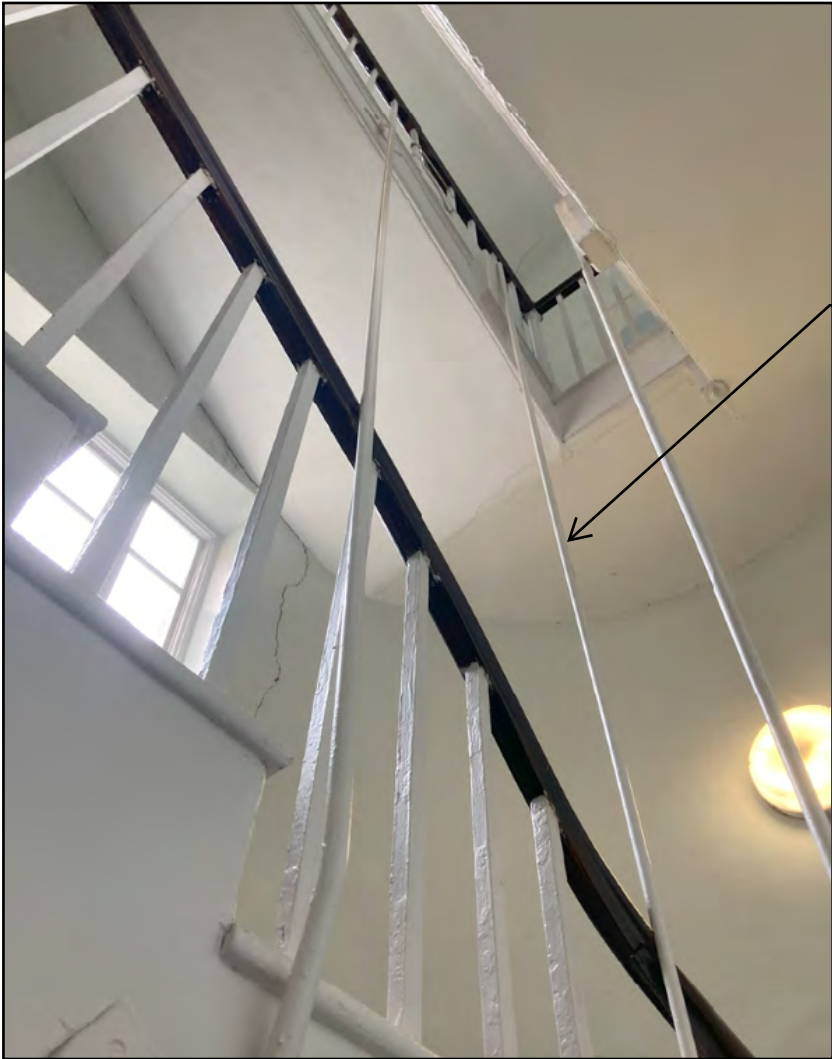
Stair 1LT at First Floor - Second Floor

Note retrofit hangers suspended from upper flights

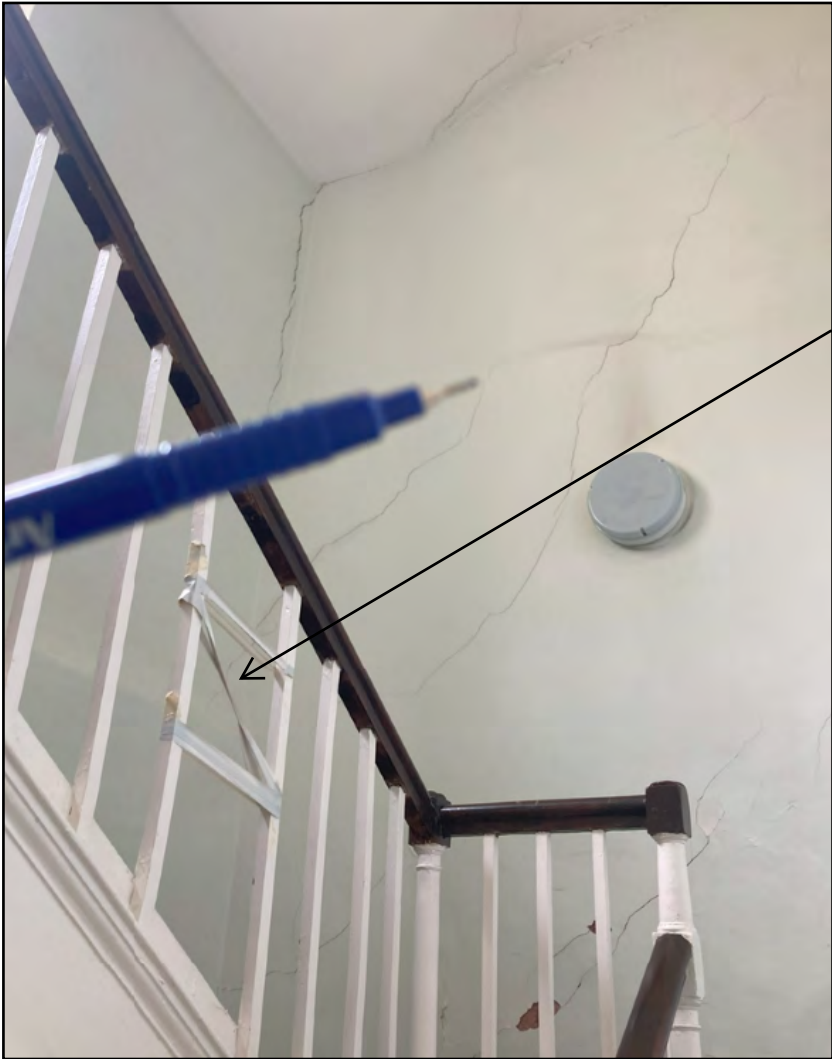
Stair 1LT at First Floor - Second Floor

Not missing
spindle

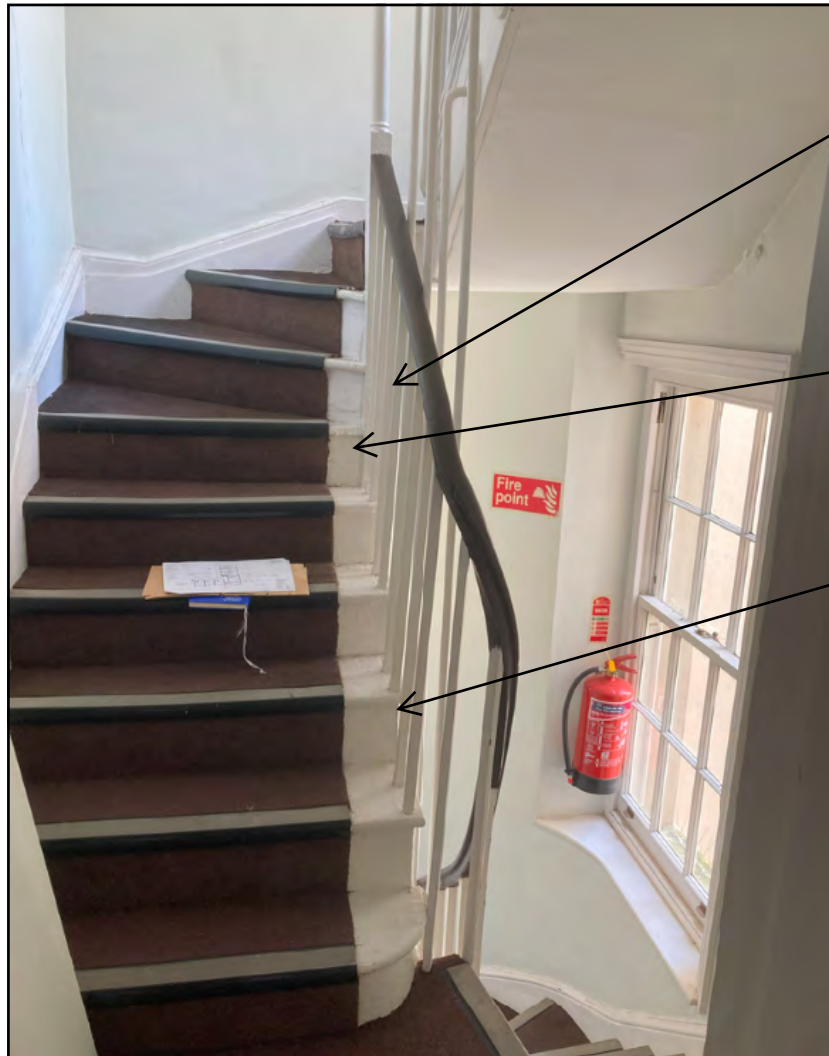
Stair 92GS at First Floor - Second Floor

Note distortion of flight

Note multiple steel hanger rods suspending stair from beams above

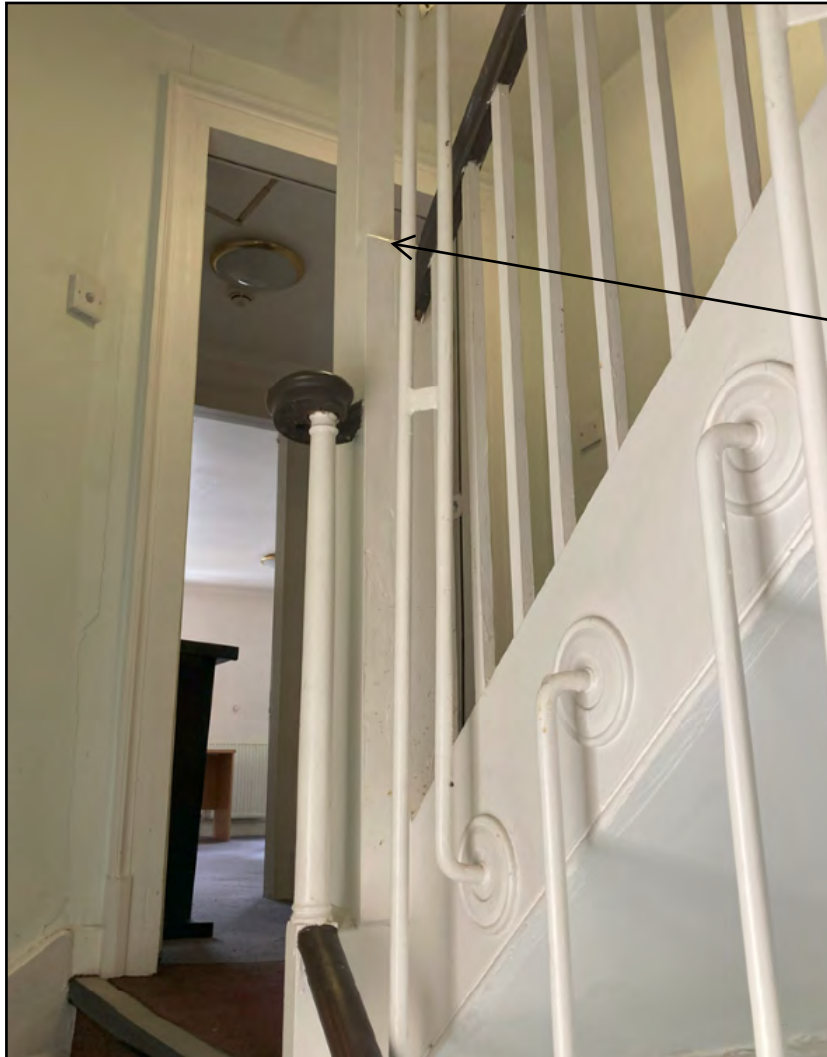
Stair 92GS at Second Floor

Note Post
providing
some rigidity
at second
floor

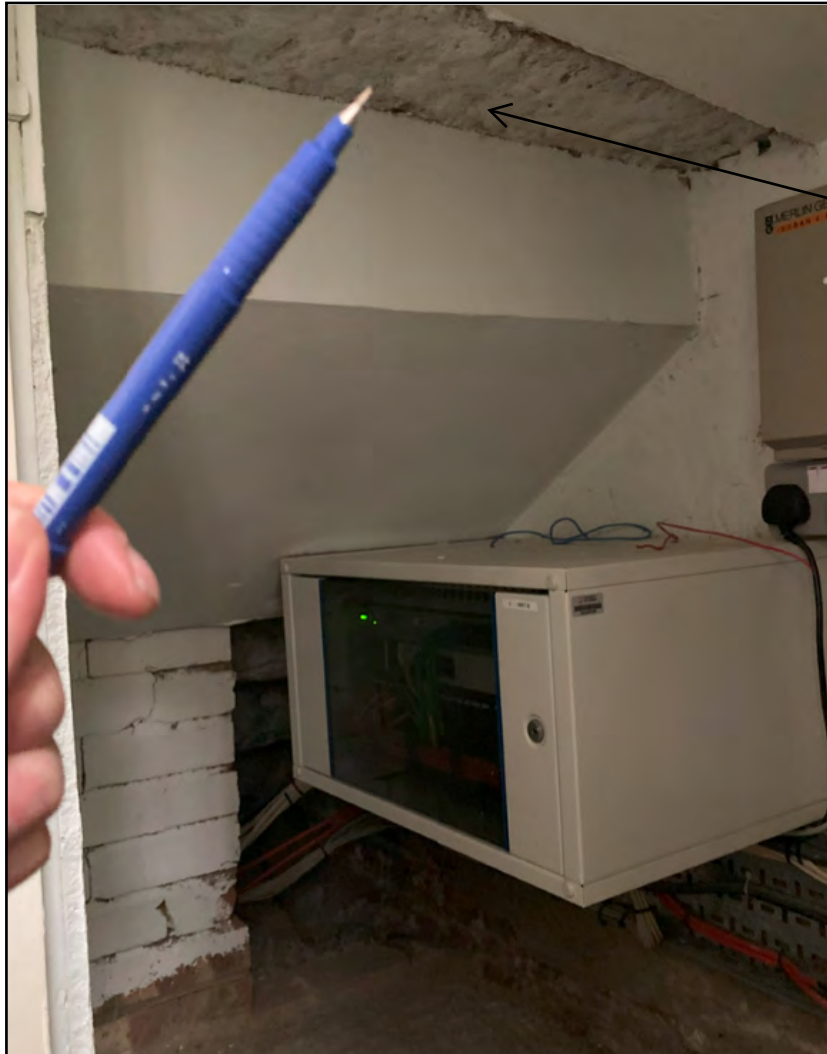
Stair 91GS - Lower Ground

Note Stone visible at lower half of first flight. Upper half possibly timber

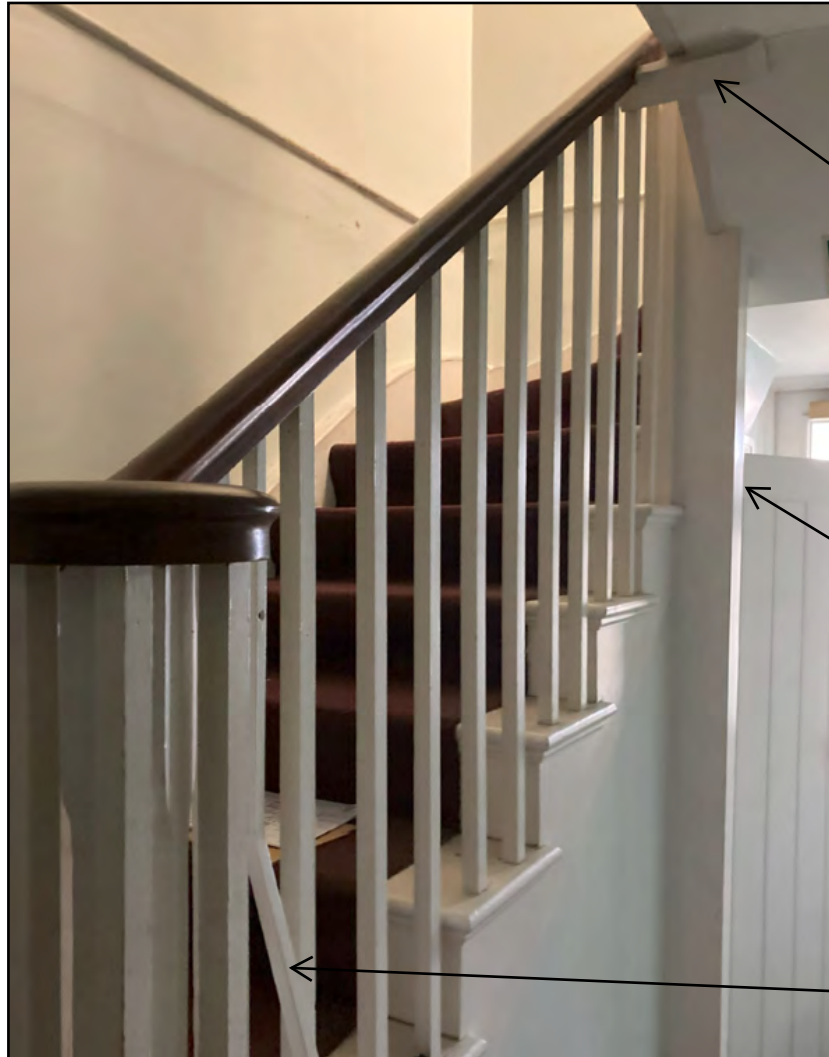
Stair 90GS - Lower Ground

Note retrofit strap

Note timber post support

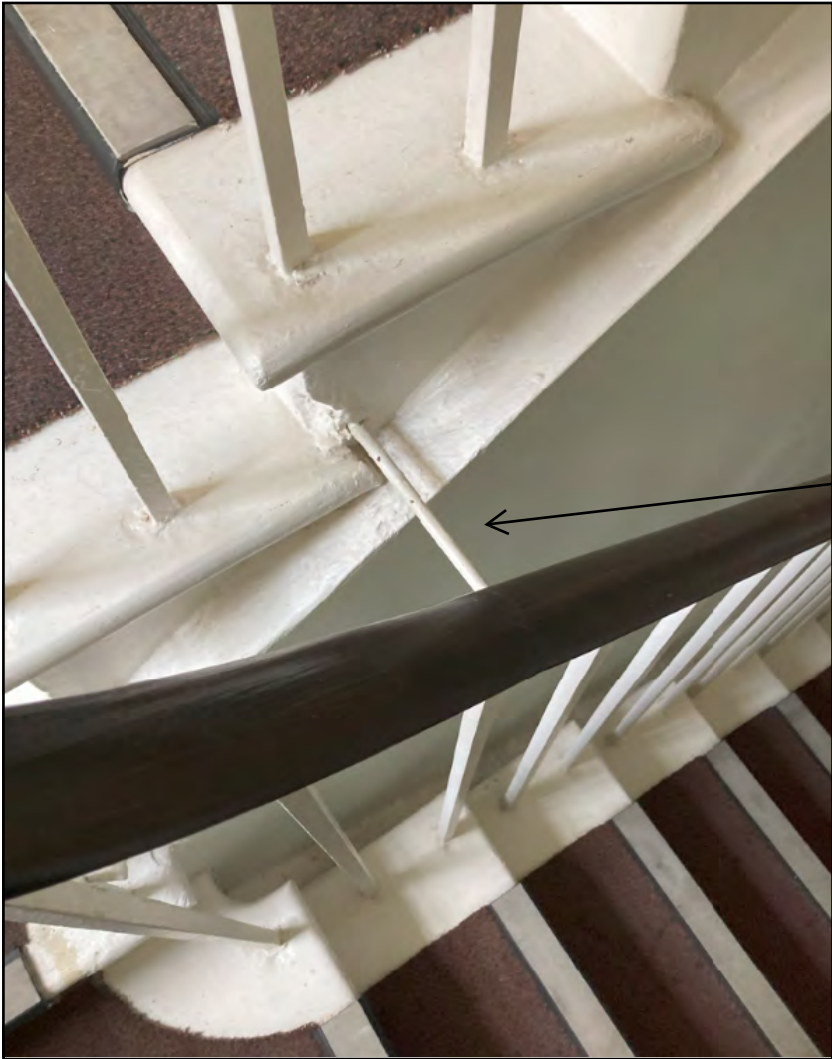
Stair 89GS at First floor - Second Floor

Note retrofit support is not fixed into wall and can move freely

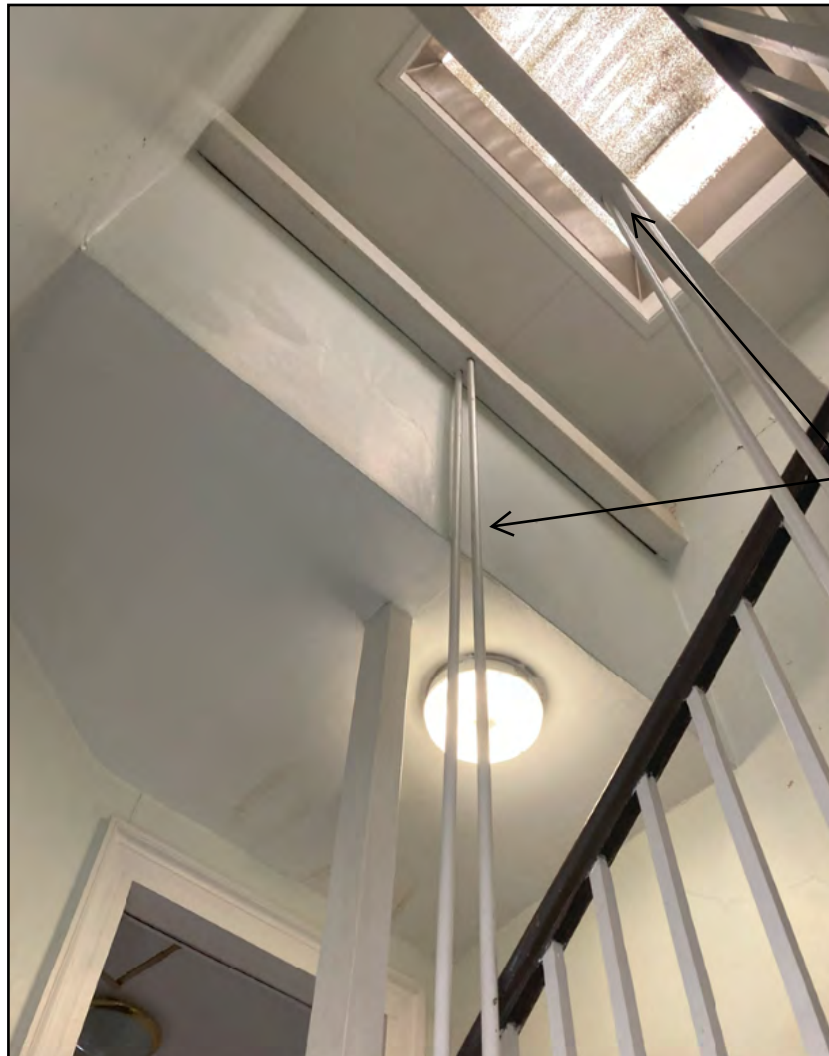
Stair 92GS at Second Floor -Third Floor

Note
possibly
undersized
timber
beams
supporting
lower stair
flights
