## Arboricultural Consultancy for LV=

| Insured | | Address | 29 Edis Street, London, NW1 8LE | |

**Scope of Report:** To survey the property and determine significant vegetation contributing to subsidence damage, make recommendation for remedial action and assess initial mitigation and recovery prospects. The survey does not make an assessment for decay or hazard evaluation.

29 Edis Street, London, NW1 8LE  
Subsidence Management Services

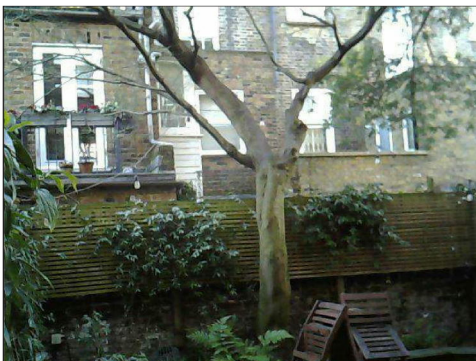
T3 - Acer

T3 (Acer) cannot be discounted as contributing to the overall level of soil drying proximate to the area of damage and is therefore also considered to retain a contributory influence, albeit in a secondary capacity when compared to T2.

Consequently, we have advocated the complete removal of T2 (Mimosa) and T3 (Acer) as it will offer the most certain arboricultural solution likely to restore long-term stability.

| Tree No. | Species | Age Cat | Approx. Height (m) | Distance to Building (m) * | Ownership | Action | Requirement |
|---|---|---|---|---|---|---|---|
| T3 | Acer | 1 | 8 | 4.5 | C - Insured | Remove | Remove close to ground level and treat stump to inhibit regrowth. |
