## Arboricultural Consultancy for LV=

| | | Address | 29 Edis Street, London, NW1 8LE |

### 2. Property and Damage Description

# GEOTECHNICAL

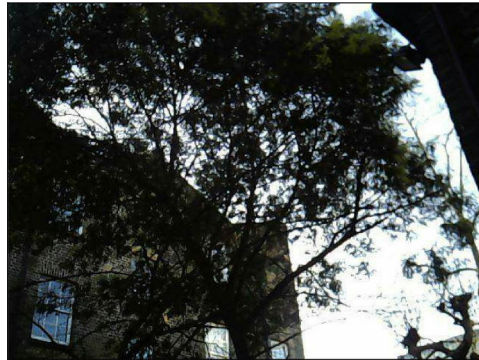
T2 - Mimosa

With due regards to species profile, size and proximity, T2 (Mimosa) is considered the dominant feature proximate to the focal area of movement and accordingly, where vegetation is confirmed as being causal, we have identified it as the primary cause of the current subsidence damage.

Consequently, we have advocated the complete removal of T2 (Mimosa) and T3 (Acer) as it will offer the most certain arboricultural solution likely to restore long-term stability.

| Tree No. | Species | Age Cat | Approx. Height (m) | Distance to Building (m) * | Ownership | Action | Requirement |
|---|---|---|---|---|---|---|---|
| T2 | Mimosa | 1 | 11.5 | 4.1 | A - Third Party | Remove | Remove close to ground level; do not treat stump due to translocation risk. Where such a risk exists, we advise that any emergent regrowth is removed annually. |

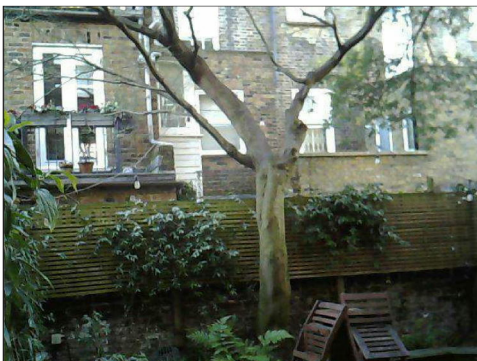
T3 - Acer

T3 (Acer) cannot be discounted as contributing to the overall level of soil drying proximate to the area of damage and is therefore also considered to retain a contributory influence, albeit in a secondary capacity when compared to T2.

| Tree No. | Species | Age Cat | Approx. Height (m) | Distance to Building (m) * | Ownership | Action | Requirement |
|---|---|---|---|---|---|---|---|
| T3 | Acer | 1 | 8 | 4.5 | C - Insured | Remove | Remove close to ground level and treat stump to inhibit regrowth. |

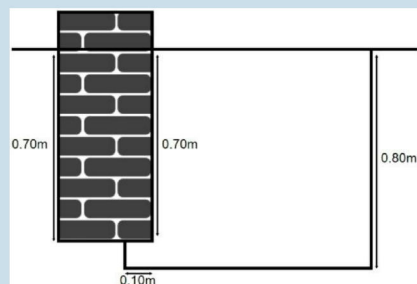
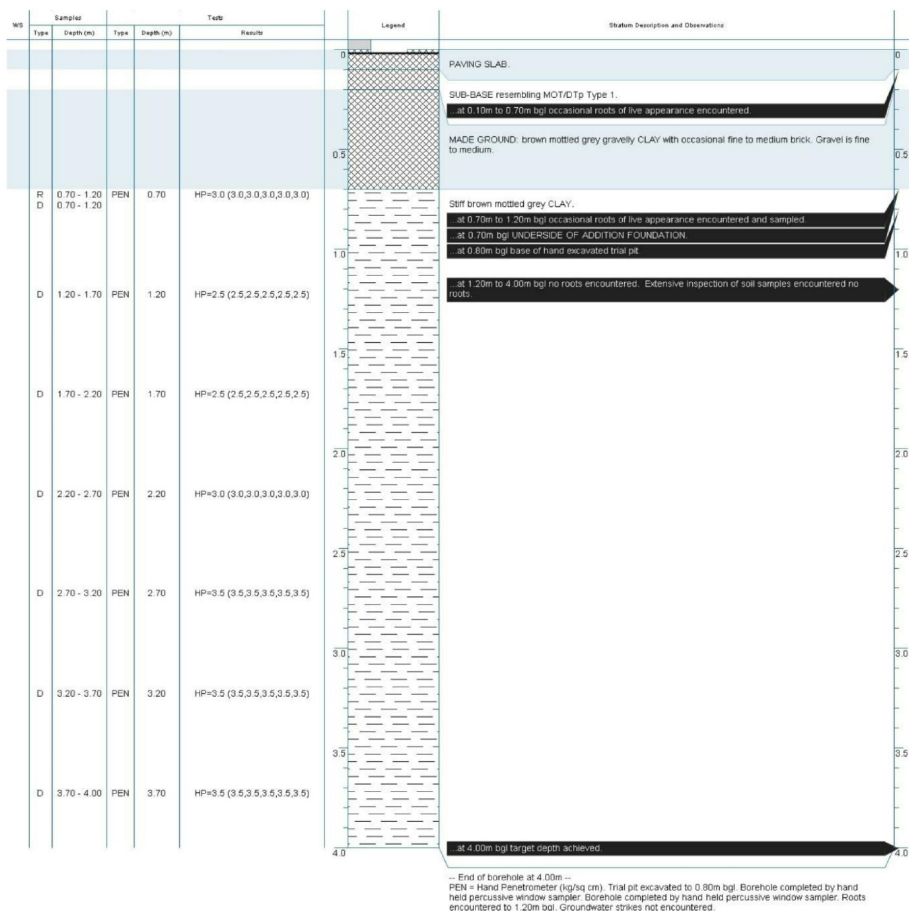
## TP/BH1 Foundation Detail and Borehole Log

Addition foundation comprised of brick wall to 700mm bgl with no projection from the elevation. Underside of foundation (USF) was exposed to 100mm back from the face of the foundation and probed 400mm back from the face of the foundation.
