**North Elevation - Restoration Scoping**  
1 : 75

Project  
**IoN/DRI Redevelopment Project**  
256 Grays Inn Road, London, WC1X 8LD

Drawing  
**North Elevation - Facade Restoration Scoping**

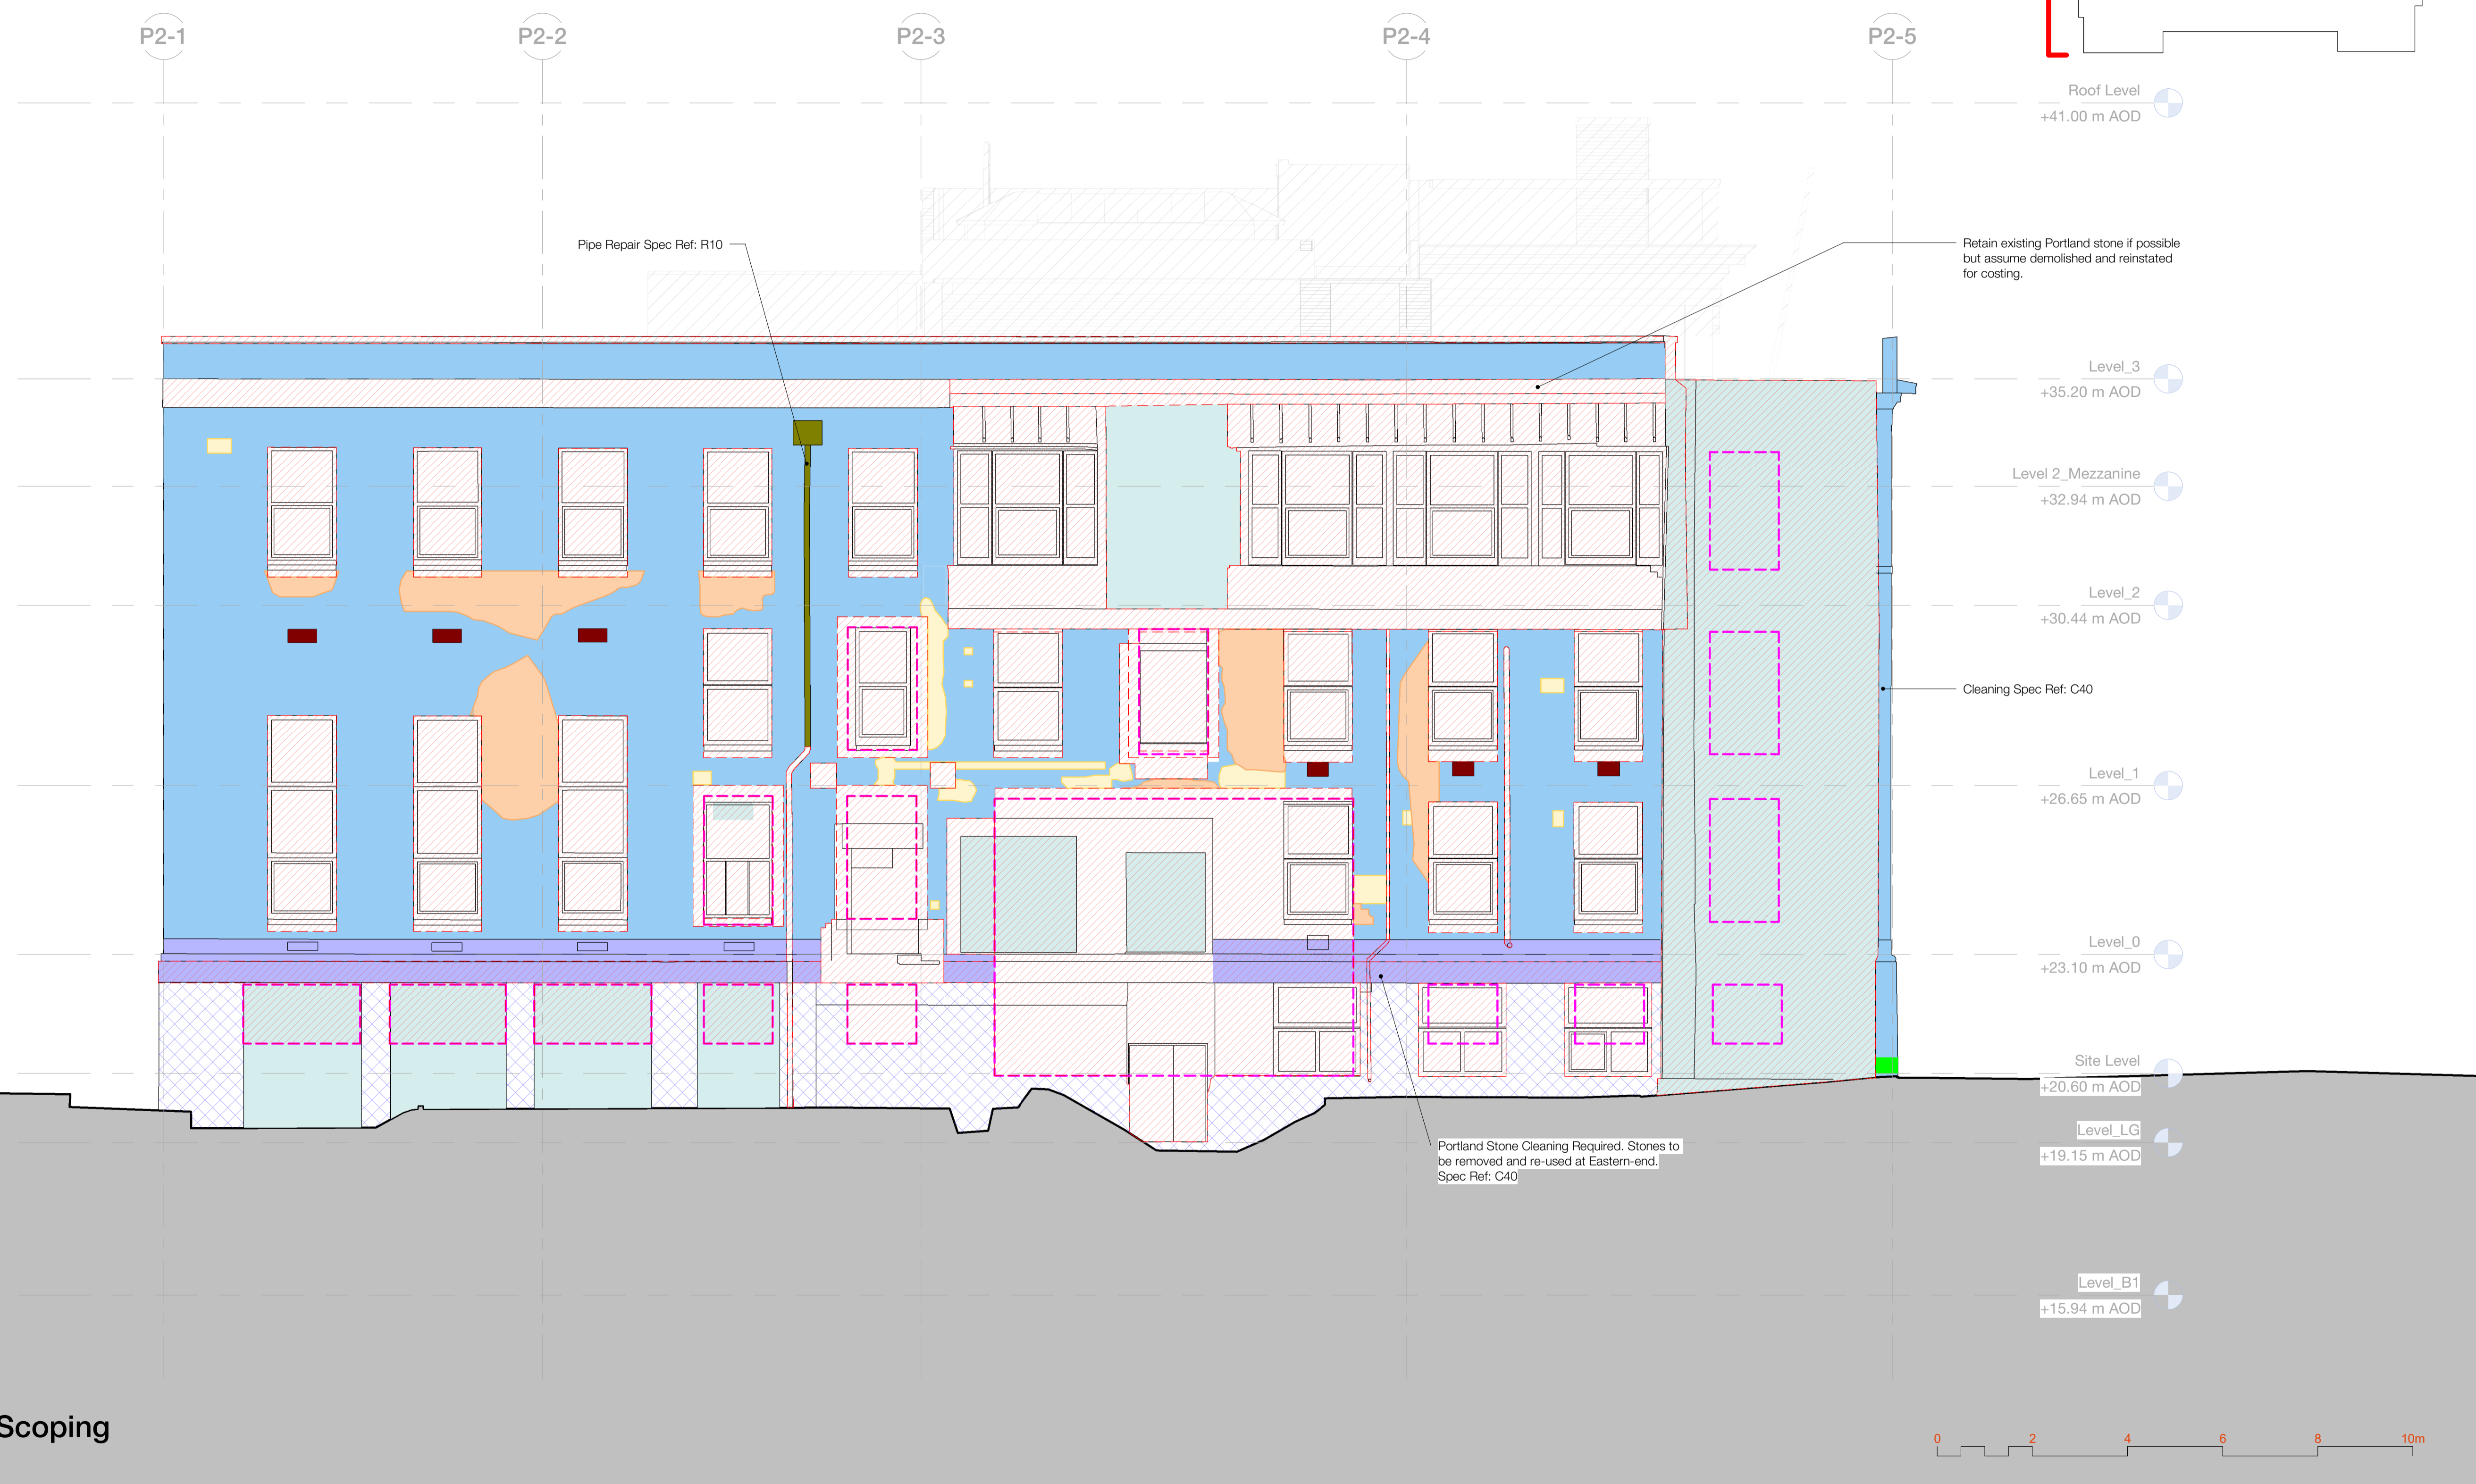
- Brick Appearance B  
*Abuse: stains, discoloration and soiling on the brick surfaces.*  
Spec Ref: C40
- Brick Appearance C  
*Brick and mortar appears to be damaged, fractured and/or displaced. Establish cause of defect before repairing via condition survey. Assumed that external skin will need to be removed and reinstated. Further works to be defined by condition survey.*  
Spec Ref: C41
- Grilles to be Cleaned, Restored and Repaired  
Spec Ref: R10
- Granite Cleaning Required  
Spec Ref: C40
- Areas of Facade to be Overclad
- Rainwater Pipe Repair  
Spec Ref: R10
- General Cleaning Required  
*Demolition areas not included*  
Spec Ref: C40
- Portland Stone Cleaning Required  
Spec Ref: C40
- Areas of structural demolition/external fabric removal.
- Area with Temporary Covering - Not Surveyed
- Proposed Through-Wall Opening
- Not within Scope
