Our Ref: 31530 - Chester Terrace Gardens, NW1 4ND
Camden Planning Ref: 2023/0282/P

Chester Terrace Gardens - retaining wall repair and reconstruction proposals

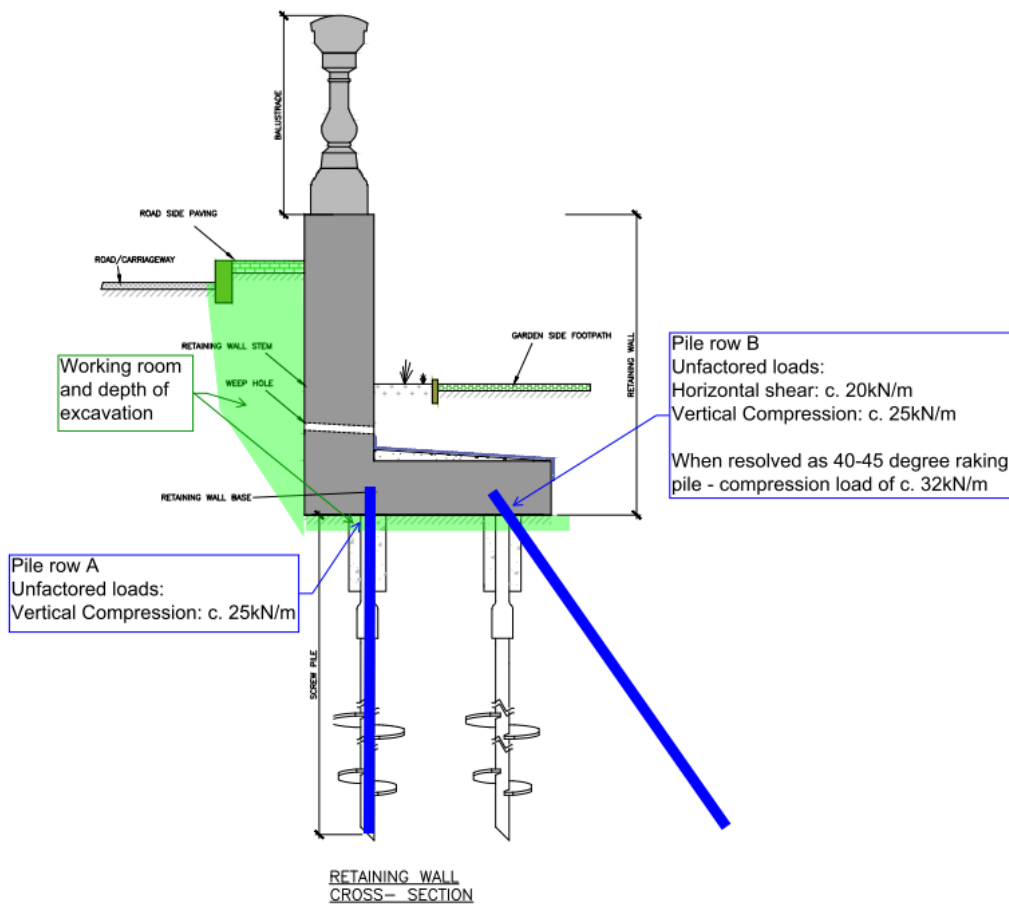
Notably, the method statement suggests that a "21 tonne excavator" is required to install the steel screw piles that will support the new L-shaped reinforced concrete (RC) retaining wall. This would presumably necessitate the destruction of all the mature trees and shrubs in the vicinity. HPM's drawings do not note the required capacities for the piles, however our own calculations show that (all loads here are unfactored) vertical compression loads of around 25kN/m, to each of the two rows of piles, and horizontal shear loads of around 20kN/m, to the outer pile row, are needed to resist the applied forces. If the outer pile row is installed at a 40-45 degree rake from vertical, resolving the forces removes the shear load and it puts the pile essentially in pure compression (and so leaves a far more structurally efficient arrangement), with a load capacity of around 32kN/m required. This arrangement is as shown in the sketch below, with proposed pile rows shown in blue.

Proposed alternative piling arrangement, with approximate piles loads

Given that screw piles can typically be installed at approximately 500mm centre spacing before adverse group action needs to be considered, it is certainly not unreasonable to assume that screw piles could be installed at 1m centre spacing along each row. This would result in piles needing to take unfactored compression loads in the order of 25-35kN. Having spoken to some screw pile specialists, including Target Fixings (website: <https://targetfixings.co.uk/products/heli-pile/>) it is clear that piles achieving such loads in the London Clay assumed to exist on the site can readily be installed using hand held equipment, for example a 63kg pneumatic driver, and at the 45 degree rake indicated in the sketch above given the available working room. Even if the piles needed to be installed using a 1.5 tonne mini-excavator to get the required torque to reach the necessary capacity, this would still likely be possible with minimal destruction of the local mature flora. The currently proposed use of a 21 tonne excavator to install the piles therefore seems needlessly excessive, destructive, and expensive, for such modest loads that are only, after all, generated from supporting what is a relatively low level retaining wall.

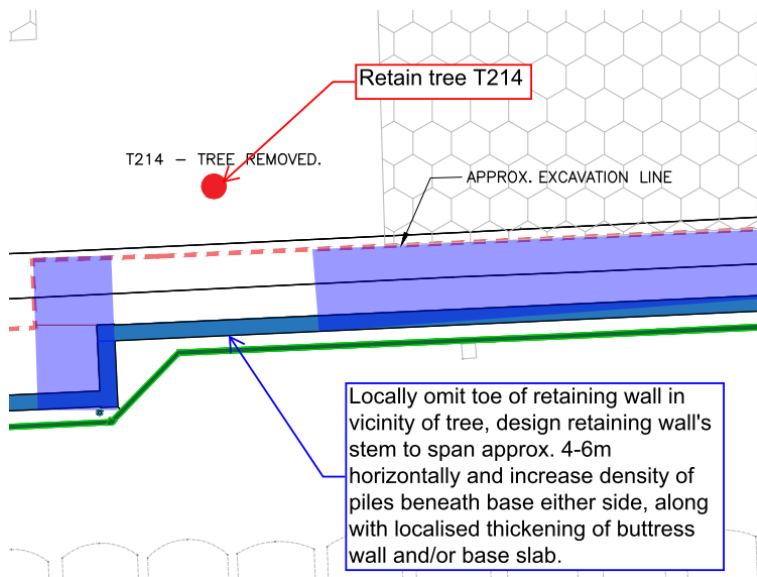
Whilst it is acknowledged that any flora immediately adjacent to where the sections of wall will be replaced will need to be removed, it does appear that an alternative structural arrangement could be pursued local to trees marked T214 and T217 and so not require their removal. Please refer to the two sketches below, which are mark ups of HPM drawing 24509-82 rev P1, showing

the basic principle. The sketches show the toe/base of the retaining wall locally being left out for a 4-6m length of wall in the vicinity of the trees, therefore meaning that the tree roots would remain relatively undisturbed. The new 450mm thick RC retaining wall stem appears to already be thick enough to span this distance horizontally, but it, or the buttressing wall and/or base at either end, could be increased in size if necessary. The density of piles beneath the toe of the retaining wall would also need to be increased at either end, but a detailed analysis of the arrangement and refinement of loads should prove it feasible.

Tree T214 - near Wall 2 - proposed alternative retaining wall arrangement
