Landmark Trees

ARBORICULTURAL IMPACT ASSESSMENT REPORT FOR:

10a Oakhill Avenue

Ref: ADC/10aOA/AIA/05a

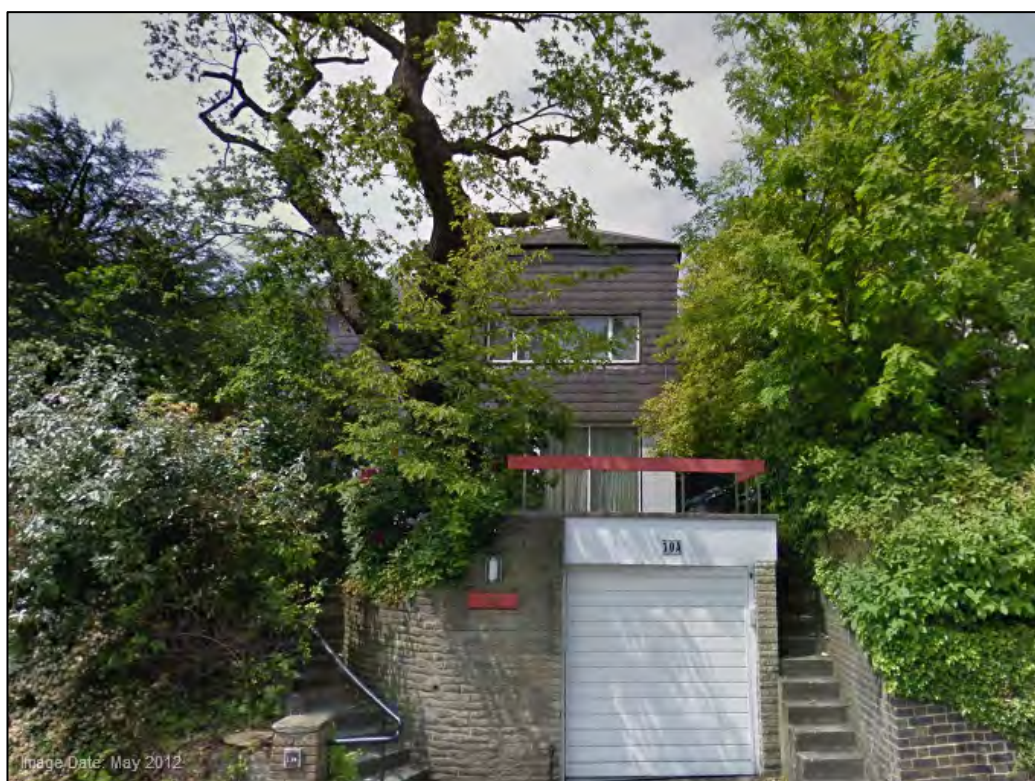
- 3.1.2 The site levels vary over 2 metres in height across the site and between the neighbouring properties (see Photograph 2 below).
- 3.1.3 We are not aware of the existence of any Tree Preservation Orders*, but understand the site stands within the Redington and Frogna Conservation Area, which will affect the subject trees: it is a criminal offence to prune, damage or fell such trees without permission from the local authority.

Photograph 2: Extreme level changes within site (Source: Google Maps)

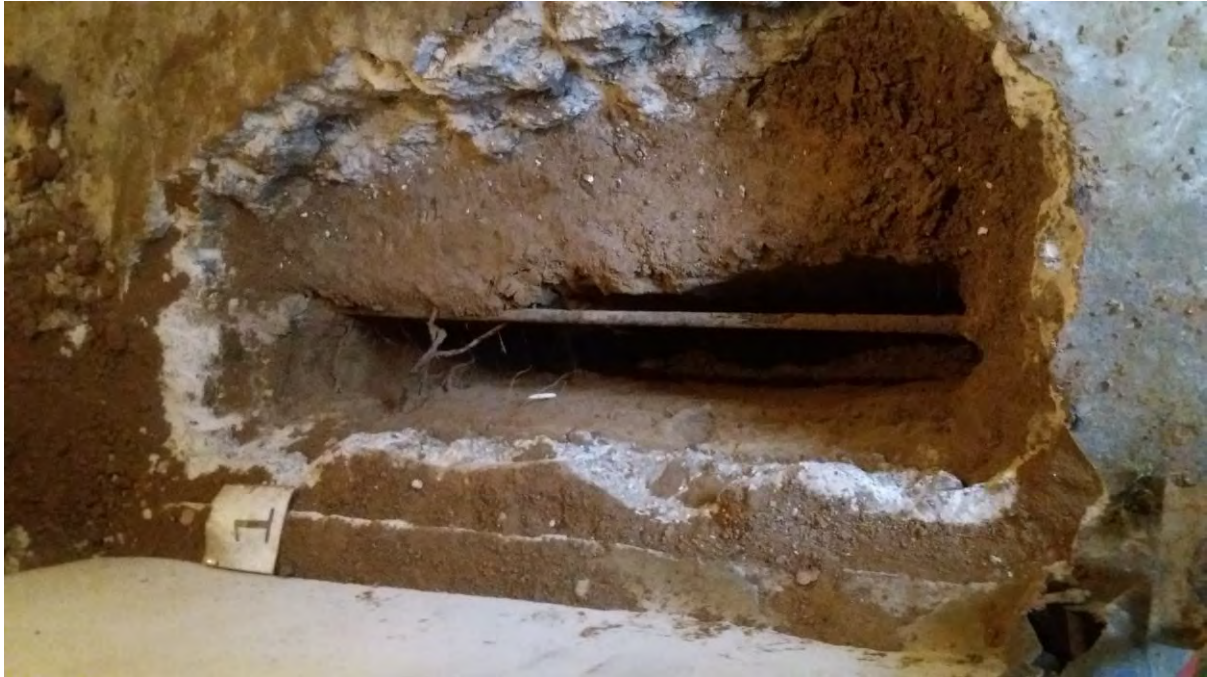
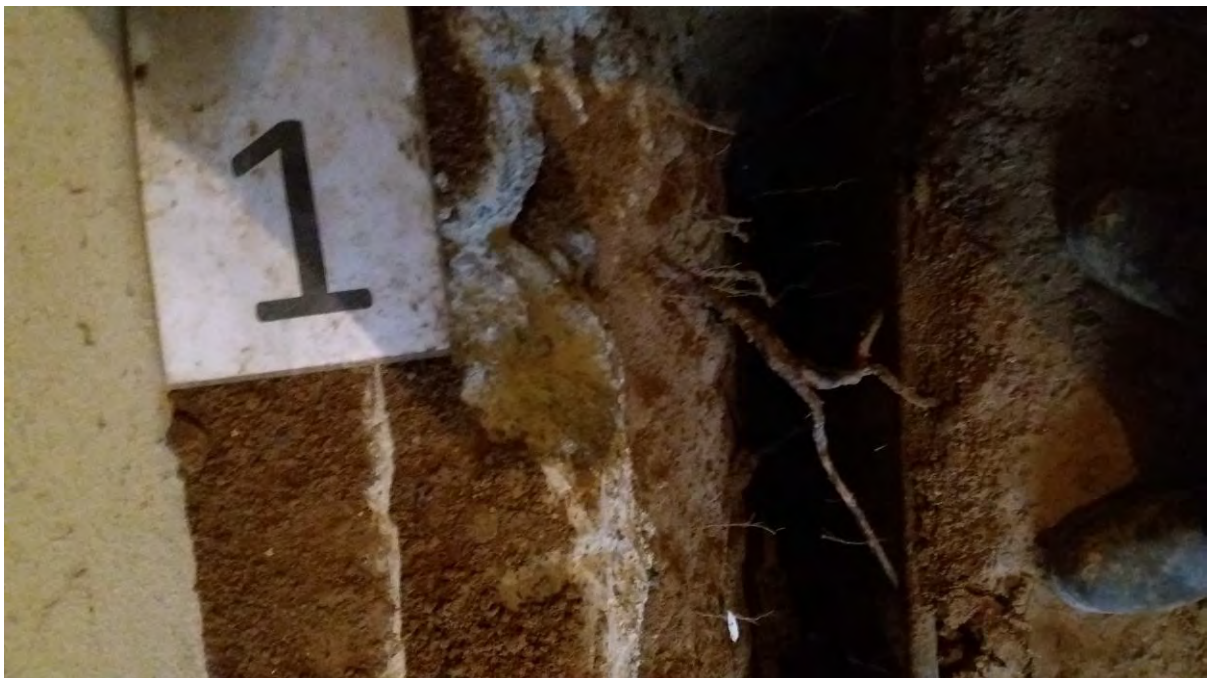
Trial Pit 1

There was a large concentration of roots though a 50cm length of the trench at the south end.
The centre of the trench was excavated deeper than the ends as this was the section closest to the oak. Once complete the Trial pits were covered with hardwood boards.
