GLOUCESTER GATE
EXPLORATORY WORKS

INVESTIGATION WORKS

MAIN HOUSE GROUND & FIRST FLOOR

8 Gloucester Gate
 Photographs taken June 2024

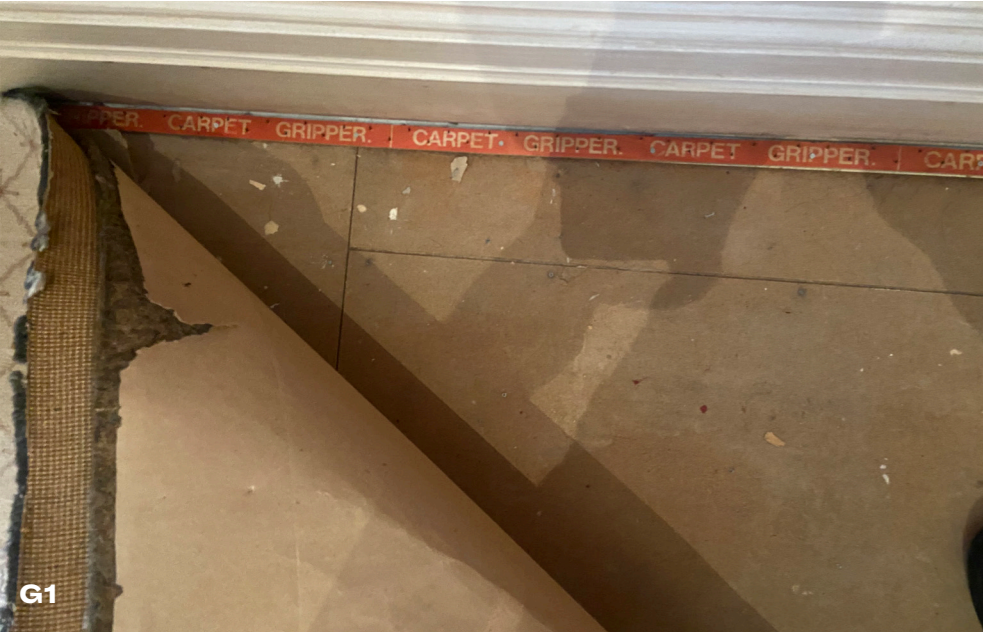
G1
 Formal Dining Room (24)
 Carpeting and underlay were lifted up, showing modern boarding on top of joists.

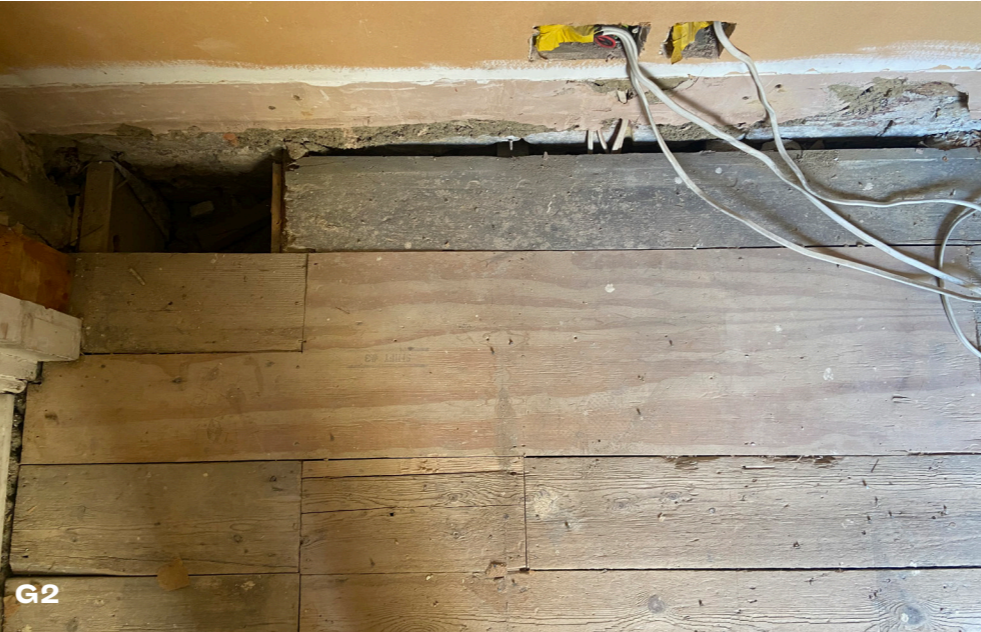
G2
 Bar/Library Room (22)
 Carpeting and underlay were lifted up, showing cut floorboards with modern inserts.

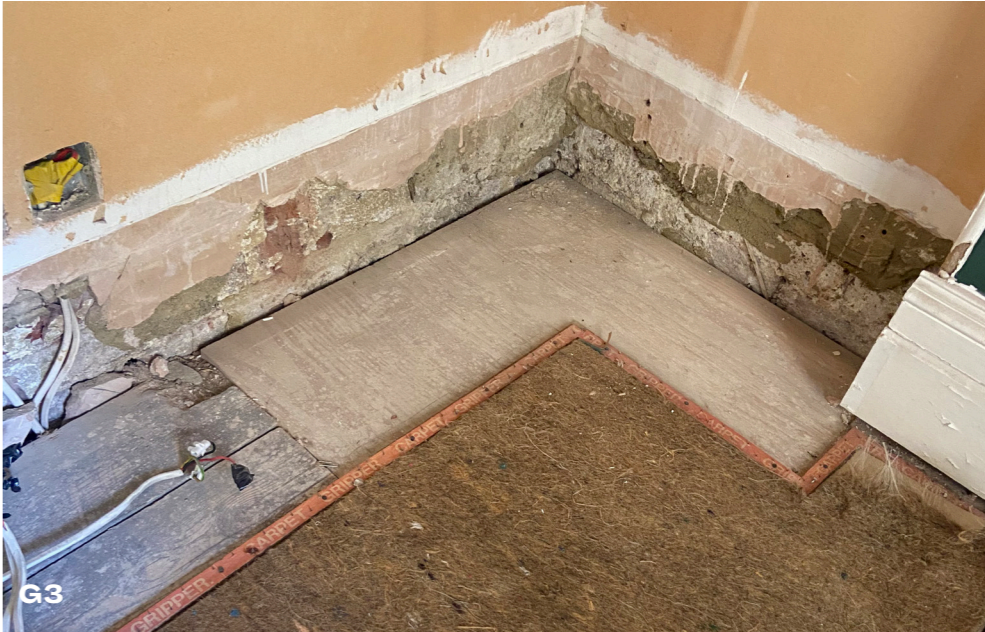
G3
 Bar/Library Room (22)
 Carpeting and underlay were lifted up, showing cut floorboards with large sections of plywood boarding

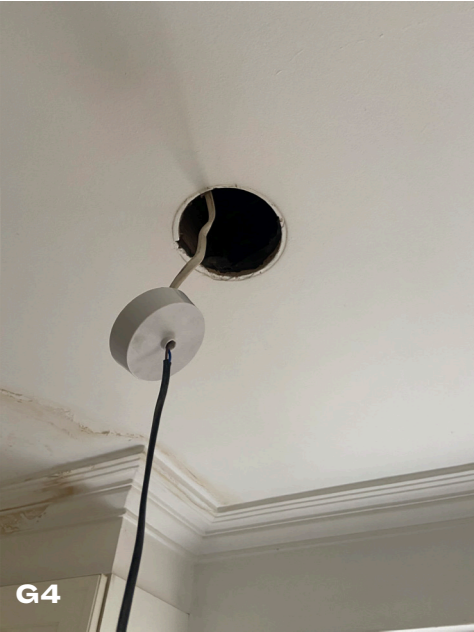
G4
 Kitchen (21)
 Downlight removed to show non original ceiling construction.

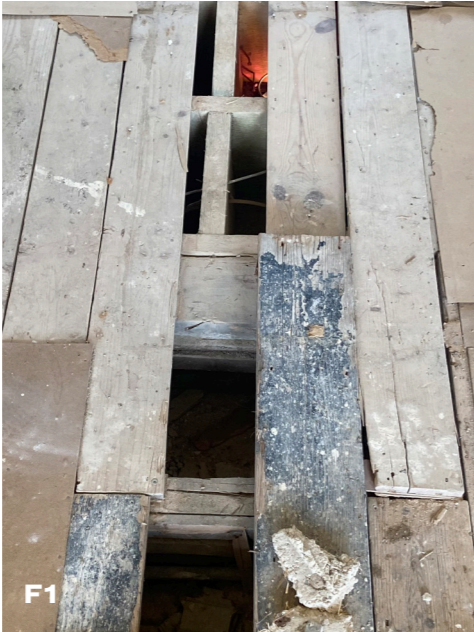
F1
 Reception Room (30)
 Carpeting and underlay were lifted up, majority newer floorboards with sections of larger boarding

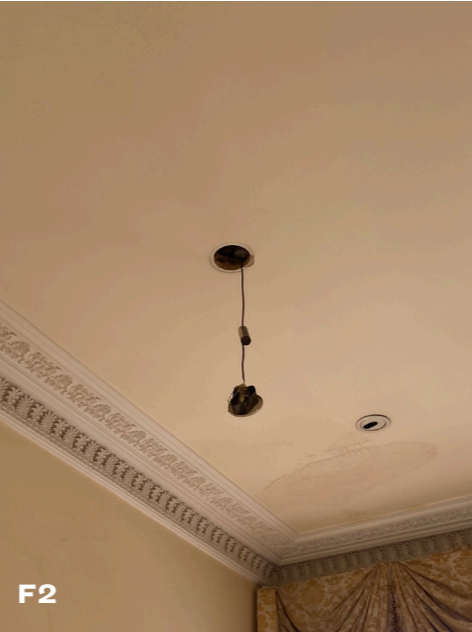
F2
 Reception Room (30)
 Downlight removed to show non original ceiling construction.

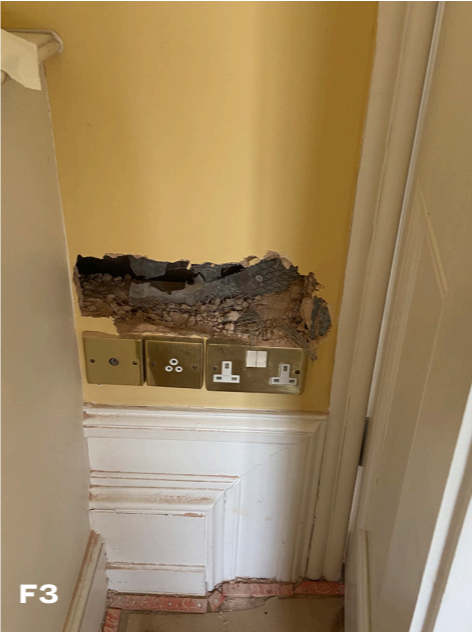
F3
 Sitting Room (28)
 Opening reveals wall is made of timber battens with EML mesh and plaster.

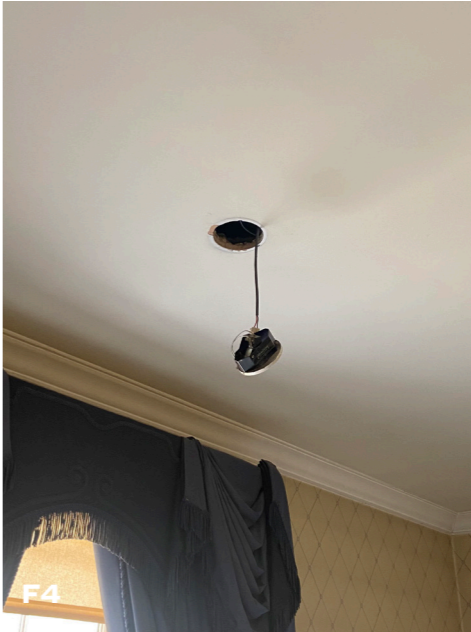
F4
 Study (27)
 Downlight removed to show non original ceiling construction.

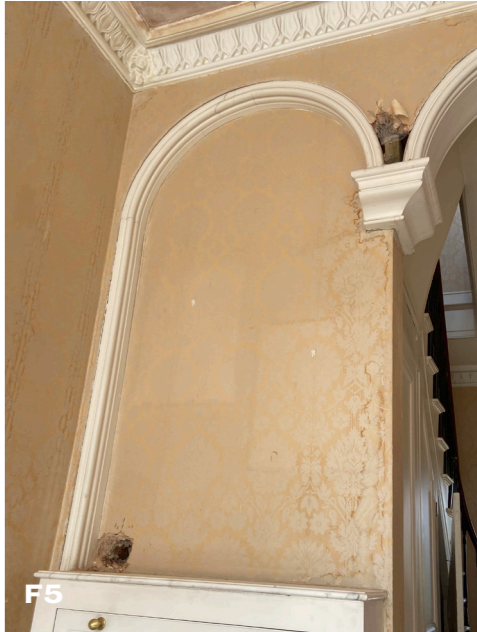
F5
 Main Stair (29)
 Small openings made in the archway at the top of the main stair indicating the wall is timber study on EML mesh and plaster.

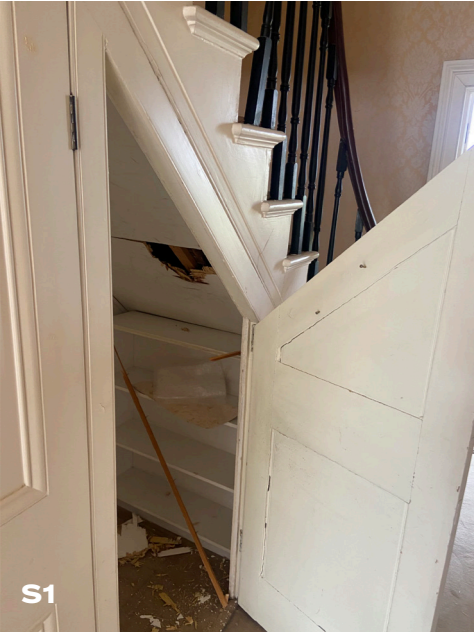
S1
 Second Stair (35)
 Small opening made to the underside of the stair for structural engineer to inspect the structure. Ply boarding and sawn timber battens.

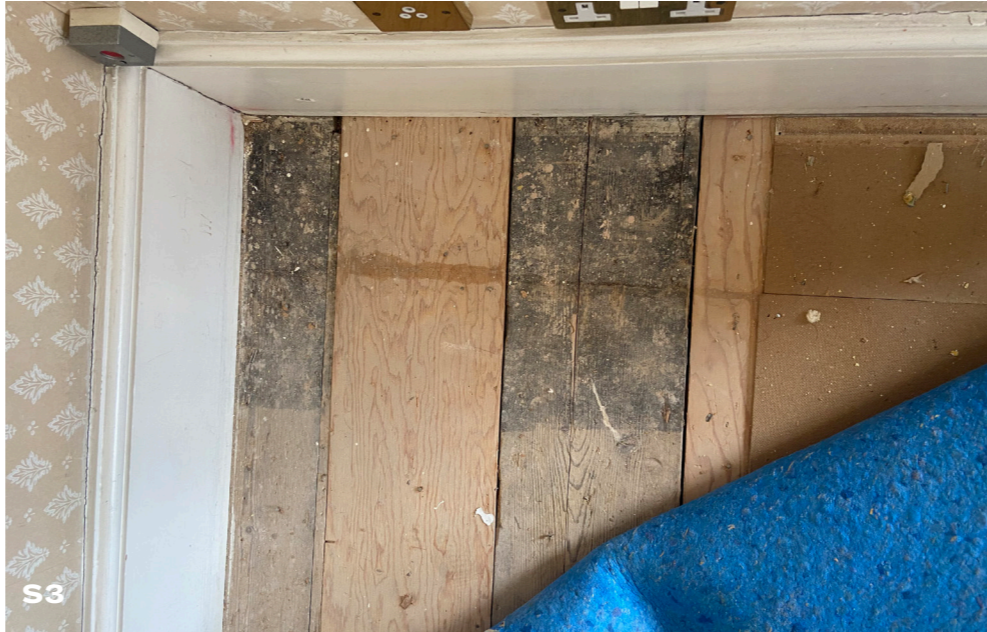
S3
 Master Bedroom (34)
 Carpeting and underlay were lifted up, showing cut floorboards and modern inserts.

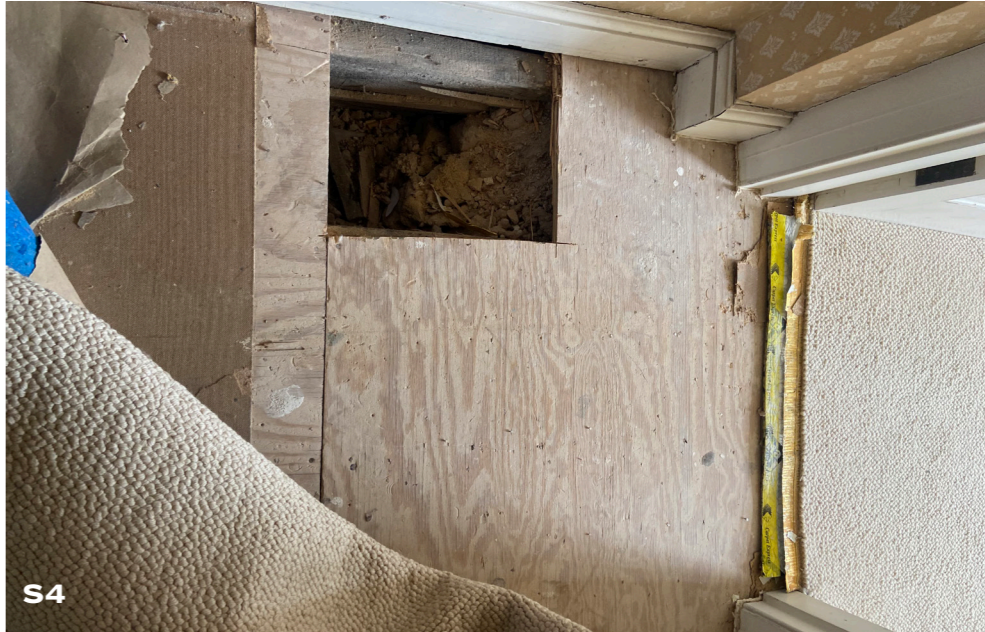
S4
 Master Dressing Room (33)
 Carpeting and underlay were lifted up, showing plywood boarding on joists.

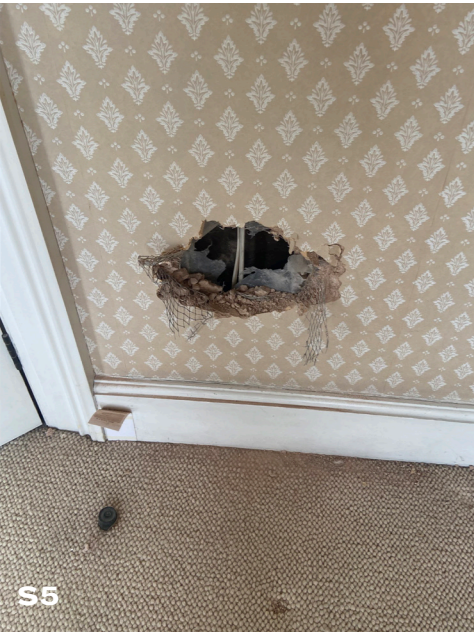
S5
 Master Bedroom (34)
 Opening reveals wall is made of timber battens with EML mesh and plaster.

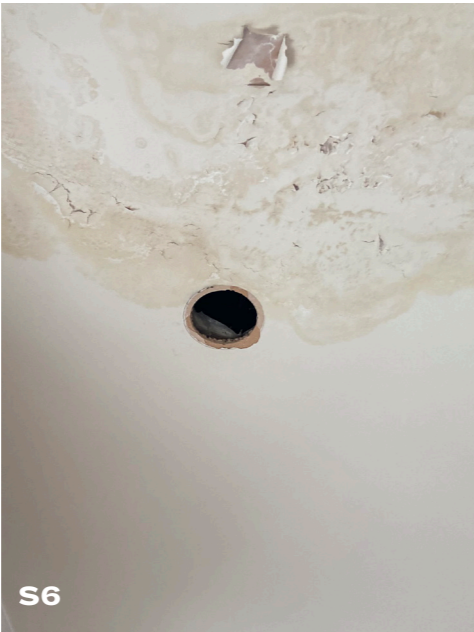
S6
 Master Bedroom (34)
 Downlight removed to show non original ceiling construction.

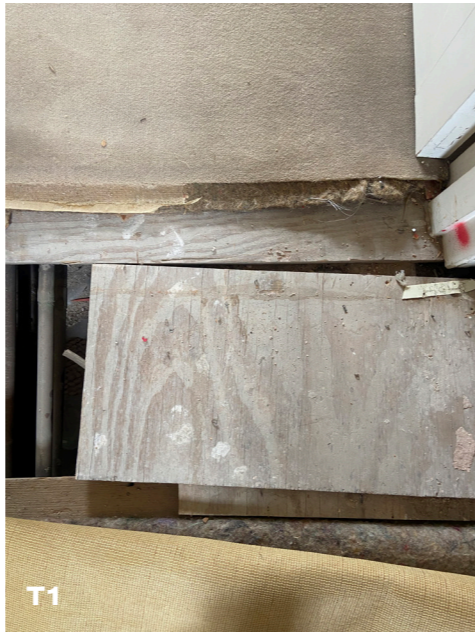
T1
 Second Stair (40)
 Carpeting and underlay were lifted up, showing plywood boarding on joists.

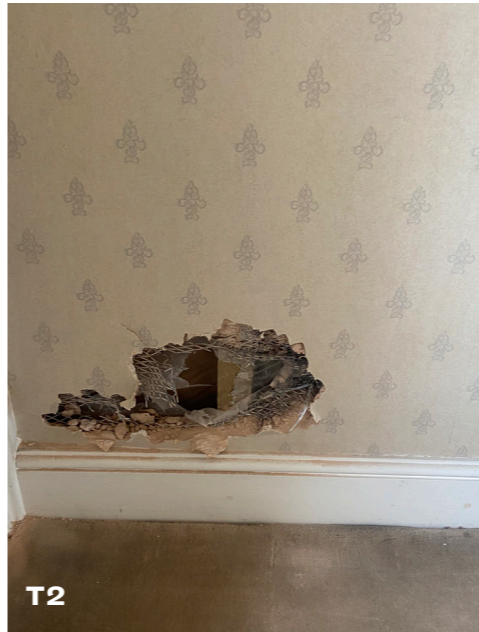
T2
 Third Floor Bedroom (41/39)
 Opening reveals walls are made of timber battens with EML mesh and plaster.

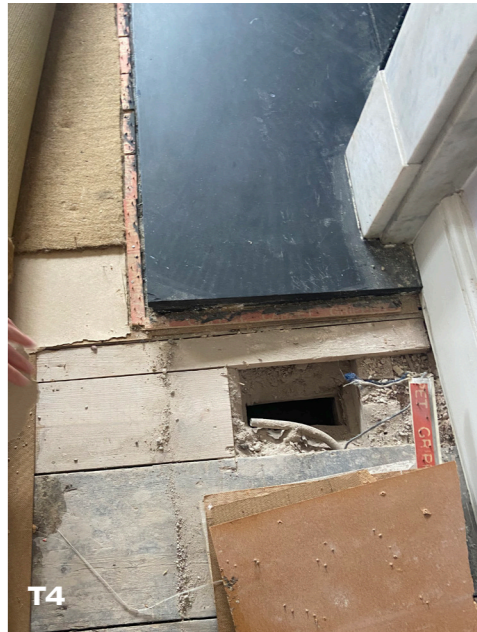
T4
 Third Floor Bedroom (39)
 Carpeting and underlay were lifted up, showing cut floorboards and modern inserts.

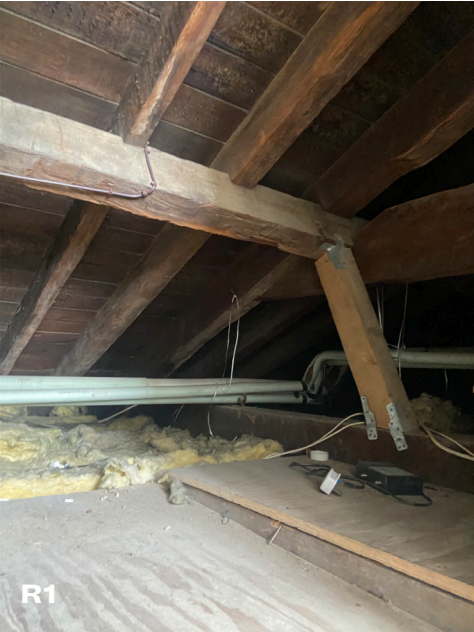
R1
 Roof space (Above 41/39)
 Plyboarding with insulation laid on top of roof joists. Sawn timber support brace.

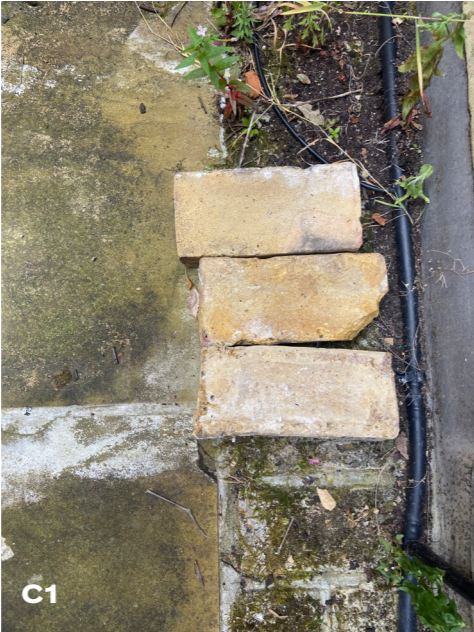
C1
 Salvaged Brickwork (Closet Wing Facade)
 Each age of brick was carefully removed to ensure they can be salvaged and reused within the proposals.

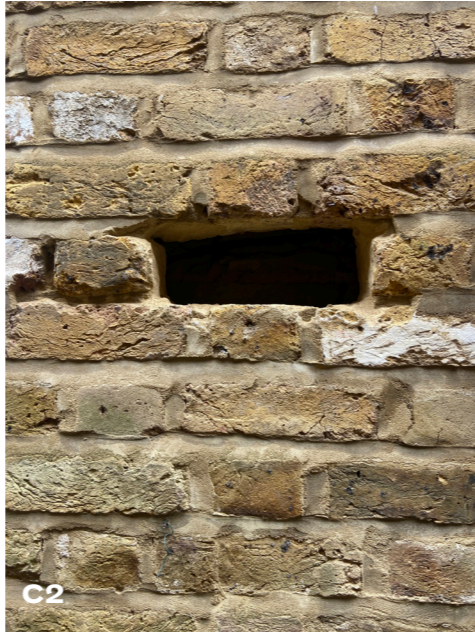
C2
 Brickwork (Closet Wing Facade)
 Transition of two brick ages.

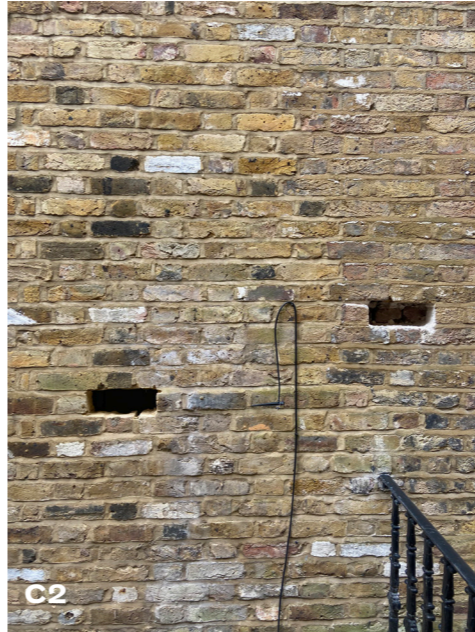
C2
 Brickwork (Closet Wing Facade)
 Transition of two brick ages.

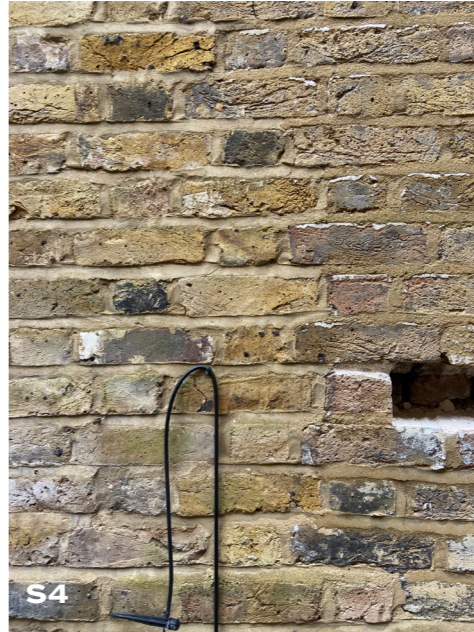
S4
 Brickwork (Mews Facade)
 Modern infill to the arches

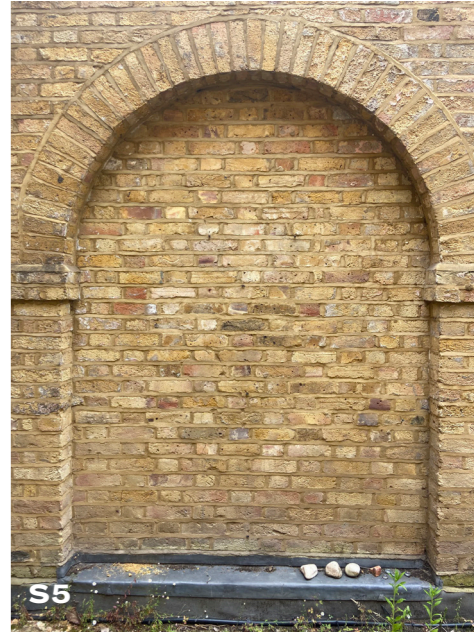
S5
 Brickwork (Mews Facade)
 Modern infill to the arches

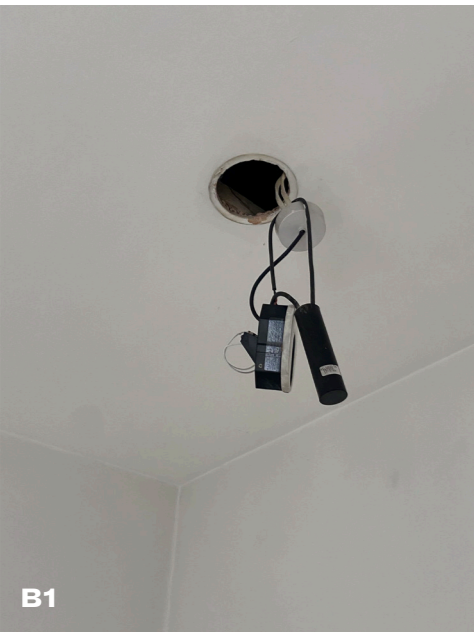
B1
 Spa (02)
 Downlight removed to show non original ceiling construction.

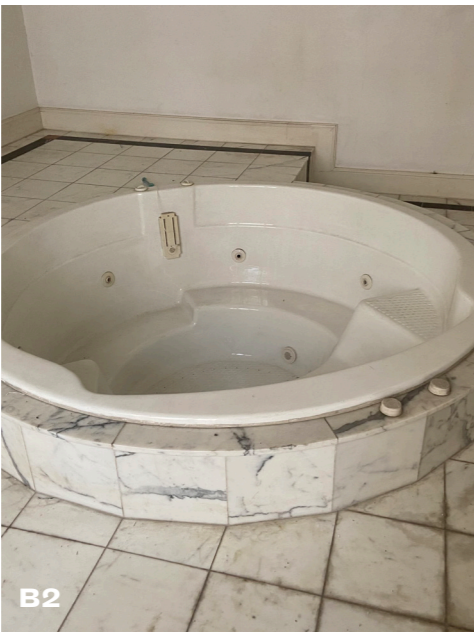
B2
 Spa (02)
 Jacuzzi shows significant existing excavation.

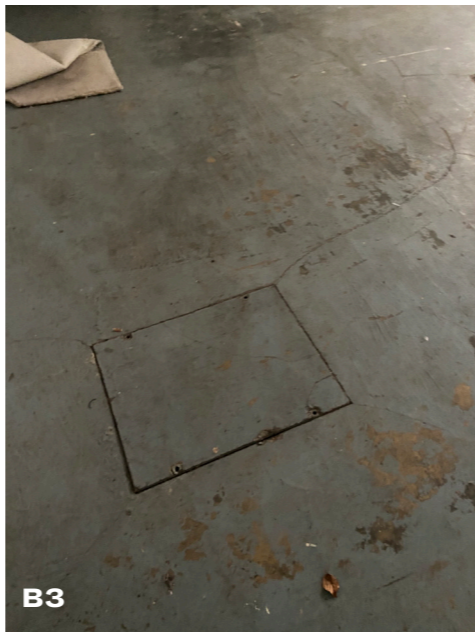
B3
 Garage (01)
 Concrete slab with paint finish

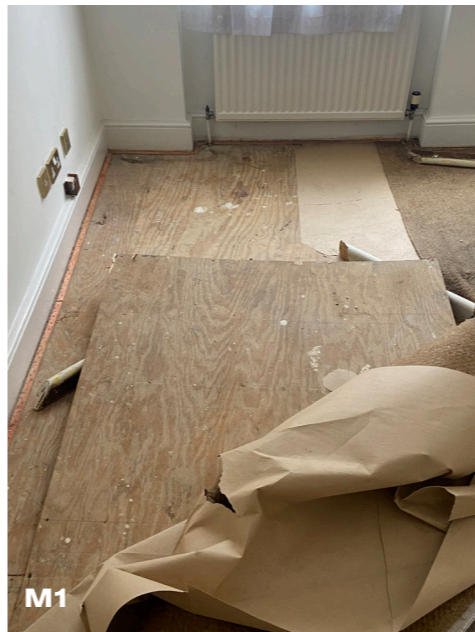
M1
 Mews Bedroom (16)
 Carpeting and underlay were lifted up, showing plywood boarding on joists.

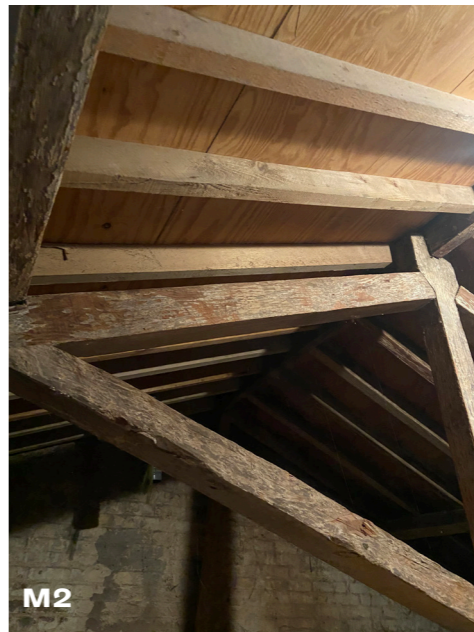
M2
 Mews Roof
 Ply boarding to both sides and sawn timber joists to courtyard side section of mews roof and spanning horizontal sections above ceiling. Plasterboard ceiling on battens fixed below.

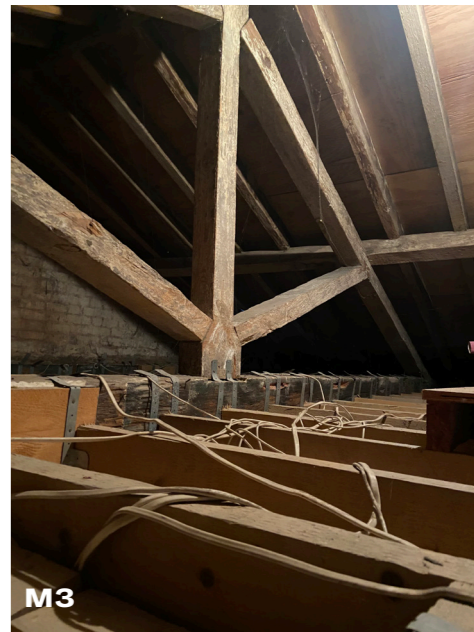
M3
 Mews Roof
 Ply boarding to both sides and sawn timber joists to courtyard side section of mews roof and spanning horizontal sections above ceiling. Plasterboard ceiling on battens fixed below.
