HISTORICAL PLASTERWORK CEILING INSPECTIONS TO THE 8 GLOUCESTER GATE, LONDON, NW1 4HG

Locker & Riley Photographic Survey and Material Characterisation of Existing Decorative Cornices and Provenance in conjunction with John Nash Regency Period

8 Gloucester Gate, London, NW1 4HG

H24511

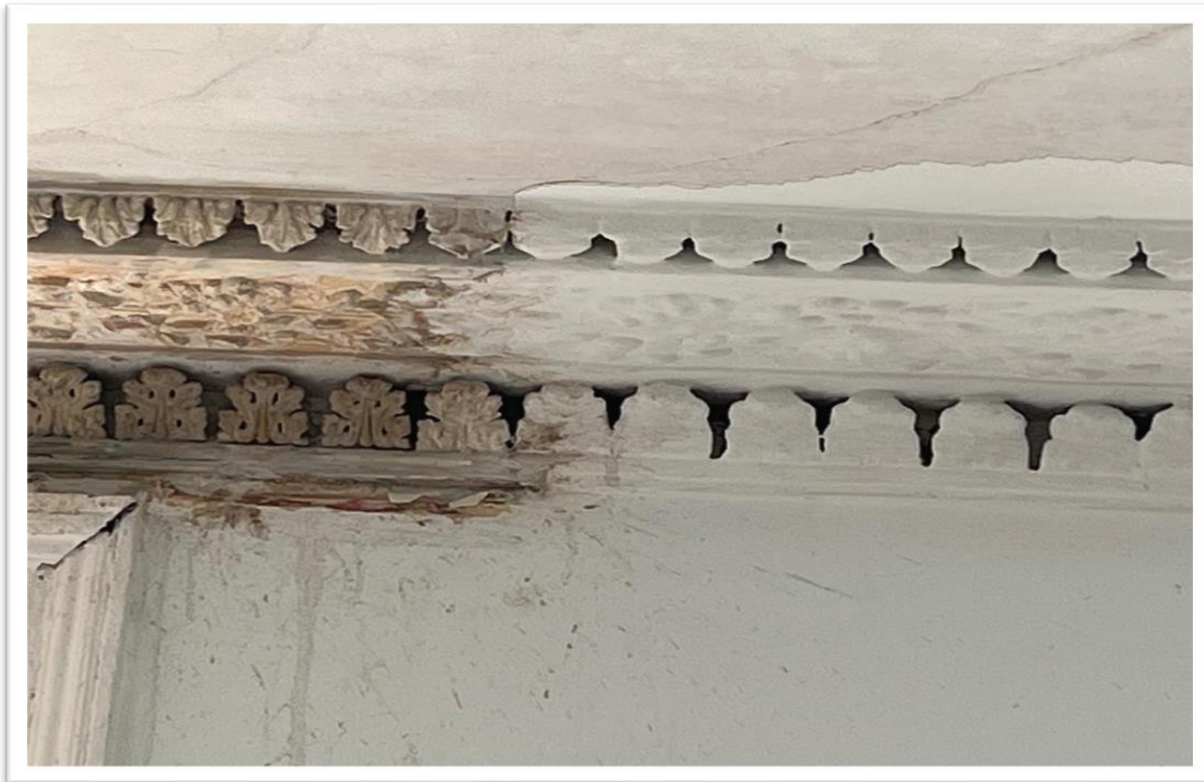
Photo 1 Typical lime plaster cornice C1820

We have attached photos (photo 1 & photo 2,2a) of a current cornice restoration project C1820 for non-hydraulic lime putty with sand on timber lath, the decorative plaster ornamentation which would have been cast off site and dressed onto the run insitu lime plaster plain moulding. Cornice styles for this period predominantly have embedded lime cast components secured in place with animal glue C1820 mixed with resins and bonding materials relevant to the period.

In photo 1 the paint stripping works are in progress; photo 2/2a completed conservation works.

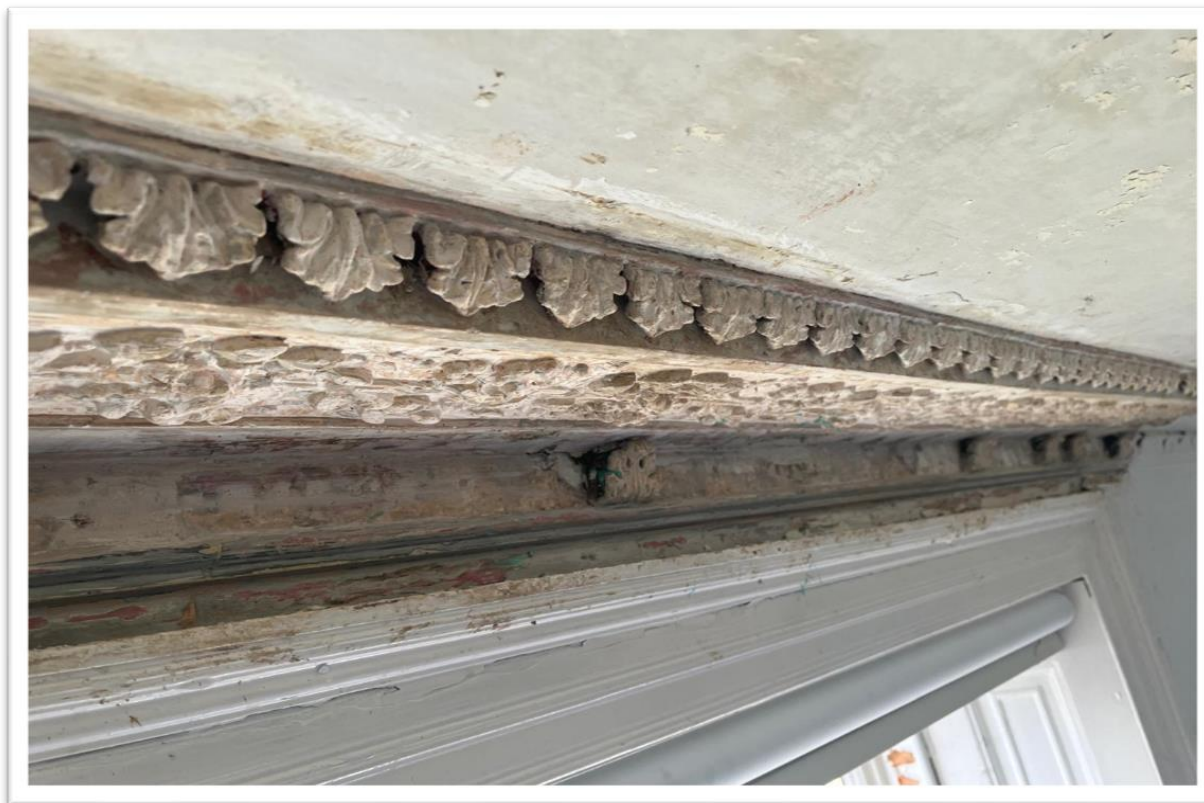
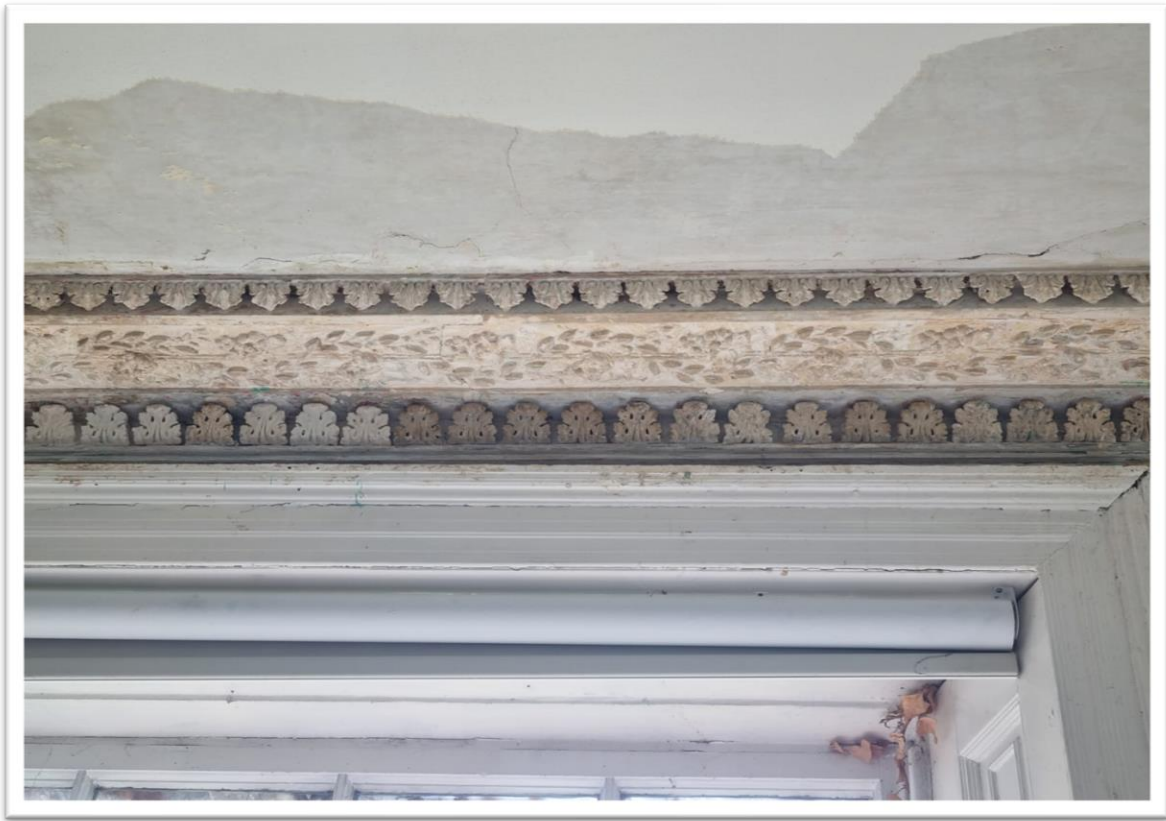
Photo 2-after paint stripping the decorative atheneum leaves de-bonded, which were carefully reconnected.

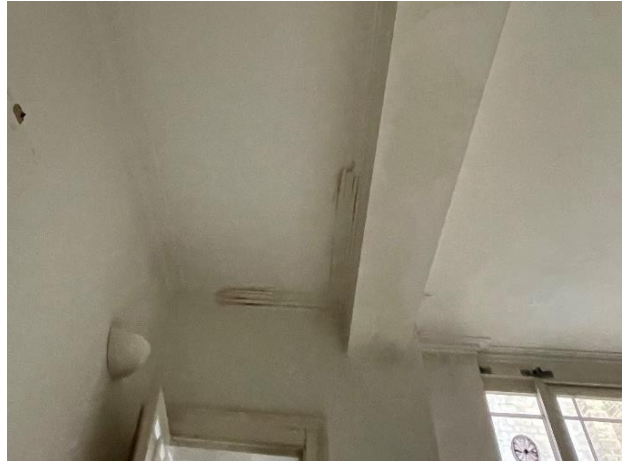
<p>Lower Ground Floor Room 02 – Jacuzzi Room</p> <ul style="list-style-type: none"> • Fibrous Cornice • 5160MMX5319MM CH 2720MM

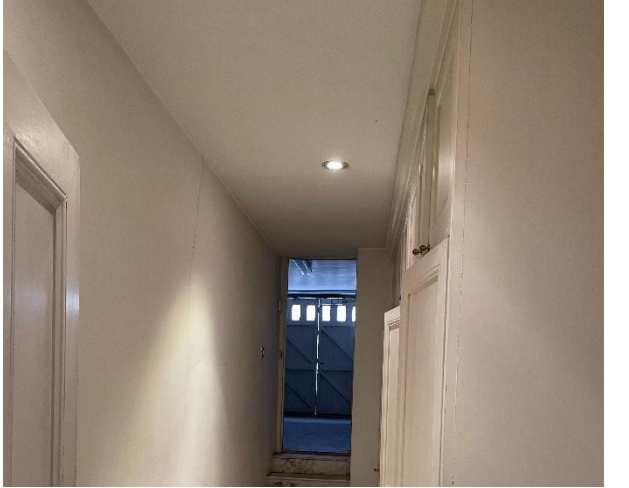
<p>Lower Ground Floor Room 03 – Hallway Running from Garage</p> <ul style="list-style-type: none"> • No Cornice • 5700MMX1600MM CH 3000MM

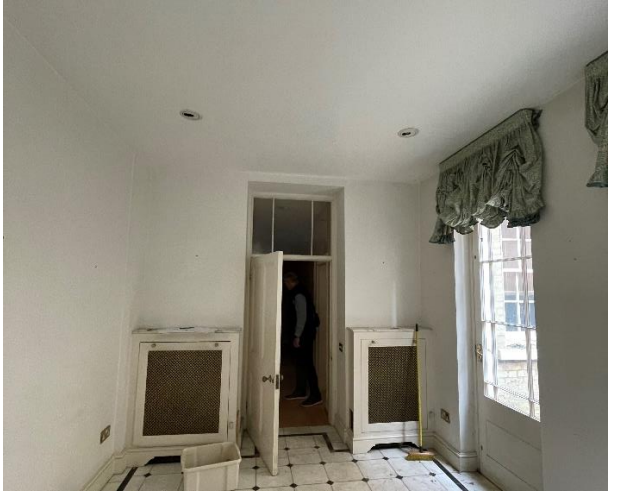
<p>Lower Ground Floor Room 05</p> <ul style="list-style-type: none"> • No Cornice • 5125MMX3069MM CH 2763MM

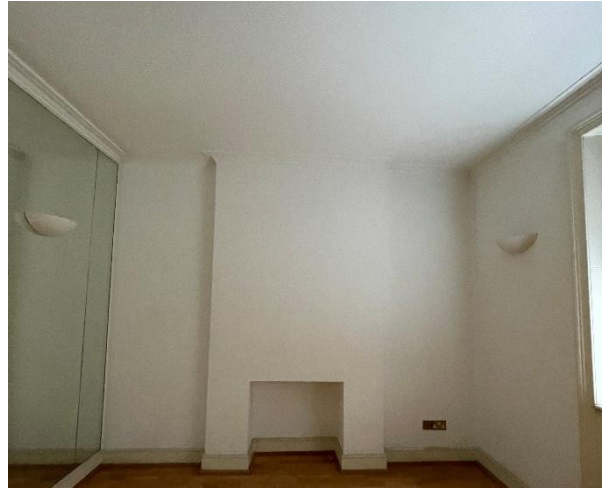
Room 06 – TV Room

- Fibrous Cornice
- 4362MMX3662MM CH 2991MM

Rooms 08,09,10 – Lobby, Sauna & Steam Room

- No Cornice

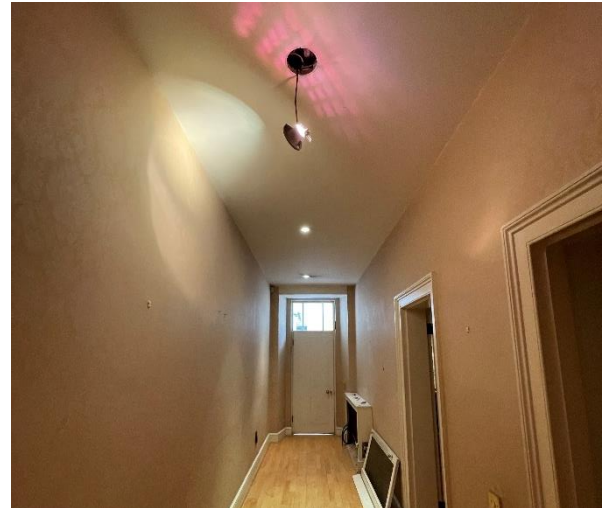
Room 07 & 11 – Lower Ground Corridor/Utility

- No Cornice
- 914MMX1546MM CH 2991MM

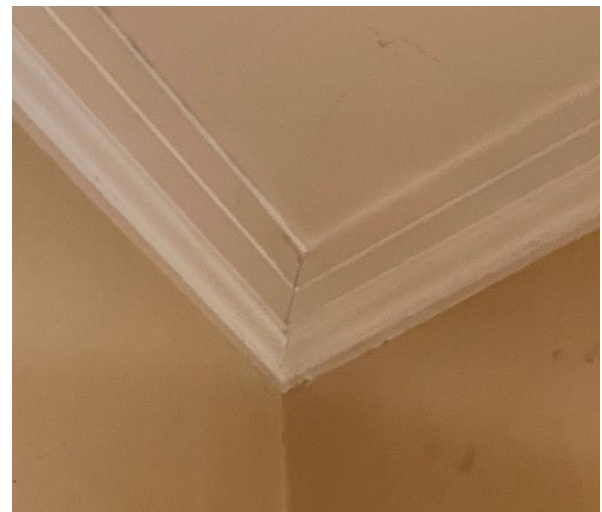
Room 12 - Bedroom 05

- Fibrous Cornice
- 4537MMX4810MM CH 2991

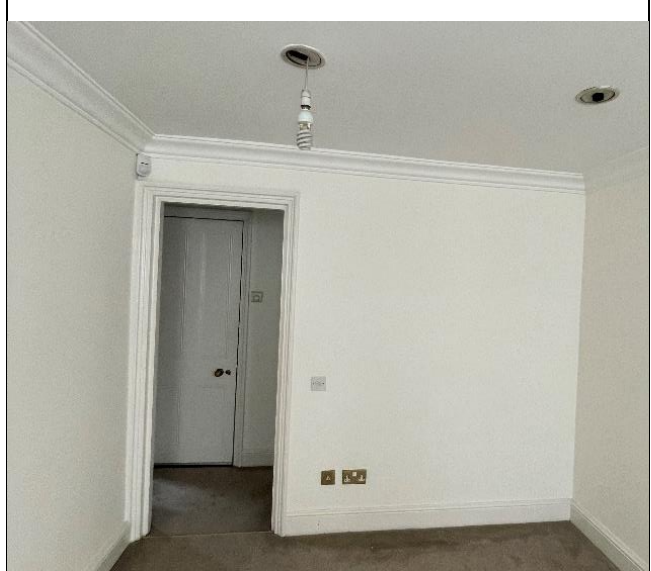
Room 15 – Mews Living Room

- Fibrous Cornice
- 2755MMX4367MM CH 2305MM
- Common CH in mews area

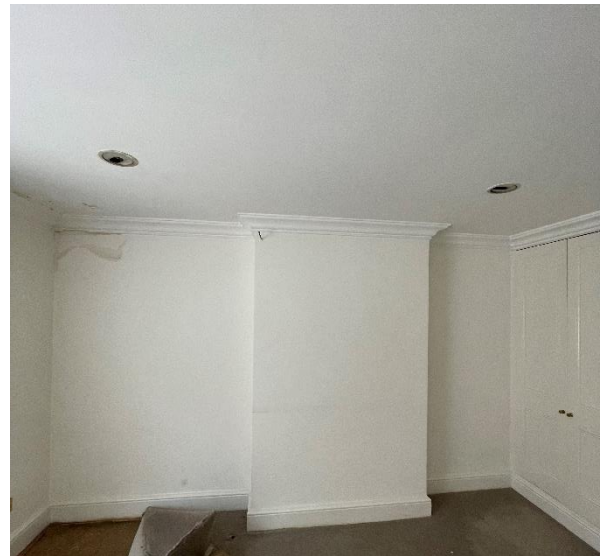
Room 16 – Mews Bedroom

- Fibrous Cornice
- 4342MMX3177MM CH 2305MM

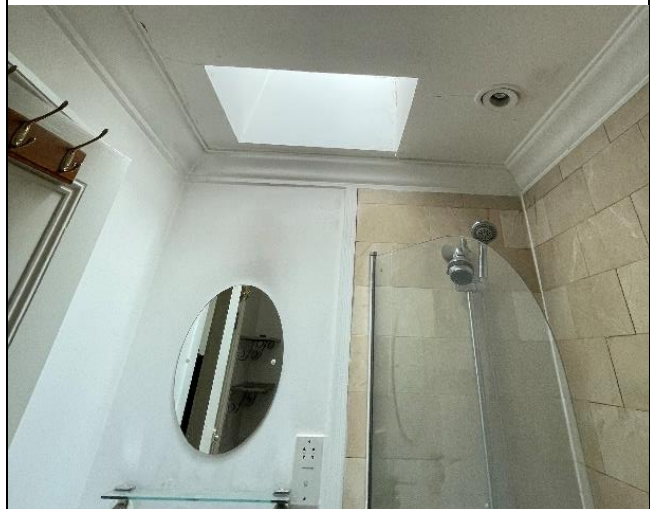
Room 17 – Mews Bathroom

- Fibrous Cornice
- 1474MMX2211MM CH 2305MM

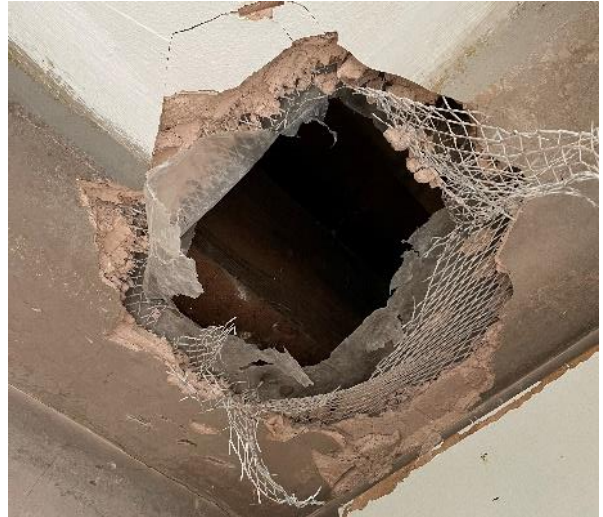
Ground Floor
Room 18 – Mews Kitchen

- No Cornice
- 2876MMX2412MM CH 2305MM

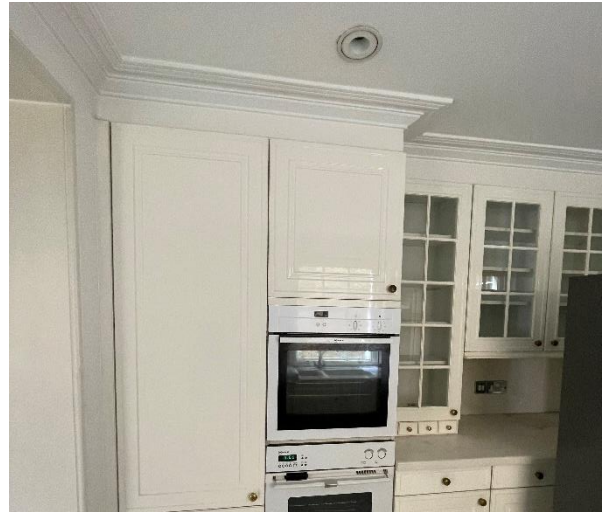
Ground Floor
Room 21 – Kitchen

21	GF	Kitchen	8519MMX3112MM CH 2468MM	Fibrous Cornice/EML Ceiling	Water ingress in back area of kitchen and NW corner of main kitchen
22	GF	Bar/Library	4398MMX3717MM CH 2468MM	Fibrous Cornice/EML polythene ceilings/EML walls	
23	GF	Entrance Lobby	6177MMX1623MM CH 3533MM	Original cornice & dentil block detail	
24	GF	Formal Dining	4984MMX 7305MM CH 3800MM	Fibrous Cornice/SW corner of ceiling original Lathe & Plaster EML visable through downlight	
27	1ST		4511MMX3203MM CH 2914MM	Fibrous Cornice Inc Lobbys and Toilet/EML ceiling	
28	1ST	Sitting Room	4400MMX5543MM CH 3883MM	Fibrous Cornice/Fitting with Regancy Style/EML ceiling	Joint lines visable/Mitres cracking/Misaligned joint lines/Water ingress present/Overall poor install

- Fibrous Cornice
- 8519MMX3112MM CH 2468MM

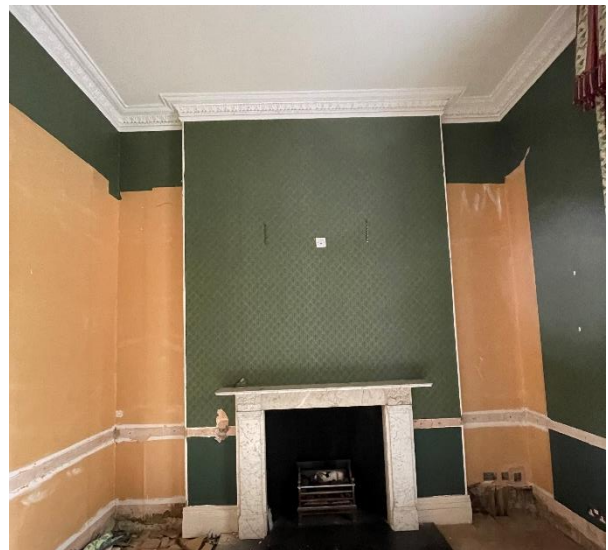
Ground Floor
Room 22 – Bar/Library

- Fibrous Cornice
- 4398MMX3717MM CH 2468MM

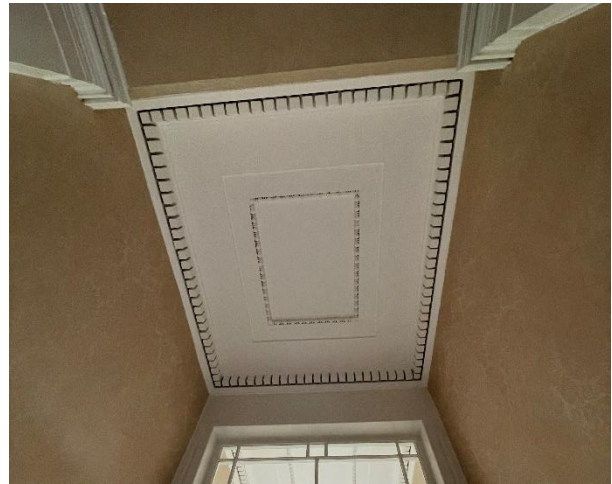
Room 23 – Entrance Lobby

The only original ceilings and cornices to remain are to the ground floor entrance hall.

- Original Cornice & Dentil Block
- 6177MMX1623MM CH 3533MM (Entrance Lobby)
- 5572MMX2105MM CH 3533 (Staircase)

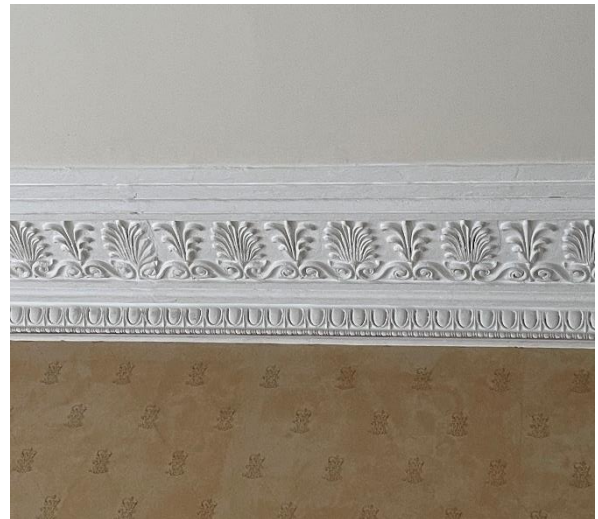
Room 24 – Formal Dining

- Fibrous Cornice
- 4984MMX 7305MM CH 3800MM

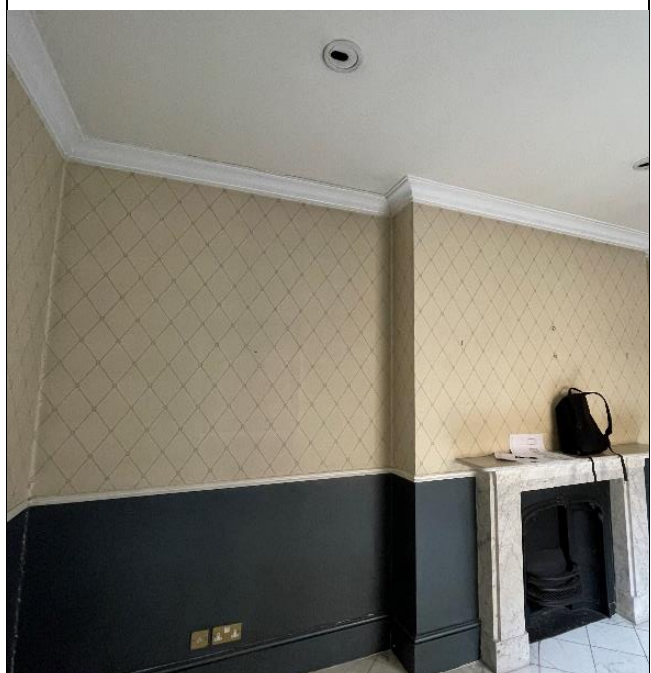
Room 27

- Fibrous Cornice
- 4511MMX3203MM CH 2914MM

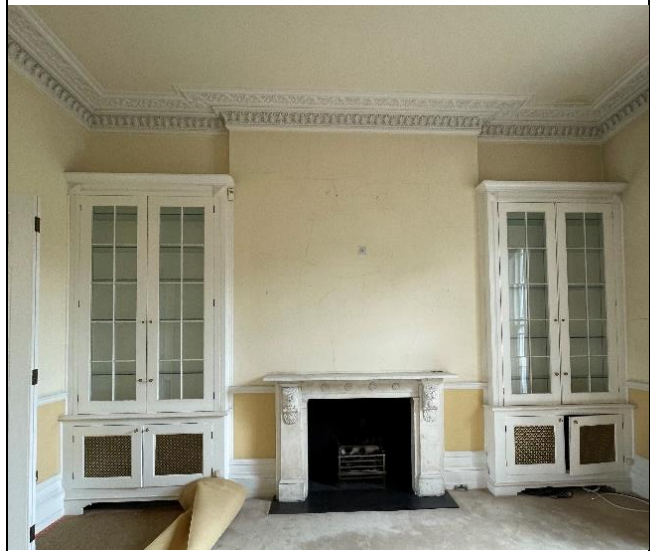
Room 28 – Sitting Room

- Fibrous Cornice
- 4400MMX5543MM CH 3883MM

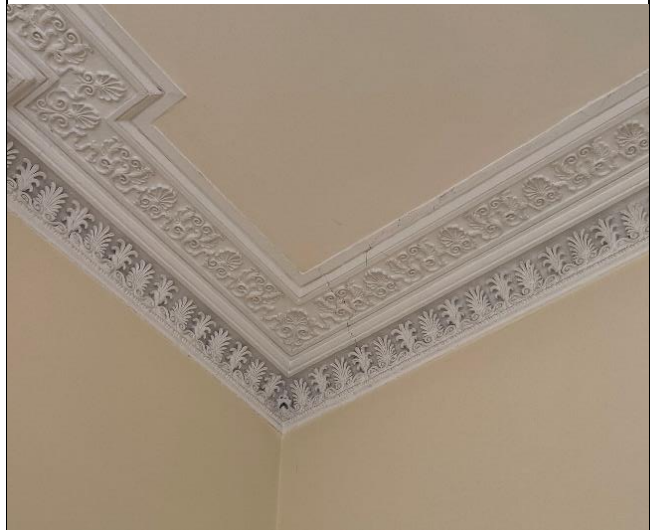
Room 30 – Reception Room

30	1ST	Reception Room	5392MMX6914MM CH 3863MM	Fibrous Cornice/Fitting with Regency Style/EML ceiling	Joint lines visible/Mitres cracking/Misaligned joint lines/Water ingress present/Overall poor install/Unsure of transition between new and old ceiling between rooms 28 & 30 visible due to floorboard removal
32	2ND	Master Bathroom	3855MMX4401MM CH 3204MM	Fibrous Cornice/EML ceiling	
33	2ND	Master Dressing Room	3160MMX2688MM CH 2994MM	Fibrous Cornice/EML ceiling	
34	2ND	Master Bedroom	4306MMX6599MM CH 3190MM	Fibrous Cornice/EML ceiling	2no areas of water ingress to ceiling
36	3RD	Bedroom 02	4156MMX4388MM CH 2510MM	Fibrous cornice (Inc. lobby area)	N/A
37	3RD	Bathroom	1919MMX4194MM CH 2546MM	Fibrous Cornice/Assume EML ceiling	Ceiling coated with lining paper
38	3RD	Bedroom 04 Ensuite	CH 2558MM	Fibrous cornice	Water ingress to ceiling 500mm2
39	3RD	Bedroom 04	4572MMX4836MM CH 2558MM	No Cornice, EML/Carlite plaster	Evidence of water ingress

- Fibrous Cornice
- 5392MMX6914MM CH 3863MM

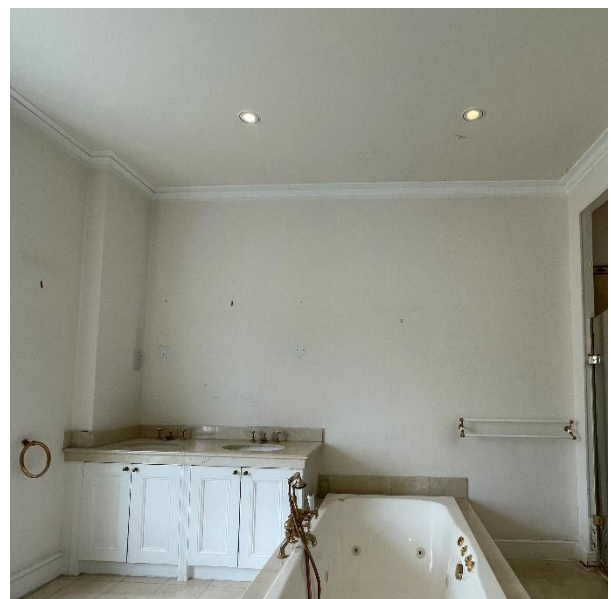
Room 32 – Master Bathroom

- Fibrous Cornice
- 3855MMX4401MM CH 3204MM

Locker & Riley would advise the fibrous plaster cornices to the master bathroom, master bedroom, on suite and 3rd floor do not reflect the Regency period and would advise a more sympathetic Regency style ceiling cornice is introduced to reflect the Grade 1 listing.

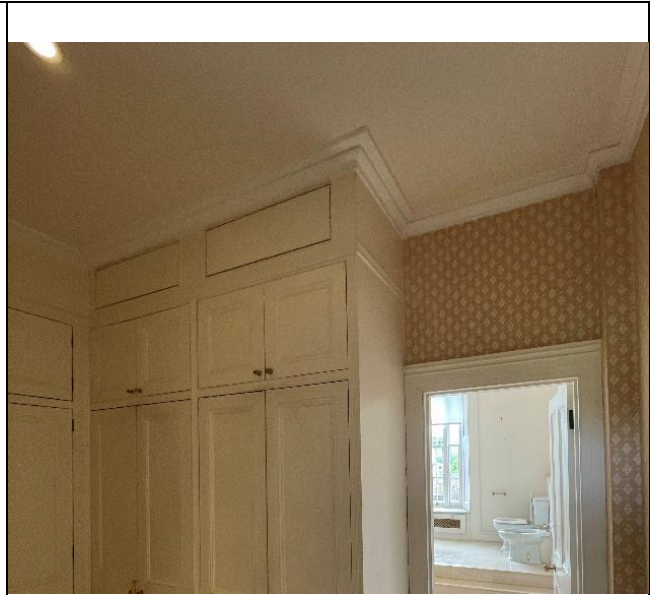
Room 33 - Master Dressing Room

- Fibrous Cornice
- 3160MMX2688MM CH 2994MM

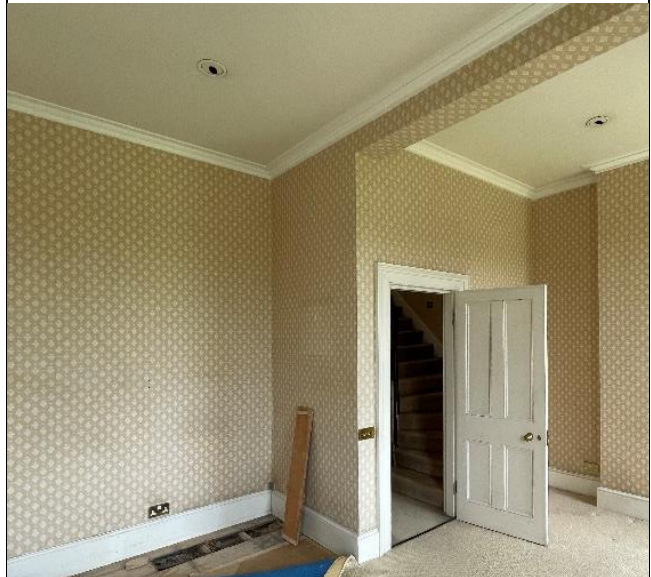
Room 34 – Master Bedroom

- Fibrous Cornice
- 4306MMX6599MM CH 3190MM

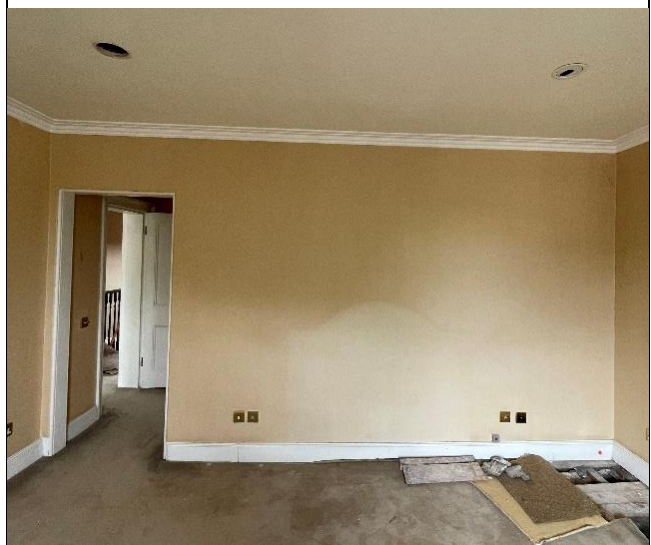
Room 36 – Bedroom 02

- Fibrous Cornice, inc. Lobby Area
- 4156MMX4388MM CH 2510MM

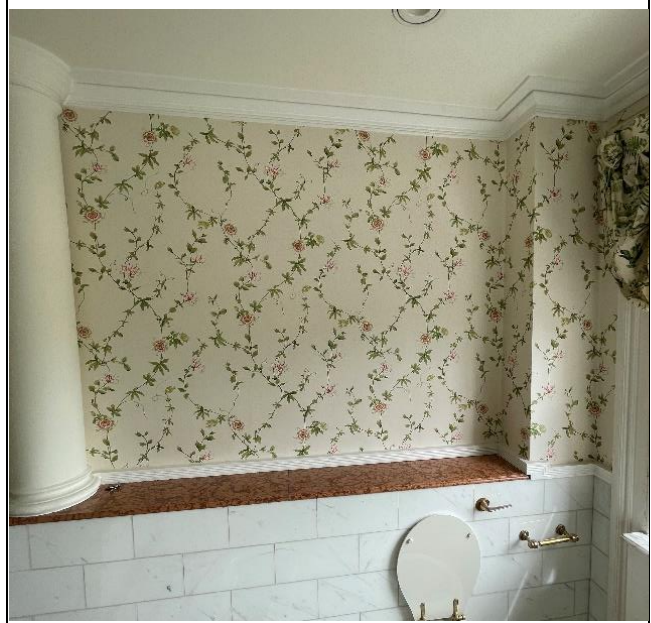
Room 37 – Bathroom

- Fibrous Cornice
- 1919MMX4194MM CH 2546MM
- Ceiling covered with lining paper assume EML ceiling

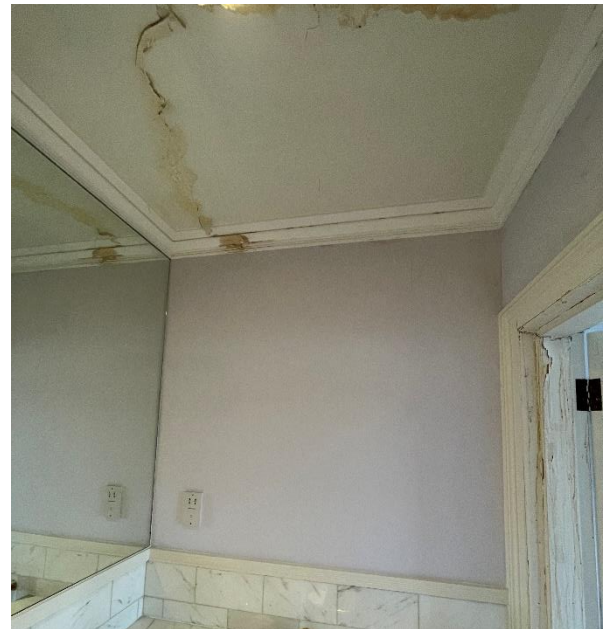
Room 38 – Bedroom 04 Ensuite

- Fibrous Cornice
- CH 2558MM

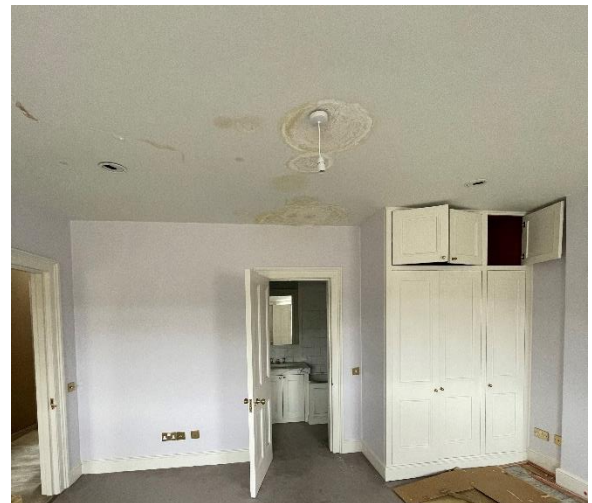
Room 39 – Bedroom 04

- No Cornice
- 4572MMX4836MM CH 2558MM

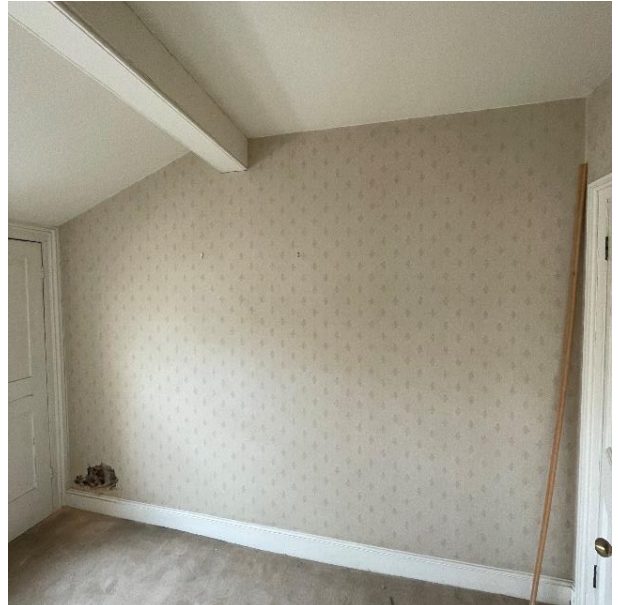
Room 41 – Bedroom 03

41	3RD	Bedroom 03	2291MMX3211MM CH 2557MM	No cornice, gypsum plaster/EML	Evidence of water ingress
		1st Floor & 2nd Floor Landings	(STAIRCASE MEASUREMENTS) 5572MMX2105MM CH 3533	Fibrous Cornice	
		GF half landing & 3rd Floor Landings	(STAIRCASE MEASUREMENTS) 5572MMX2105MM CH 3533	No Cornice	
		Mews Stairs	MEWS STAIRS 800MMX5400MM	Fibrous Cornice	
		Mews Landing	MEWS LANDING 6000MMX1000MM	Fibrous Cornice

- No Cornice
- 2291MMX3211MM CH 2557MM

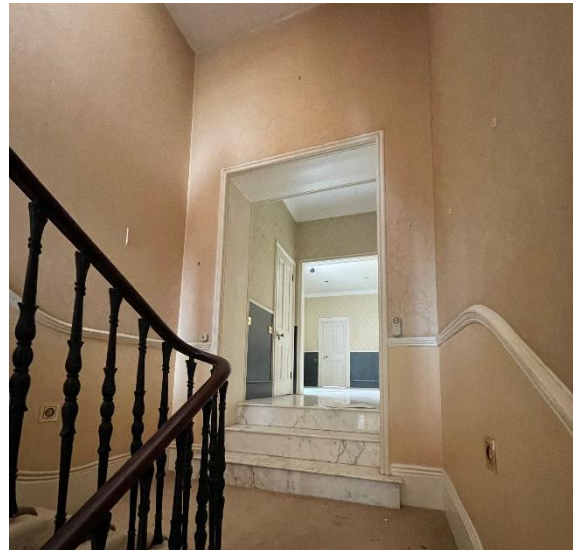
Ground Floor Half Landing

- No Cornice

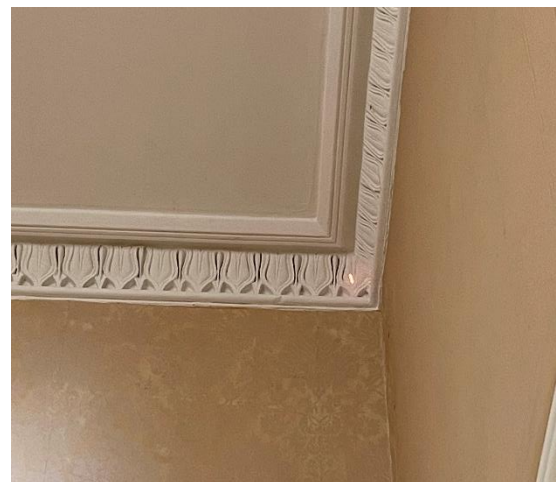
First Floor Landing

- Fibrous Cornice

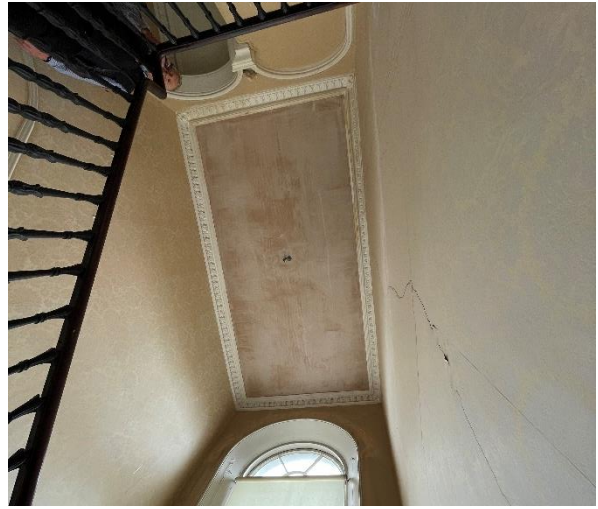
First Floor Half Landing

- Fibrous Cornice

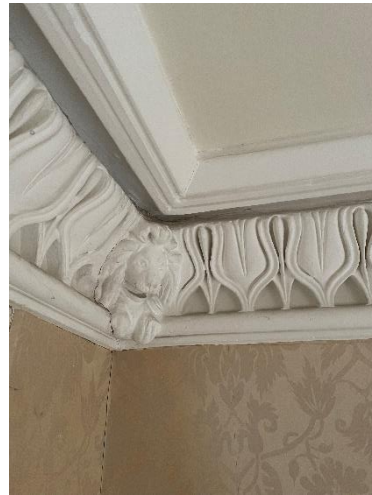
Second Floor Landing

- Fibrous Cornice

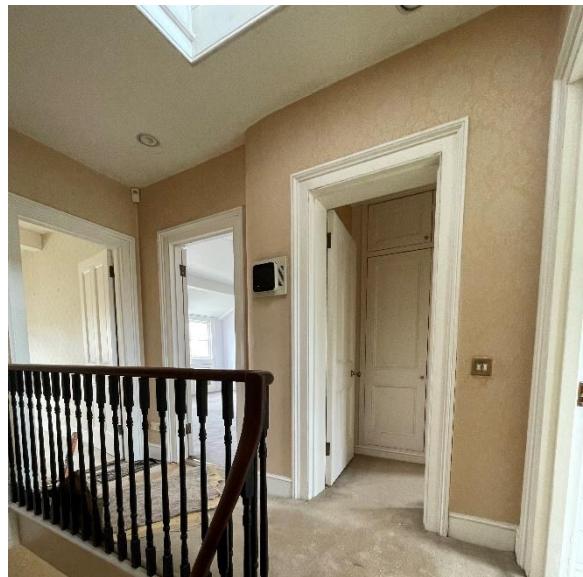
Third Floor Landing

- No Cornice
