Structural Report

**118 Malden Road
London
NW5 4BY**

Condition Report

24th May 2024

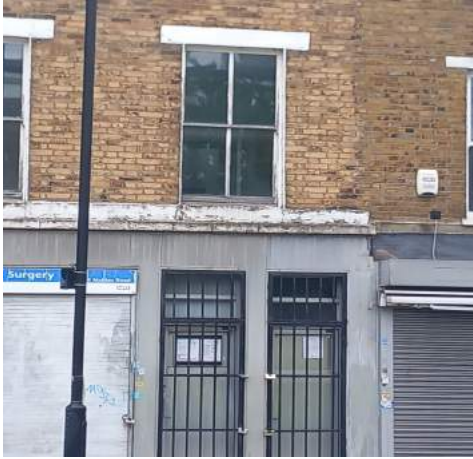
<p><u>Front Elevation</u></p> <p><u>Left side photo</u> Discoloured brickwall at first floor. Joint with crack line with sealant between the party wall</p>	.

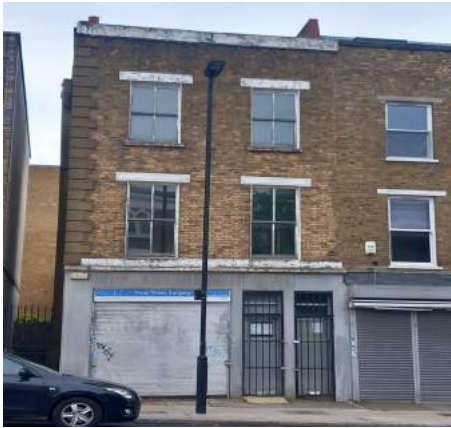
<p><u>Front Elevation</u> Front elevation of property showing alleyway 'gap' small passageway between neighbouring property</p>

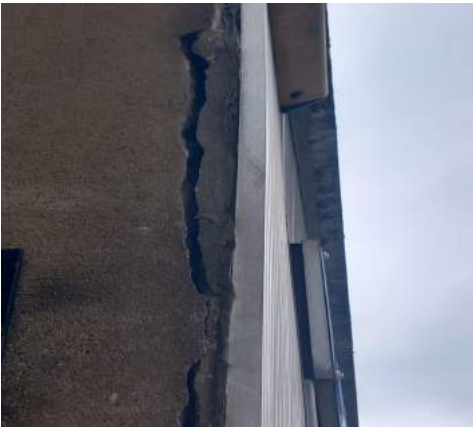
<p><u>Left side photo</u> Splitting crack/gap at the corner of the front facade and flank wall visible by alleyway.</p>

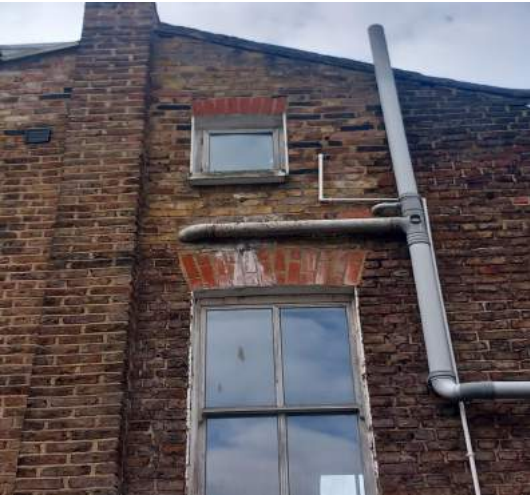
<p><u>REAR ELEVATION</u> <u>Left side photo</u> Brickwork appears to be poorly constructed around the top small window..</p> <p><u>Right side Photo</u> Brickwork appears to be poorly constructed around the top small window.</p>

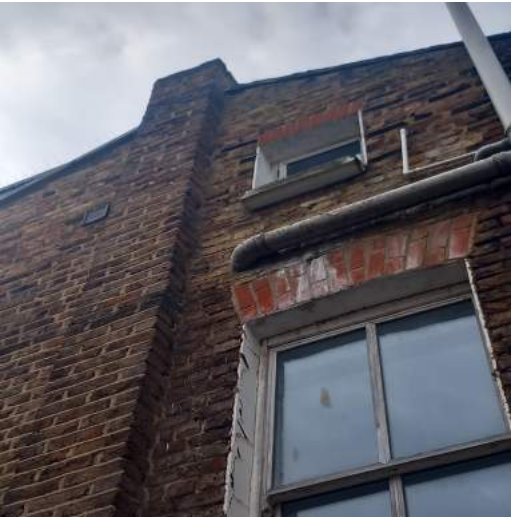
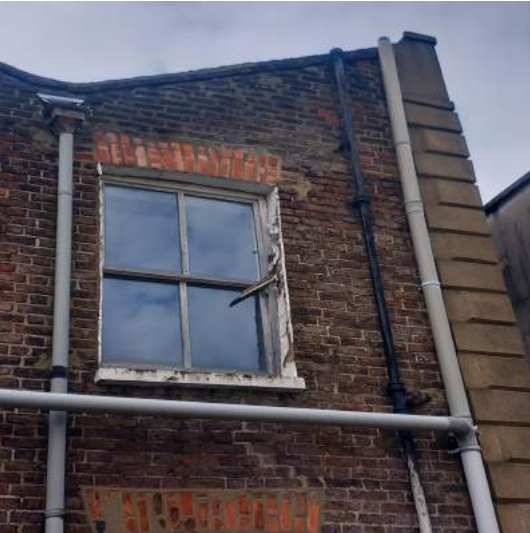
<p><u>REAR ELEVATION</u> <u>Left side photo</u> Brickwork appears to be poorly constructed around the top small window..</p> <p><u>Right side Photo</u> Paint peeling off wall around window</p>

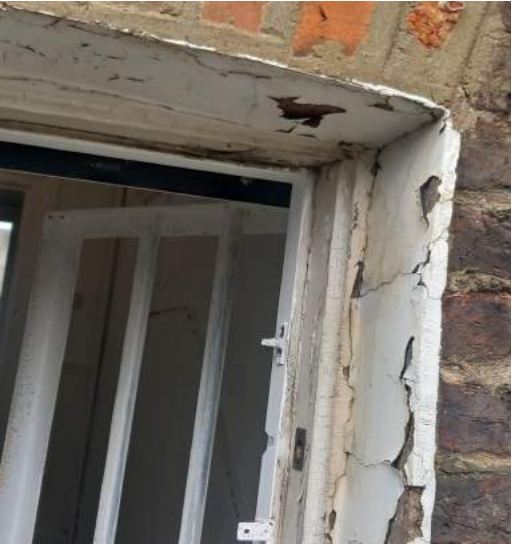
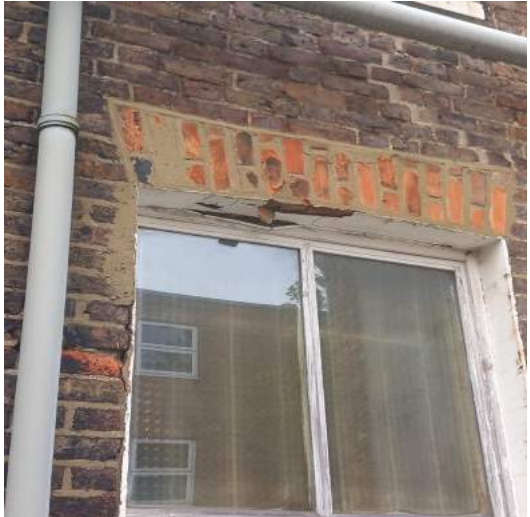
<p><u>REAR ELEVATION</u> <u>Left side photo</u> Poorly repaired brick lintel with falling plaster below</p> <p><u>Right side Photo</u> Brickwork appears to signs of distortion and unevenness</p>

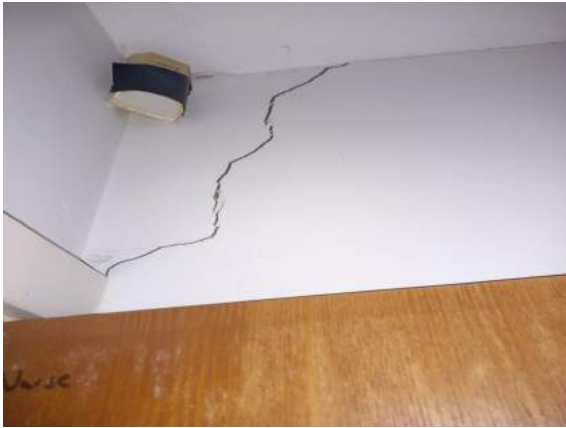
<p><u>GROUND FLOOR</u></p> <p><u>Left side Photo</u> Diagonal crack on masonry wall, top of Lintel bearing leading to ceiling</p> <p><u>Right side Photo</u> Cracking (gap) on corner wall to wall, and ceiling to wall.</p>

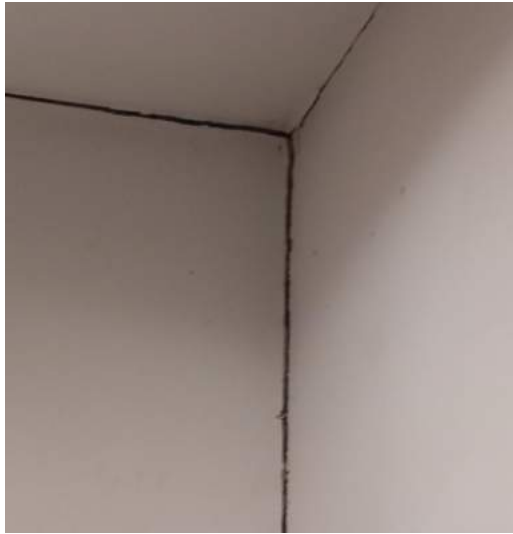
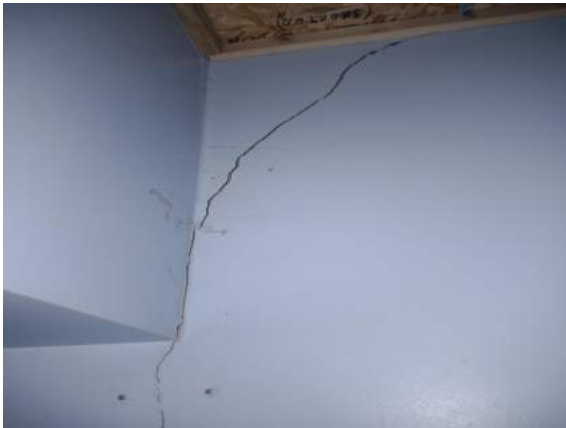
<p><u>Left side Photo</u> Vertical line crack on & below beam then diagonal crack on masonry wall, beam bearing leading to ceiling</p> <p><u>Right side Photo</u> Boarded courtyard void with temp support showing signs of cracking on the ceiling.</p>

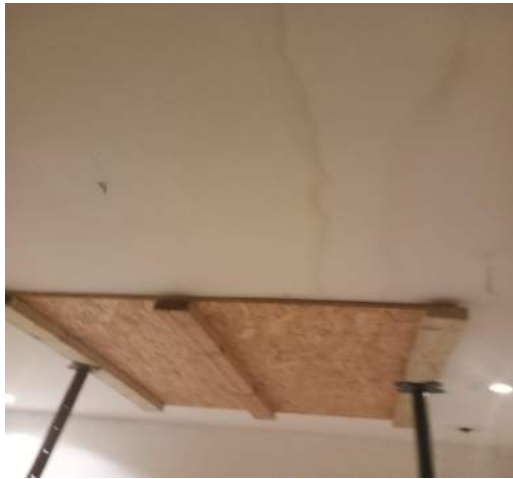
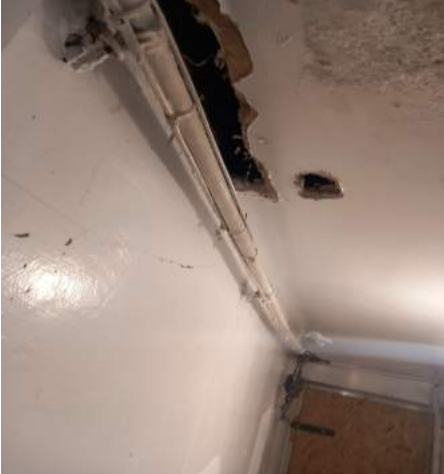
<p><u>Left side Photo</u> Section of damage ceiling with damp patches on ceiling</p> <p><u>Right side Photo</u> Boarded courtyard void with temp support</p>

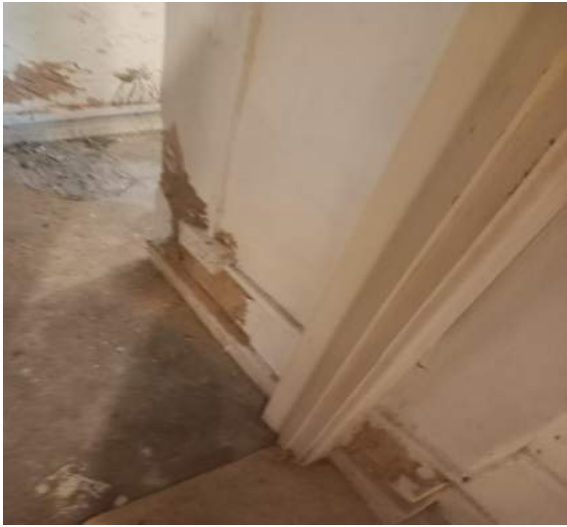
<p><u>Left side Photo</u> Section of damaged wall and floor with damp patches on skirting and wall .</p>

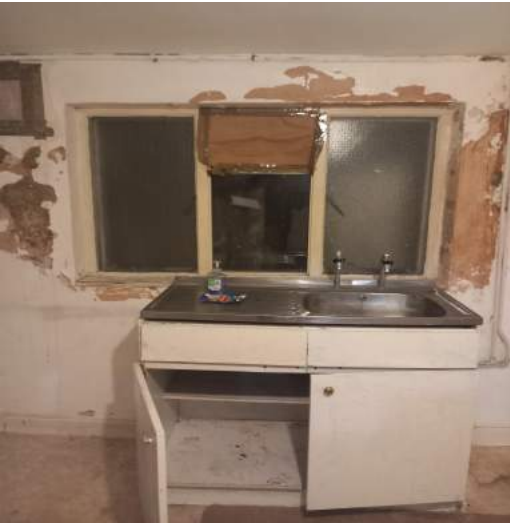
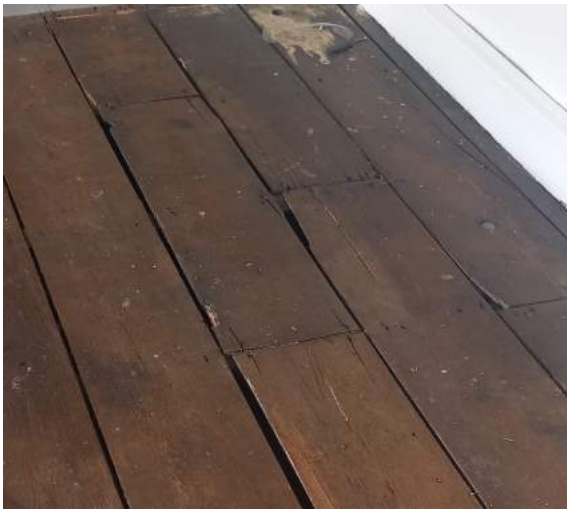
<p><u>FIRST FLOOR</u></p> <p><u>Left side Photo</u> Gaps between floor boards with and signs of unevenness on the floor</p> <p><u>Right side Photo</u> Paint peeling off external window sill.</p>

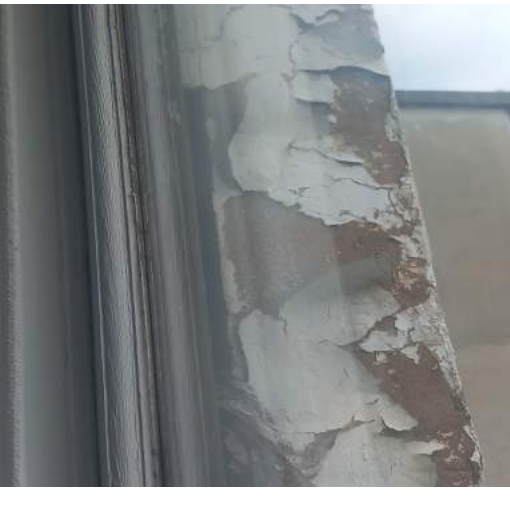
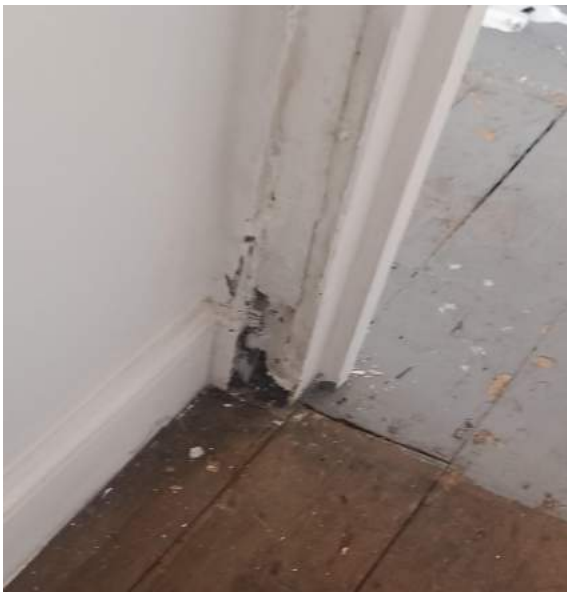
<p><u>Left side Photo</u> Bottom section of timber floor with signs of rot and vertical cracks on timber frame</p> <p><u>Right side Photo</u> signs of unevenness on the floor</p>

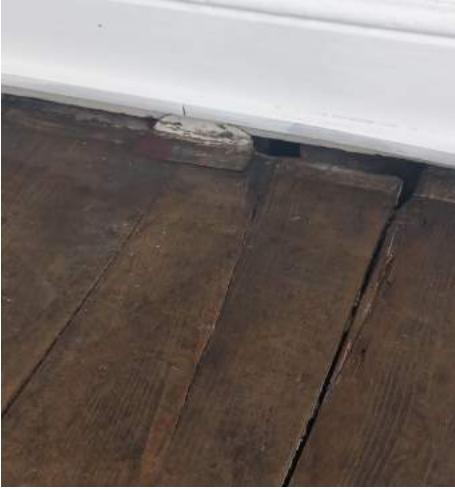
<p><u>SECOND FLOOR</u></p> <p><u>Left side Photo</u> damage boards and gaps between floor boards with and signs of unevenness on the floor</p> <p><u>Right side Photo</u> damage boards and gaps between floor boards with and signs of unevenness depression on floor</p>

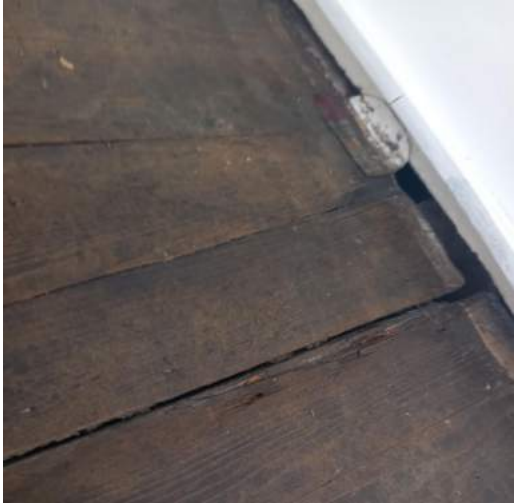
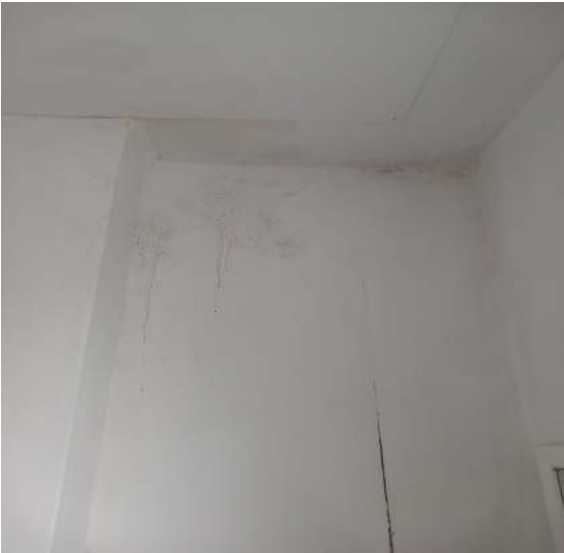
<p><u>Left side Photo</u> Damp signs on wall and ceiling.</p> <p><u>Right side Photo</u> Vertical crack line at junction of wall with patches of damp</p>

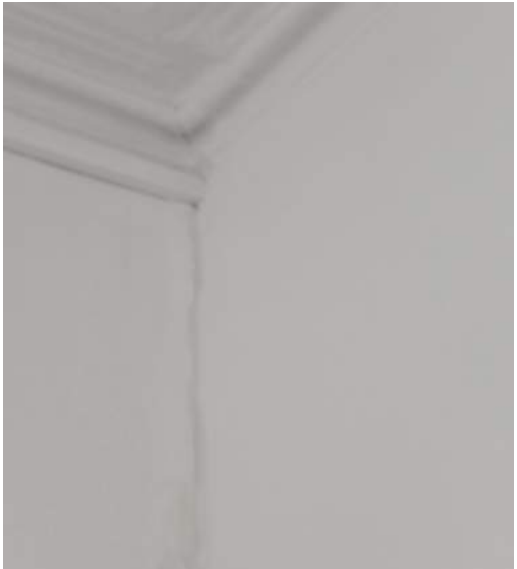
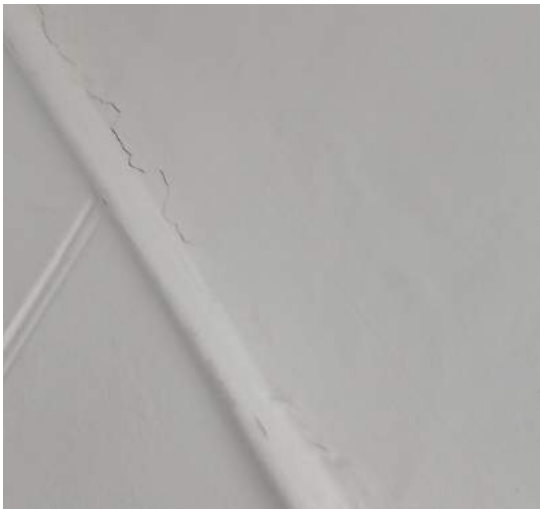
<p><u>Left side Photo</u> Horizontal crack line between ceiling and wall.</p> <p><u>Right side Photo</u> Vertical crack line at junction of wall downwards to floor level</p>
