Revised Arboricultural Appraisal Report

Subsidence Damage Investigation at:

22a Harley Road
Hampstead
London
NW3 3BN

CLIENT: Crawford & Company
CLIENT REF: [REDACTED]
MWA REF: [REDACTED]
MWA CONSULTANT: Andy Clark
REPORT DATE: 06/12/2023

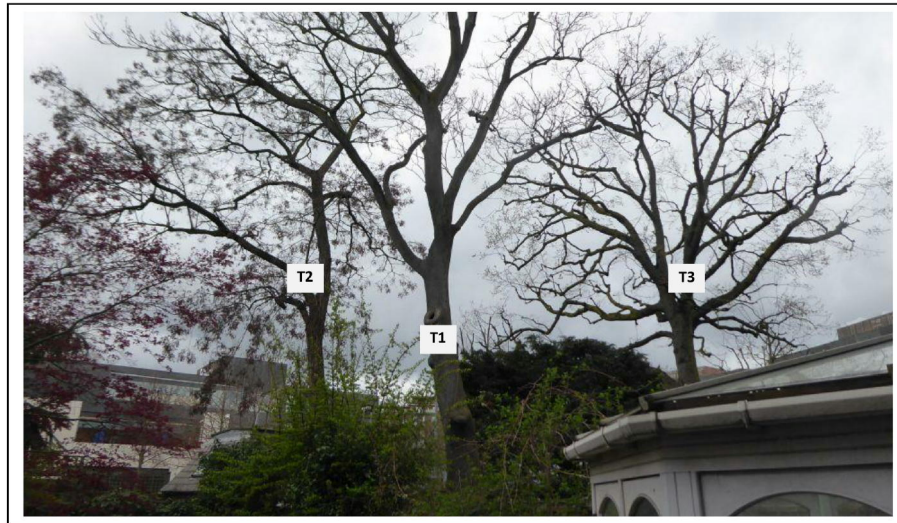
The origin of the Vitaceae spp. roots will be the grape of SG1 and are not considered significant to the current damage. The source of the Leguminosae spp. roots will be T2 False Acacia, the either Quercus spp. or [the related] Castanea spp. roots will emanate from T3 Oak, and the Ailanthus spp. roots will originate from T1 Tree of Heaven.

View of T1 Tree of Heaven, T2 False Acacia and T3 Oak

If an arboricultural solution is to be implemented to mitigate the influence of the implicated trees/vegetation we recommend that T1 Tree of Heaven and T2 False Acacia are removed at this stage. If movement persists the removal of the oak may become necessary.

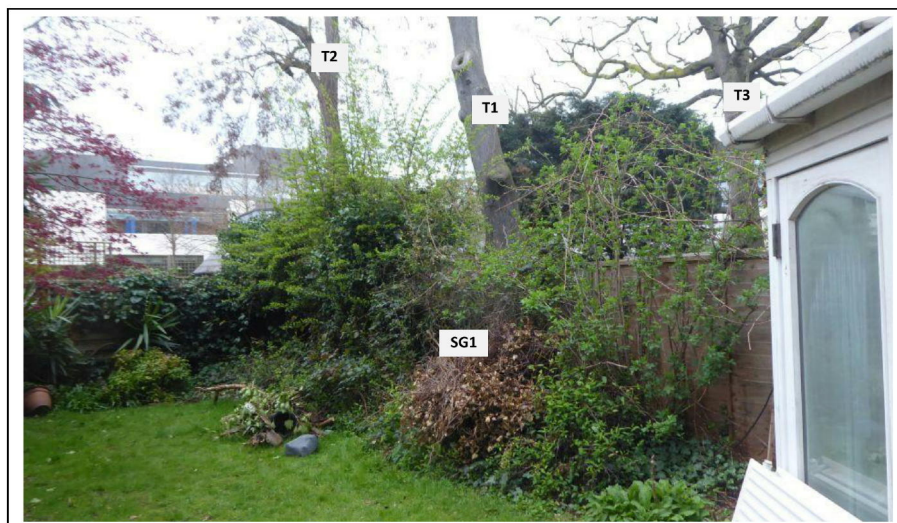
View of SG1 group with stems of T1, T2 and T3 visible beyond

SG1	Mixed spp. hedgerow group of mostly Grape, Elder, Pyracantha and Ivy	4.5	70 Ms *	5.0	0.7	Younger than Property	Policy Holder
Management history		No significant recent management noted.					
Recommendation		Reduce height to 2.0m and cut back width to 1.0m to restore to suitably managed hedge. Re-prune thereafter on an annual cycle to maintain at broadly reduced dimensions.					
SG2	Fatsia and Viburnum group	3.0	40 Ms *	4.5	1.9	Younger than Property	Policy Holder
Management history		Subject to past management/pruning - appears regularly trimmed.					
Recommendation		Maintain broadly at no more than current dimensions by periodic pruning.

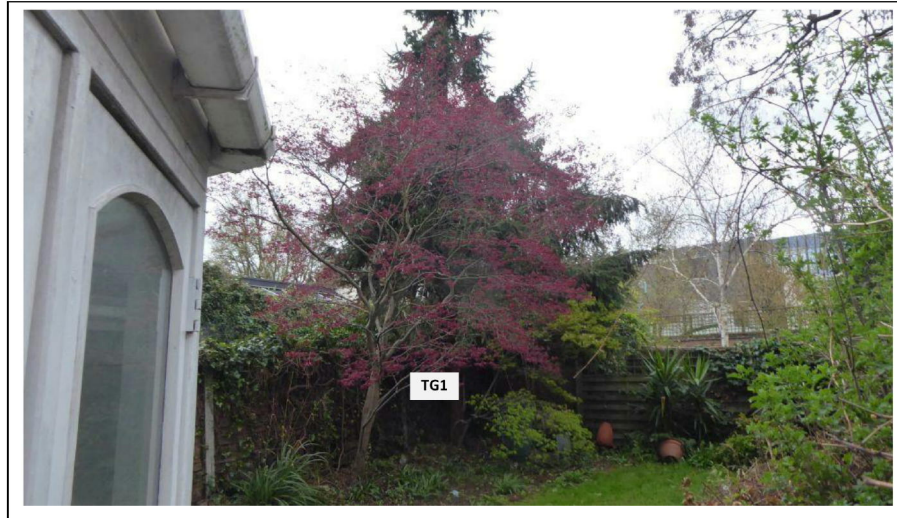
View of TG1 group
