**TECHNICAL REPORT ON A SUBSIDENCE CLAIM**

**Fivecourts Limited  
22A Harley Road  
Hampstead  
London  
NW3 3BN**

**SUBSIDENCE CLAIM**

13<sup>th</sup> April 2022

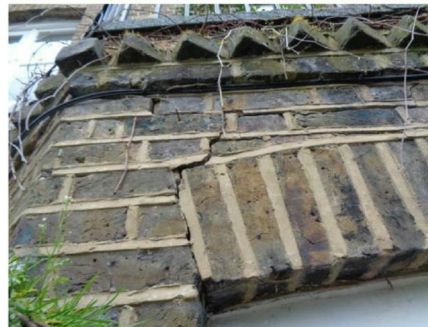
Cracking where the arch has failed

- 10mm wide crack over the left corner of the arch over the French doors to the rear bay. The arch has slipped and requires re-setting.
- Vertical cracks either side of the conservatory at the junction with the main rear elevation up to approximately 2mm width.
- Stepped crack over the left corner of the first floor window which did not extend any further upwards or downwards. This appeared longstanding and had been previously repaired and was not consistent with subsidence.
- An historic bow in the brickwork both to the rear and left hand elevations at first floor level which is not related to subsidence.

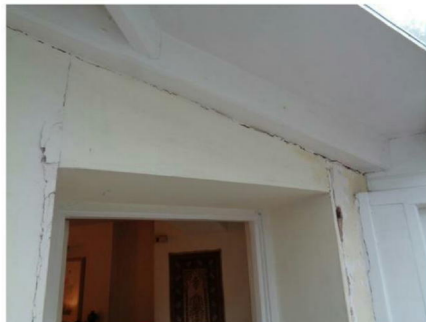
- Vertical 3mm wide crack to the right hand side of the conservatory at the junction with the main house.
- 2mm wide crack to the left hand side of the conservatory alongside the door through to the living room at the same junction.

Cracking in the conservatory over the door to the living room

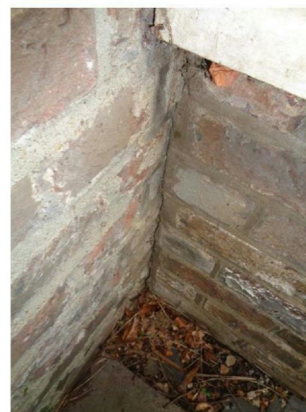
Crack to the left side of the conservatory
