SITE INVESTIGATION FACTUAL REPORT

Report No: [REDACTED]
Client: Crawford Claims Management
Site: 22A Harley Road, Hampstead
Client Ref: [REDACTED]
Date of Visit: 3/5/2022

Home Emergency Response - Subsidence Investigation - Drainage Services – Crack & Level Monitoring – Property Video Surveys

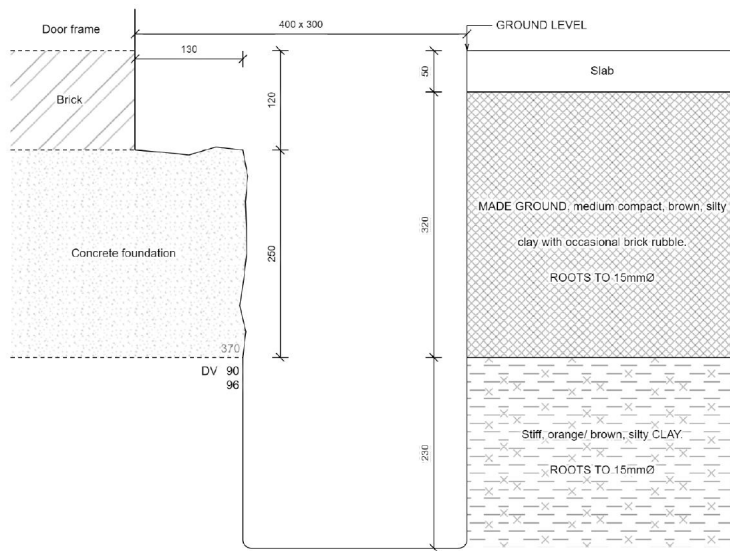
TEST REPORT: Trial Pit

For Strata below 600mm see Bore Hole log

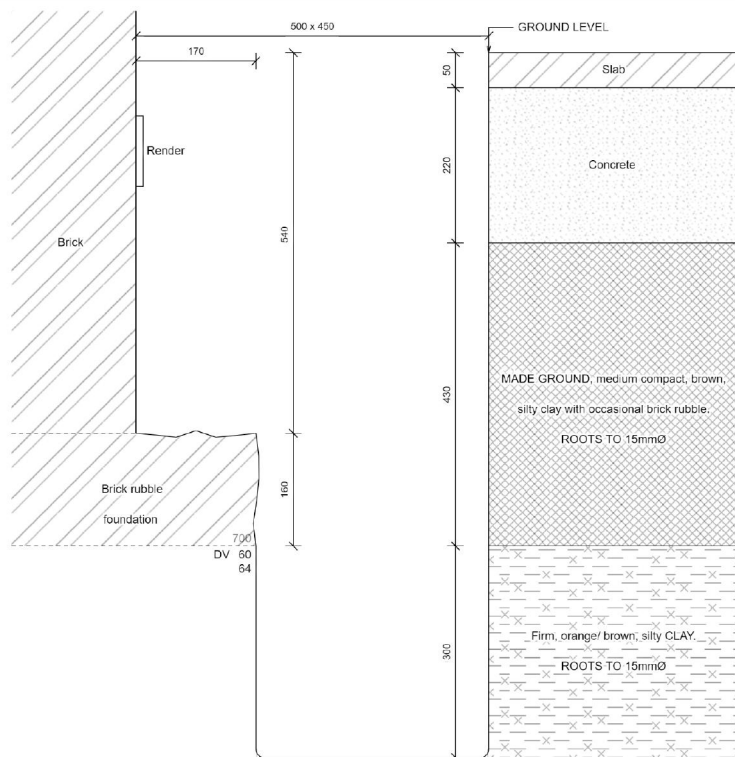
TEST REPORT: Trial Pit

For Strata below 1000mm see Bore Hole log
