## Arboricultural Consultancy for LV=

| Insured | | Address | 29 Edis Street, London, NW1 8LE | | |

**Scope of Report:** To survey the property and determine significant vegetation contributing to subsidence damage, make recommendation for remedial action and assess initial mitigation and recovery prospects. The survey does not make an assessment for decay or hazard evaluation.

# GEOTECHNICAL

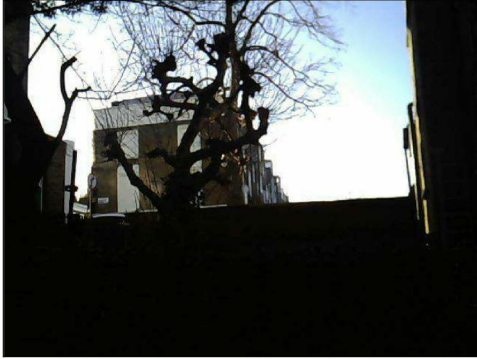
T1 - Fig

| Tree No. | Species | Age Cat | Approx. Height (m) | Distance to Building (m) * | Ownership | Action | Requirement |
|---|---|---|---|---|---|---|---|
| T1 | Fig | 1 | 10 | 8.5 | A - Third Party | Action to avoid future risk | Maintain at broadly current dimensions by way of regular pruning. |

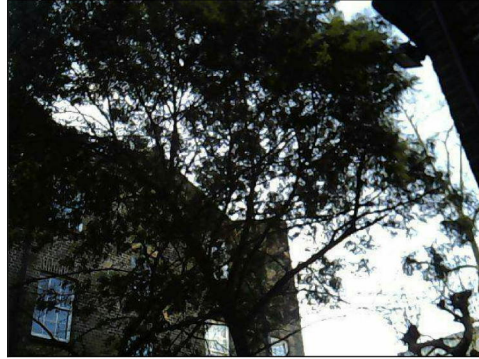
T2 - Mimosa

With due regards to species profile, size and proximity, T2 (Mimosa) is considered the dominant feature proximate to the focal area of movement and accordingly, where vegetation is confirmed as being causal, we have identified it as the primary cause of the current subsidence damage.

| Tree No. | Species | Age Cat | Approx. Height (m) | Distance to Building (m) * | Ownership | Action | Requirement |
|---|---|---|---|---|---|---|---|
| T2 | Mimosa | 1 | 11.5 | 4.1 | A - Third Party | Remove | Remove close to ground level; do not treat stump due to translocation risk. Where such a risk exists, we advise that any emergent regrowth is removed annually. |

Consequently, we have advocated the complete removal of T2 (Mimosa) and T3 (Acer) as it will offer the most certain arboricultural solution likely to restore long-term stability.

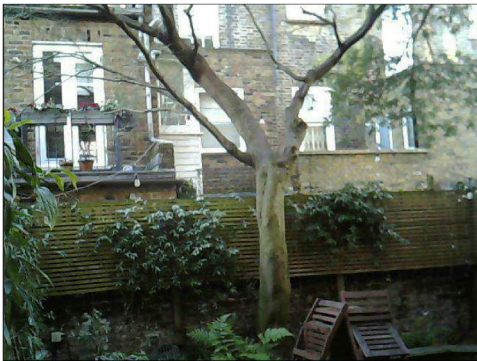
T3 - Acer

T3 (Acer) cannot be discounted as contributing to the overall level of soil drying proximate to the area of damage and is therefore also considered to retain a contributory influence, albeit in a secondary capacity when compared to T2.

| Tree No. | Species | Age Cat | Approx. Height (m) | Distance to Building (m) * | Ownership | Action | Requirement |
|---|---|---|---|---|---|---|---|
| T3 | Acer | 1 | 8 | 4.5 | C - Insured | Remove | Remove close to ground level and treat stump to inhibit regrowth. |

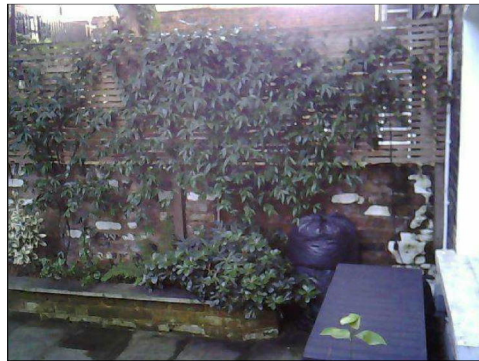
C1 - Jasmine

| Tree No. | Species | Age Cat | Approx. Height (m) | Distance to Building (m) * | Ownership | Action | Requirement |
|---|---|---|---|---|---|---|---|
| C1 | Jasmine | 1 | 2 | 1.4 | C - Insured | Action to avoid future risk | Maintain at broadly current dimensions by way of regular pruning. |

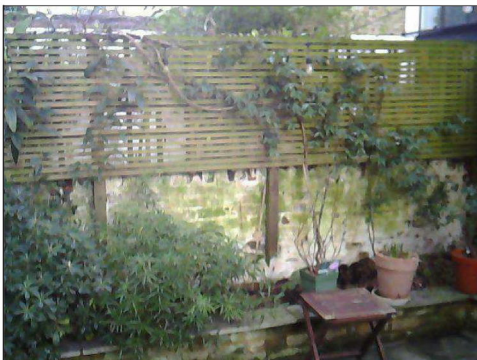
C2 - Mixed species climbers

| Tree No. | Species | Age Cat | Approx. Height (m) | Distance to Building (m) * | Ownership | Action | Requirement |
|---|---|---|---|---|---|---|---|
| C2 | Mixed species climbers | 1 | 2 | 4.6 | C - Insured | No action | No works. |

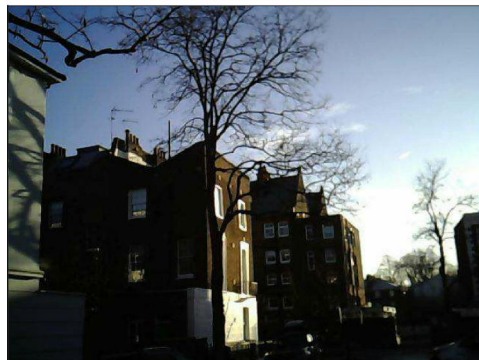
T4 - False Acacia

| Tree No. | Species | Age Cat | Approx. Height (m) | Distance to Building (m) * | Ownership | Action | Requirement |
|---|---|---|---|---|---|---|---|
| T4 | False Acacia | 1 | 20 | 18 | C - Insured | Action to avoid future risk | No works. |

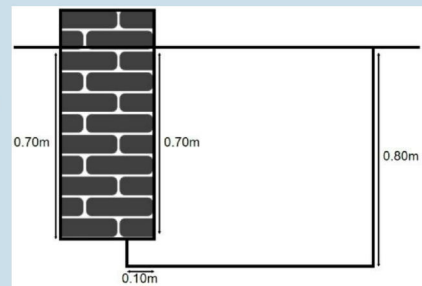
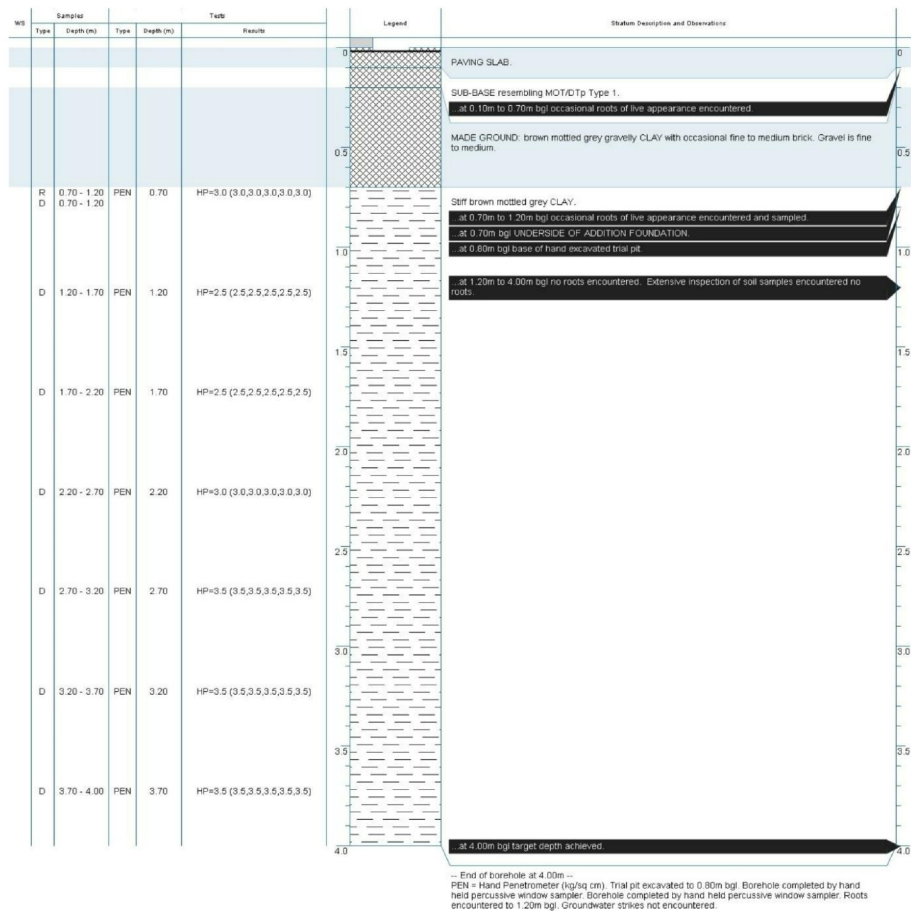
## TP/BH1 Foundation Detail and Borehole Log

Addition foundation comprised of brick wall to 700mm bgl with no projection from the elevation. Underside of foundation (USF) was exposed to 100mm back from the face of the foundation and probed 400mm back from the face of the foundation.

At 0.70m bgl UNDERSIDE OF ADDITION FOUNDATION in TP/BH1.
