**2 - 9 CAMBRIDGE GATE, LONDON NW1**

**STONE REPAIR PROPOSALS AND HERITAGE ASSESSMENT 2024**

ROBERT LOADER ARCHITECT

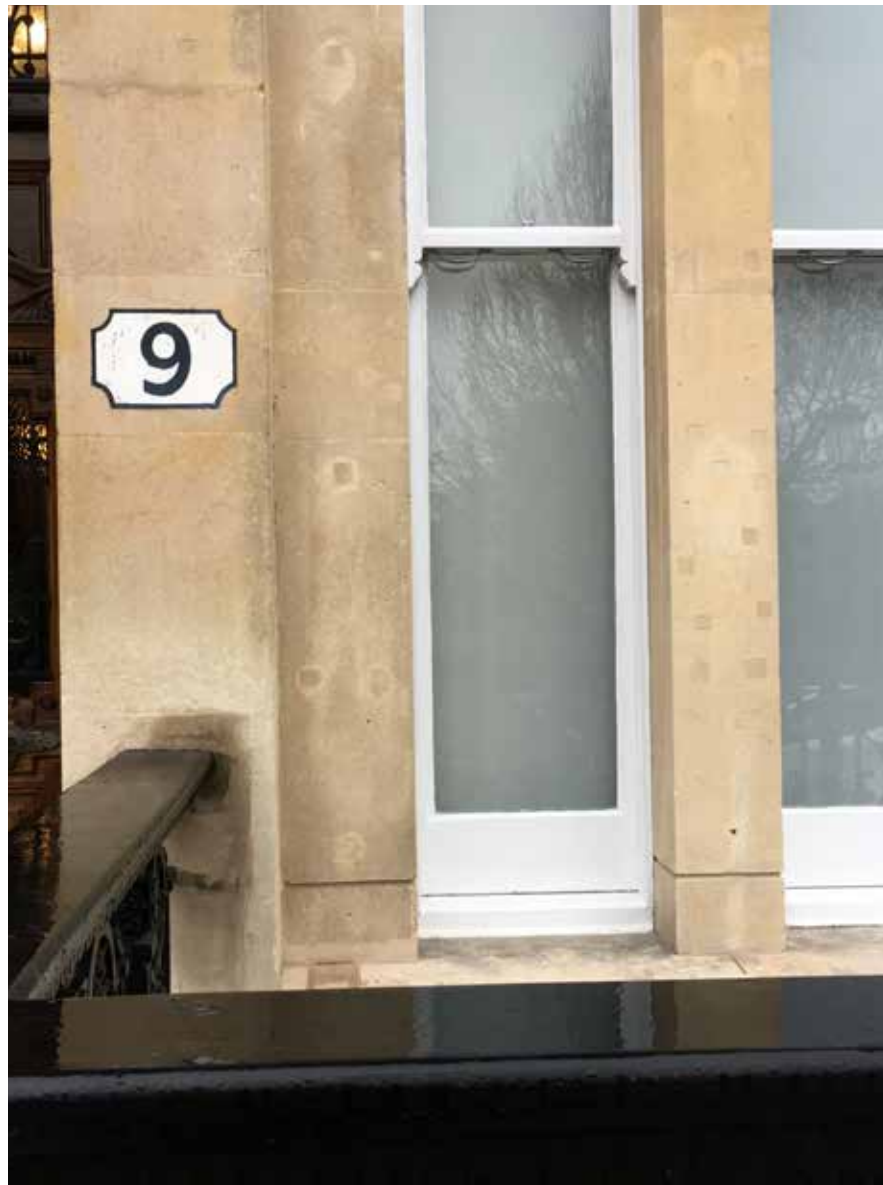
In this instance the repairs are a good match to the underlying stone, but rubbing down the repair has lightened the surrounding stone to give a 'hallow' effect.

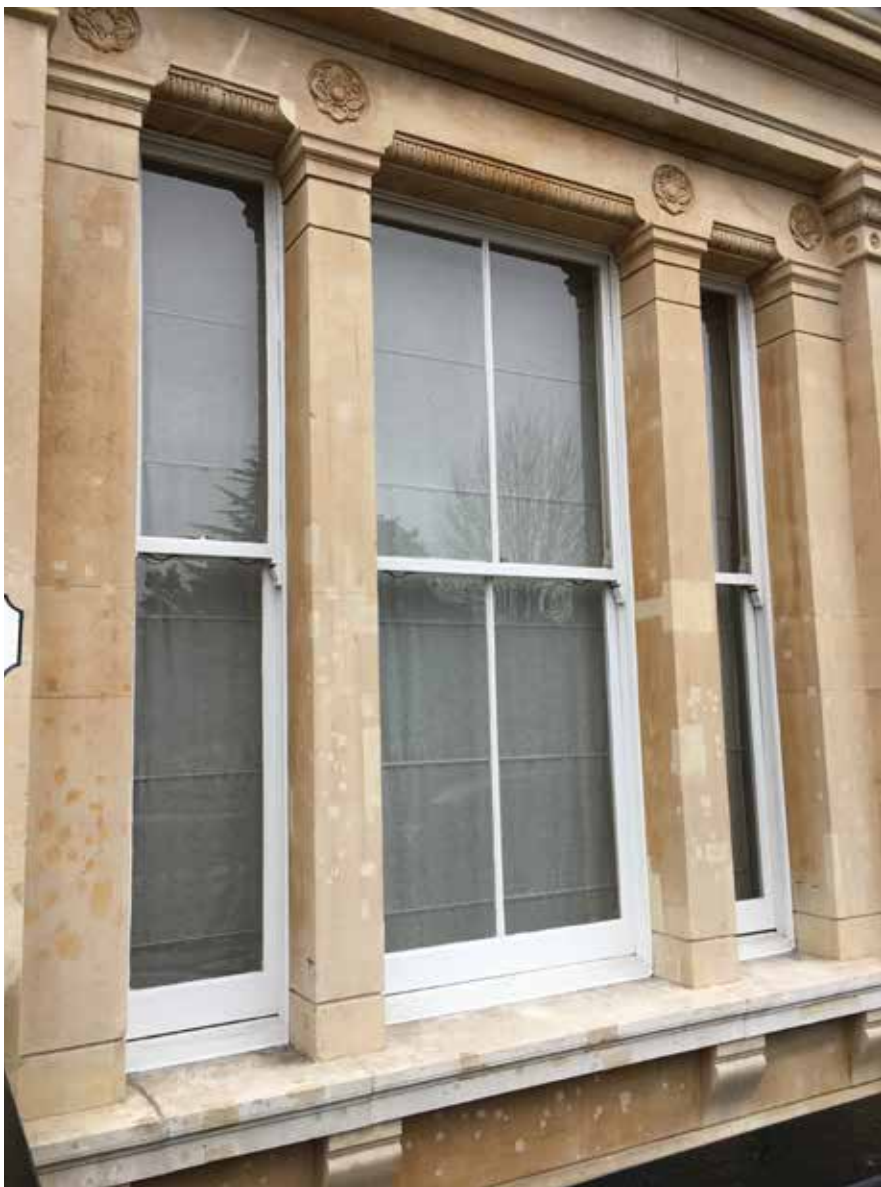
Many small poorly-matched pockmark repairs across a window bay.

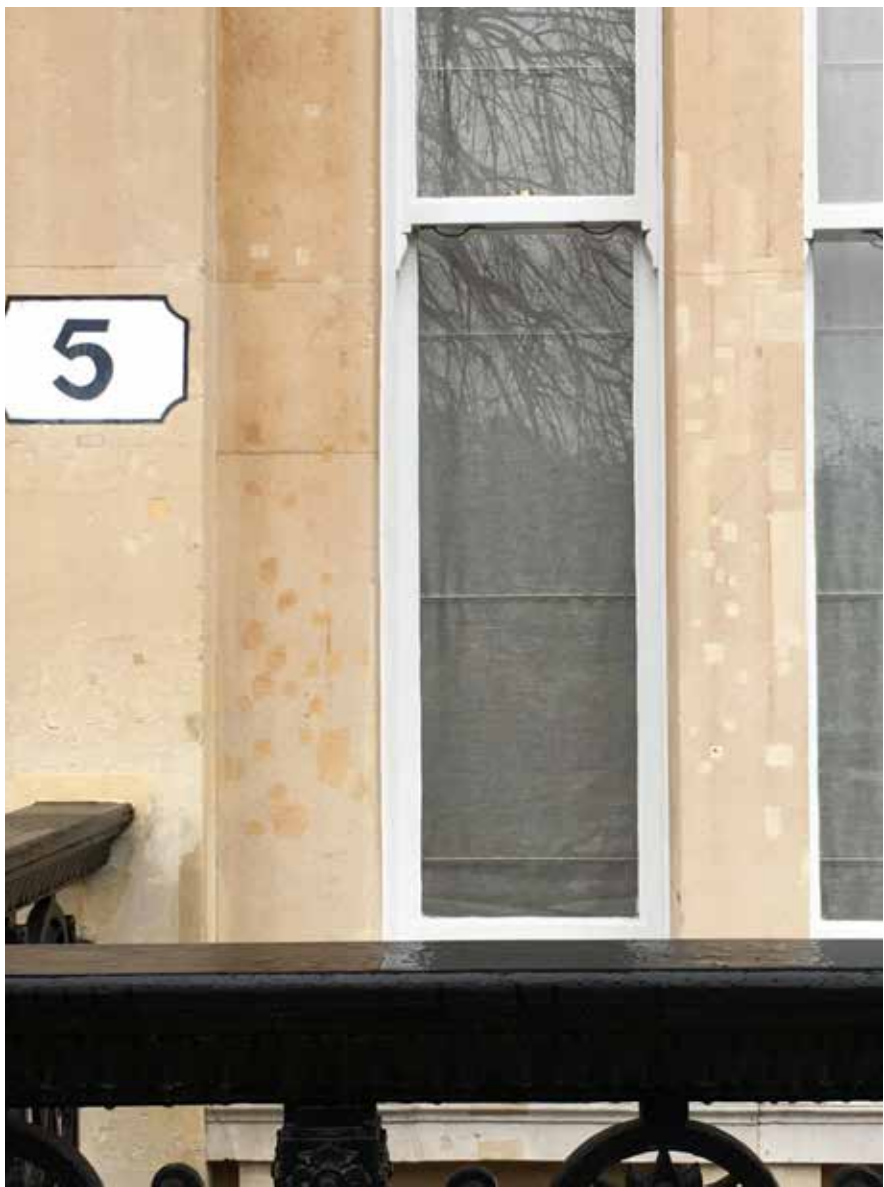
Small-scale repairs do not match the dark or lighter stone.

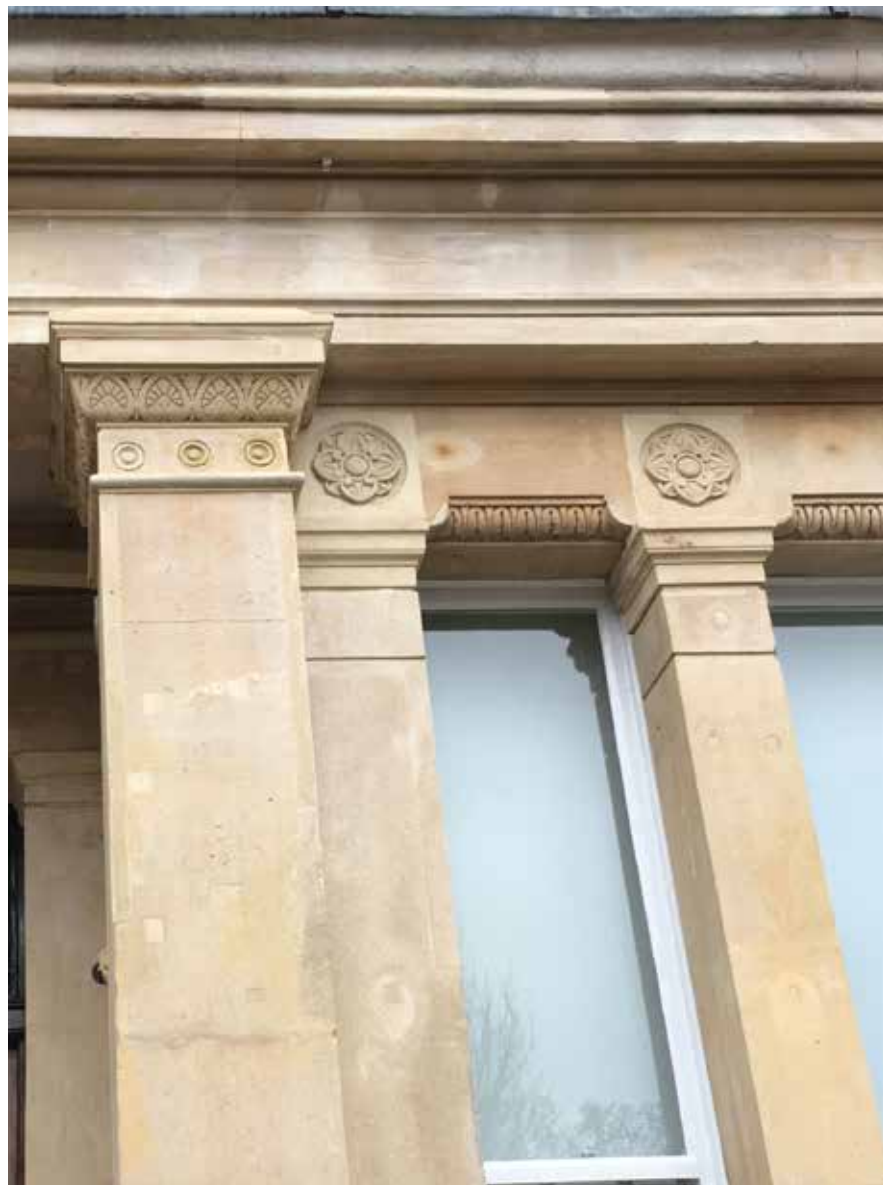
High-level poorly-matched repairs of moulded rosettes.

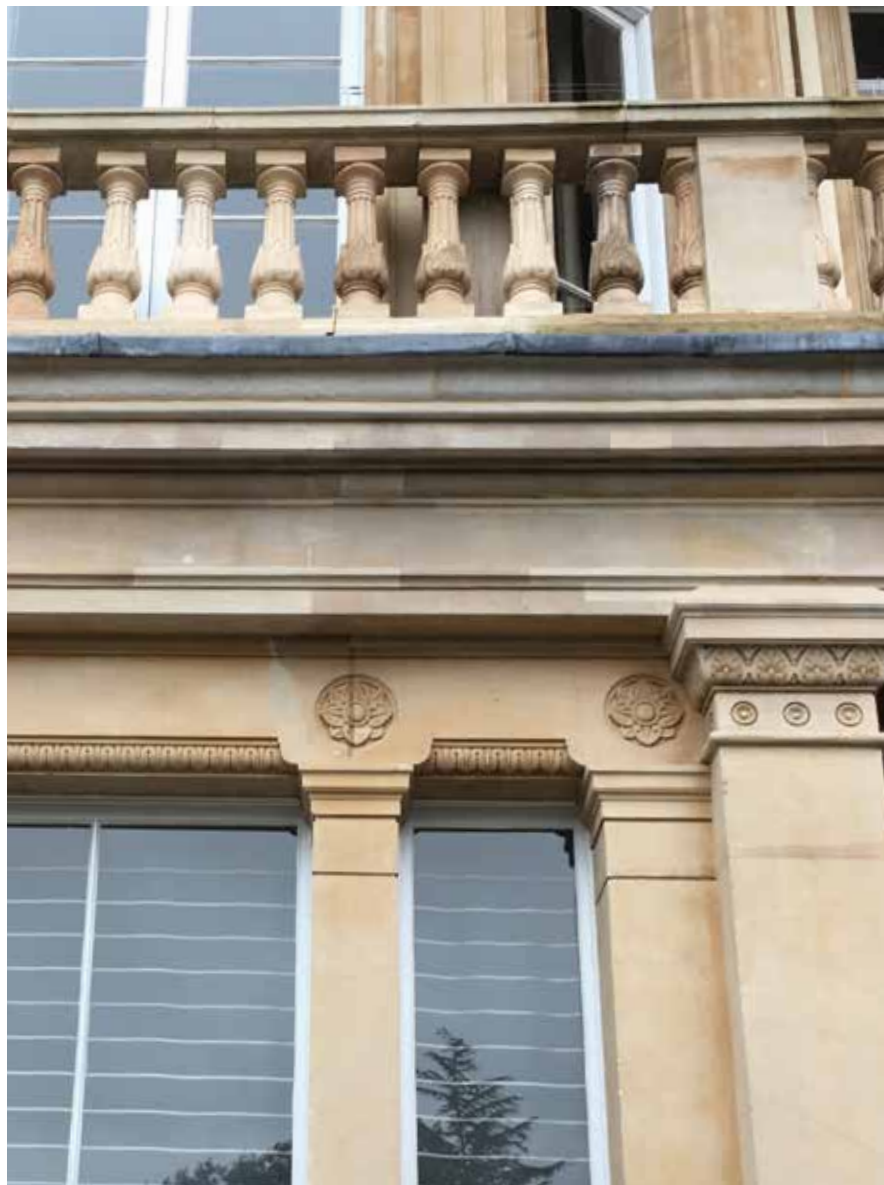
High-level poorly-matched repairs of cornice.

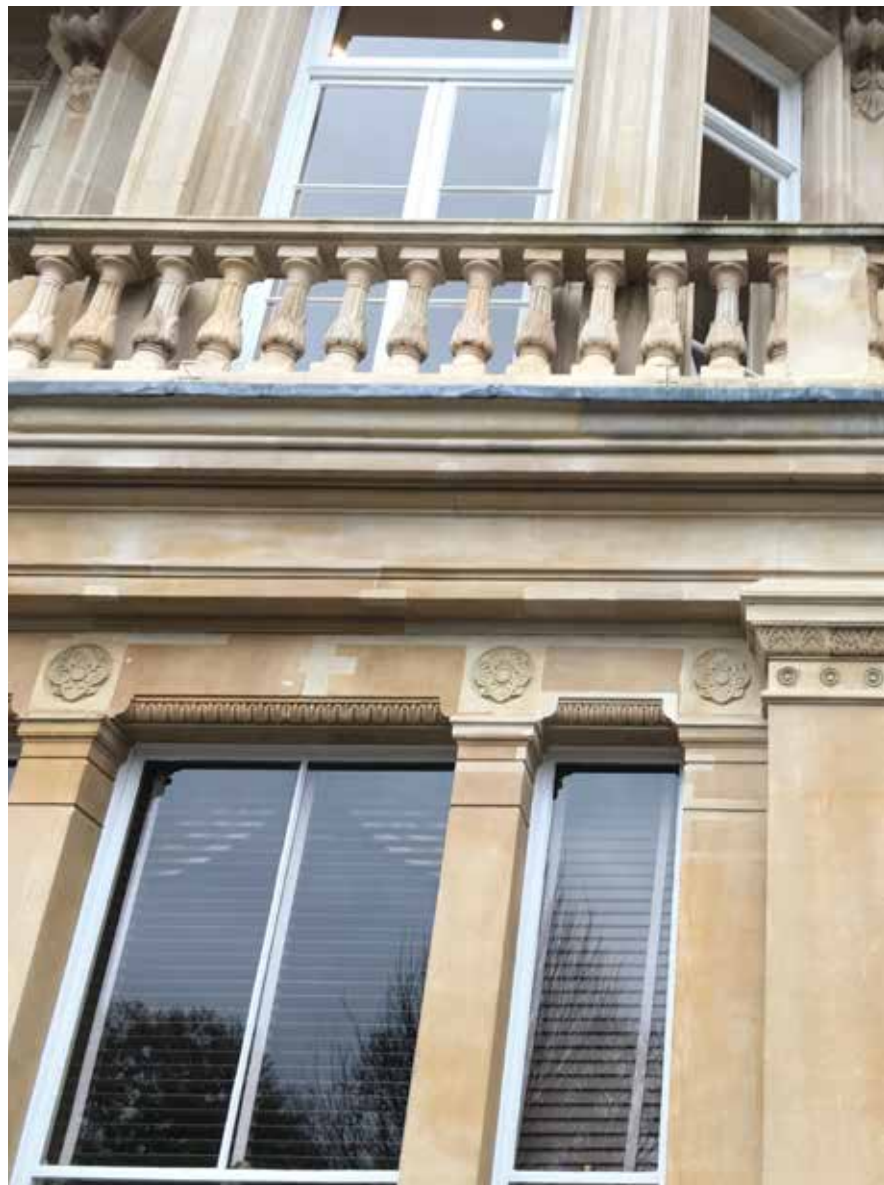
High-level poorly-matched repairs of moulded rosettes.

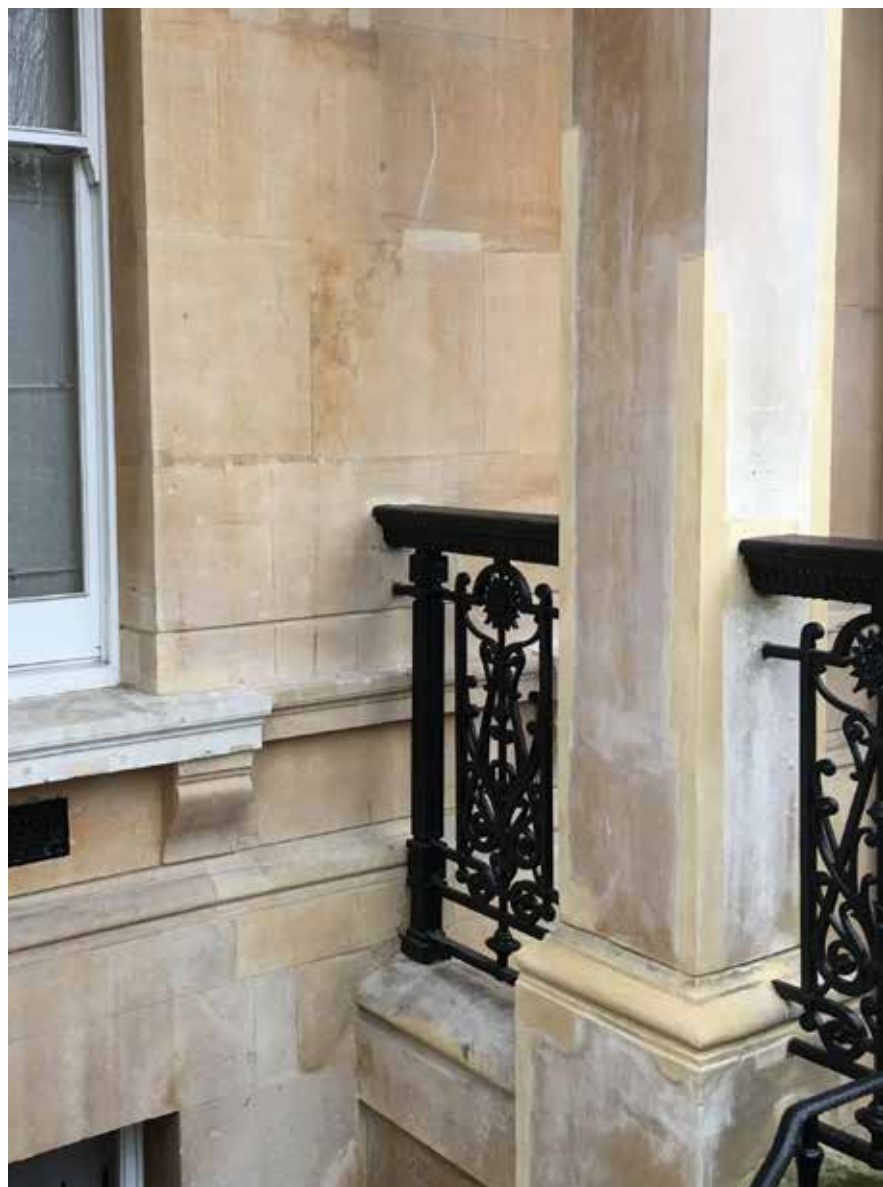
Poor colour match of corner repairs to pillar.

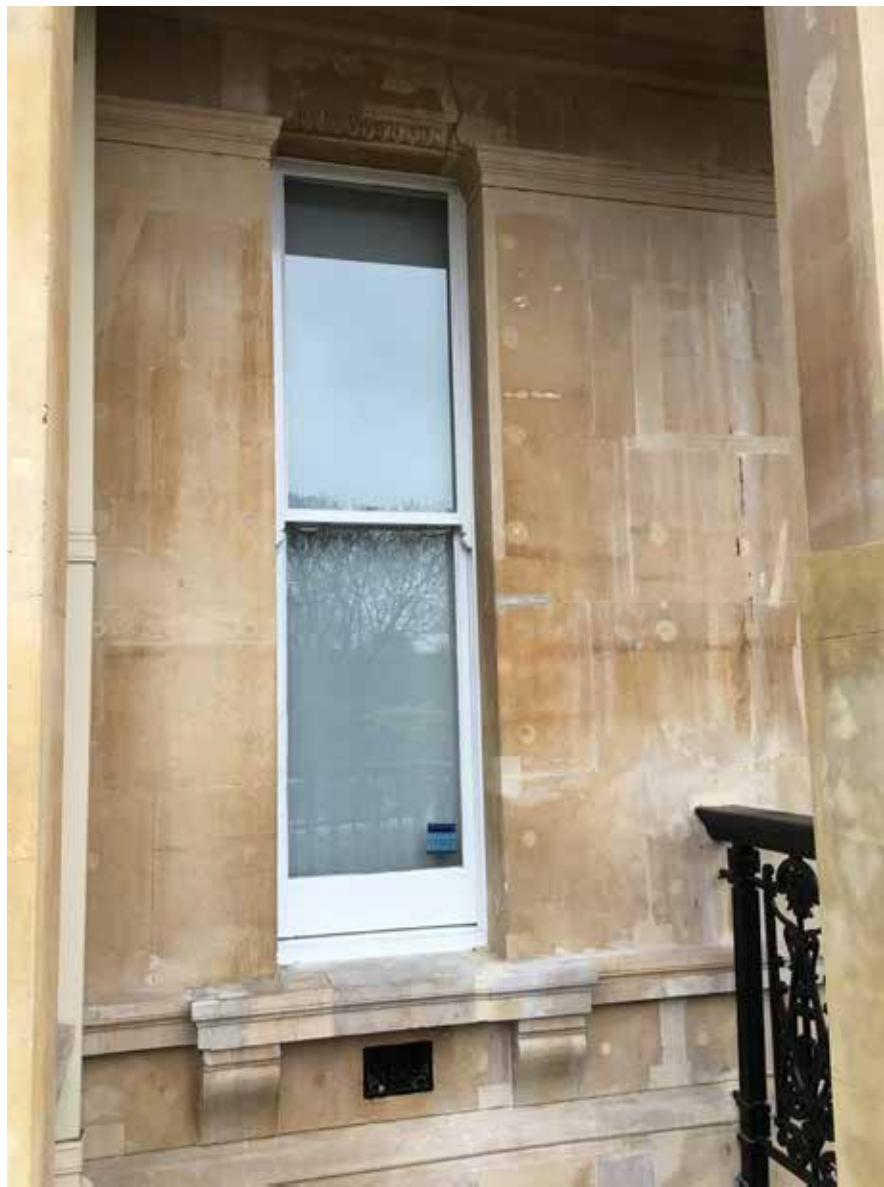
Pockmarked appearance of mortar repairs in recessed bays.

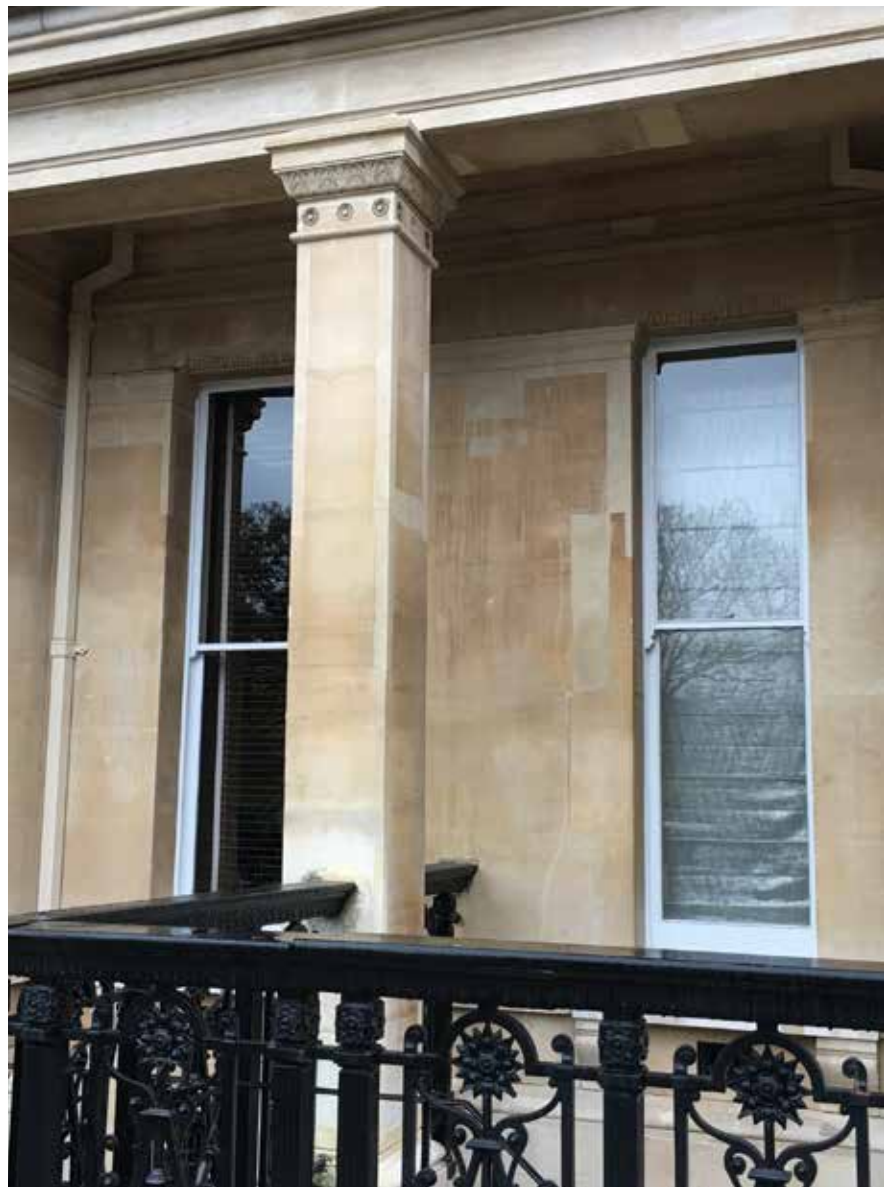
Large mis-matched mortar repairs in recessed bays.

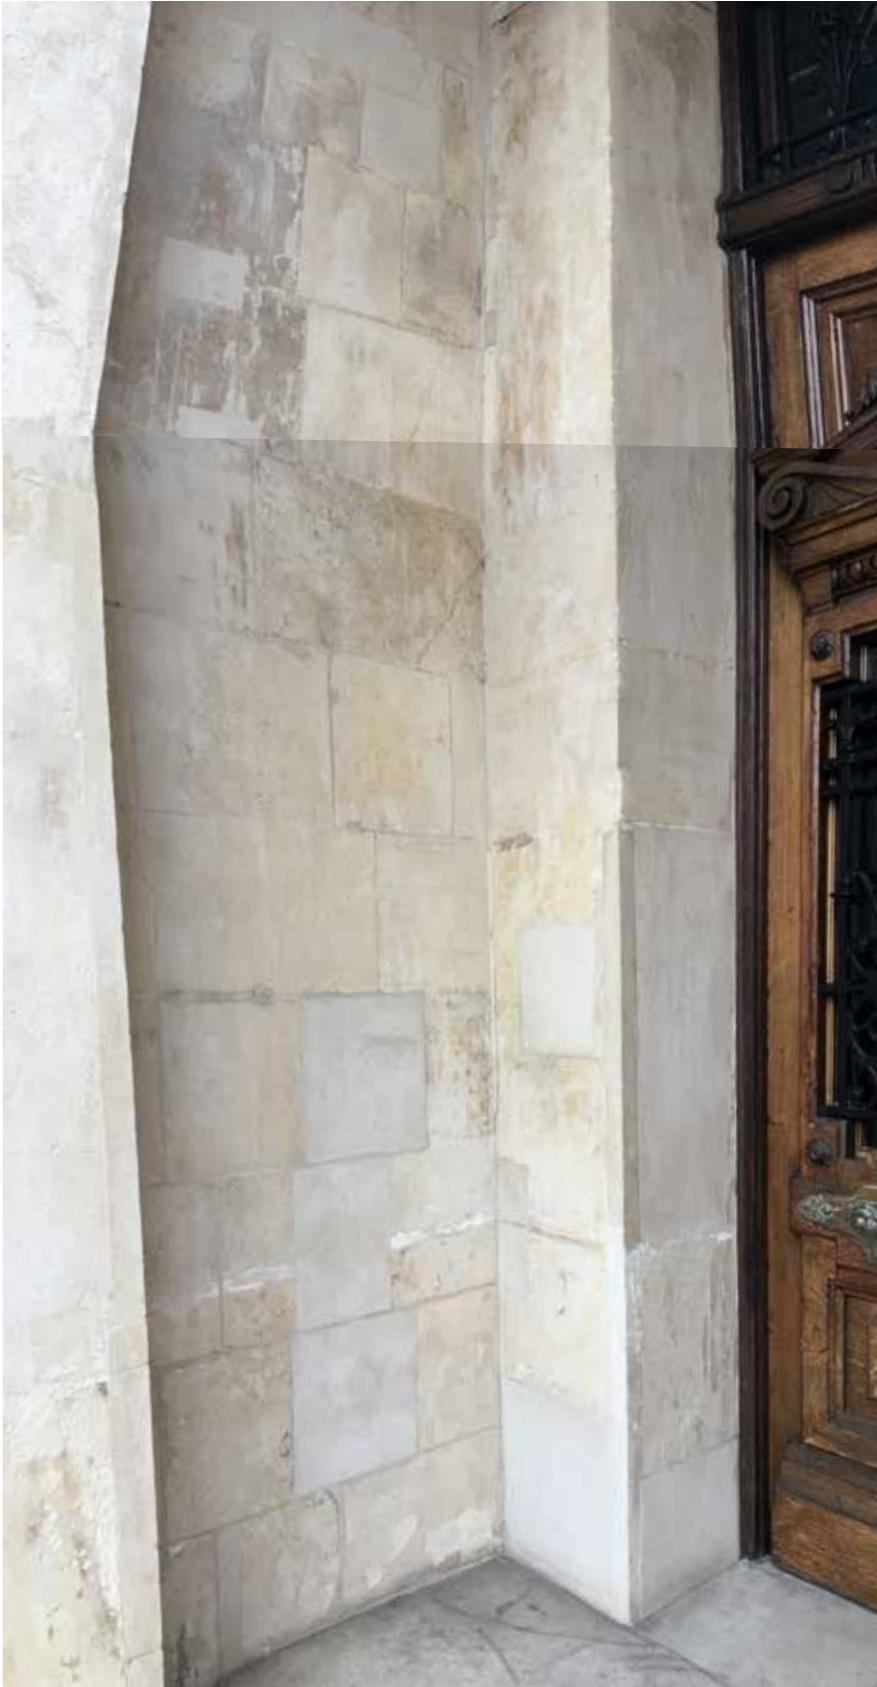
Extensive repairs and poor surface finish to the recessed entrance .

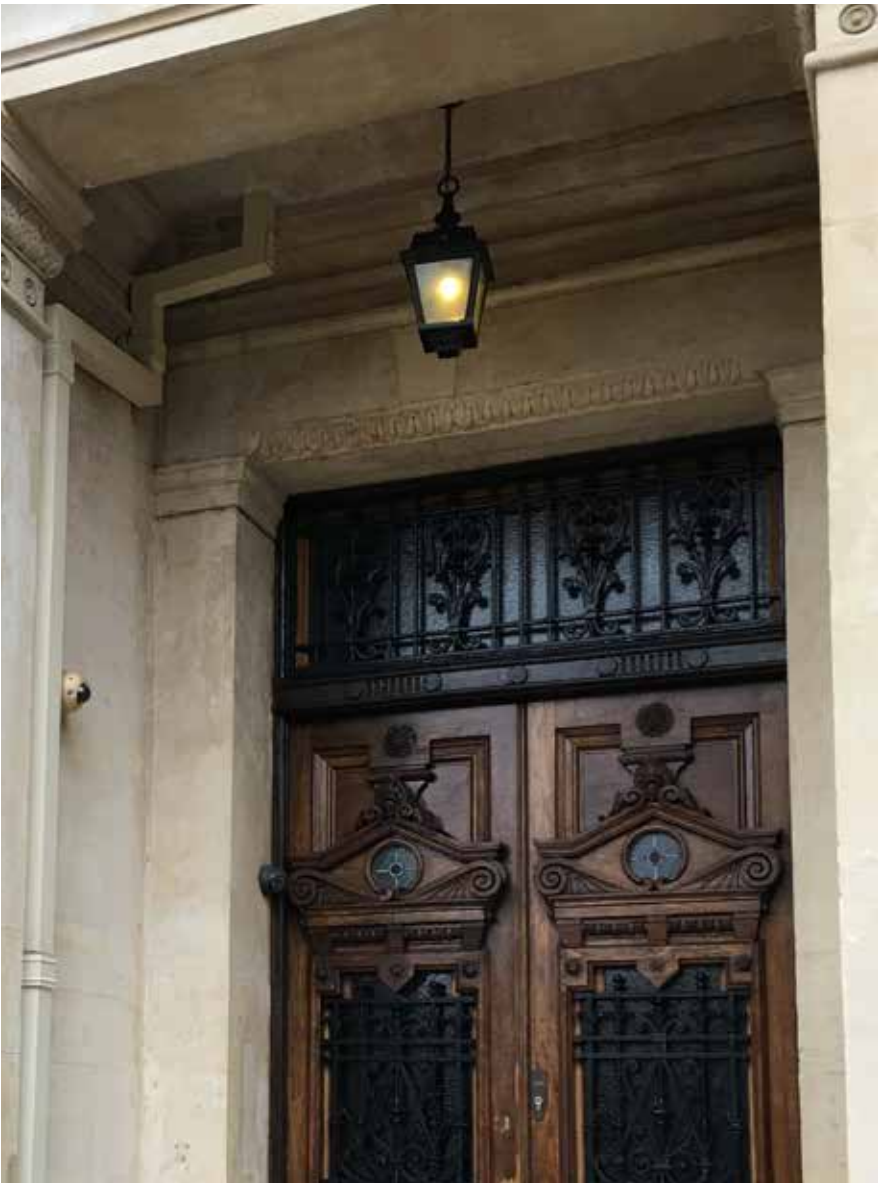
Poor surface finish above the door in this recessed entrance .

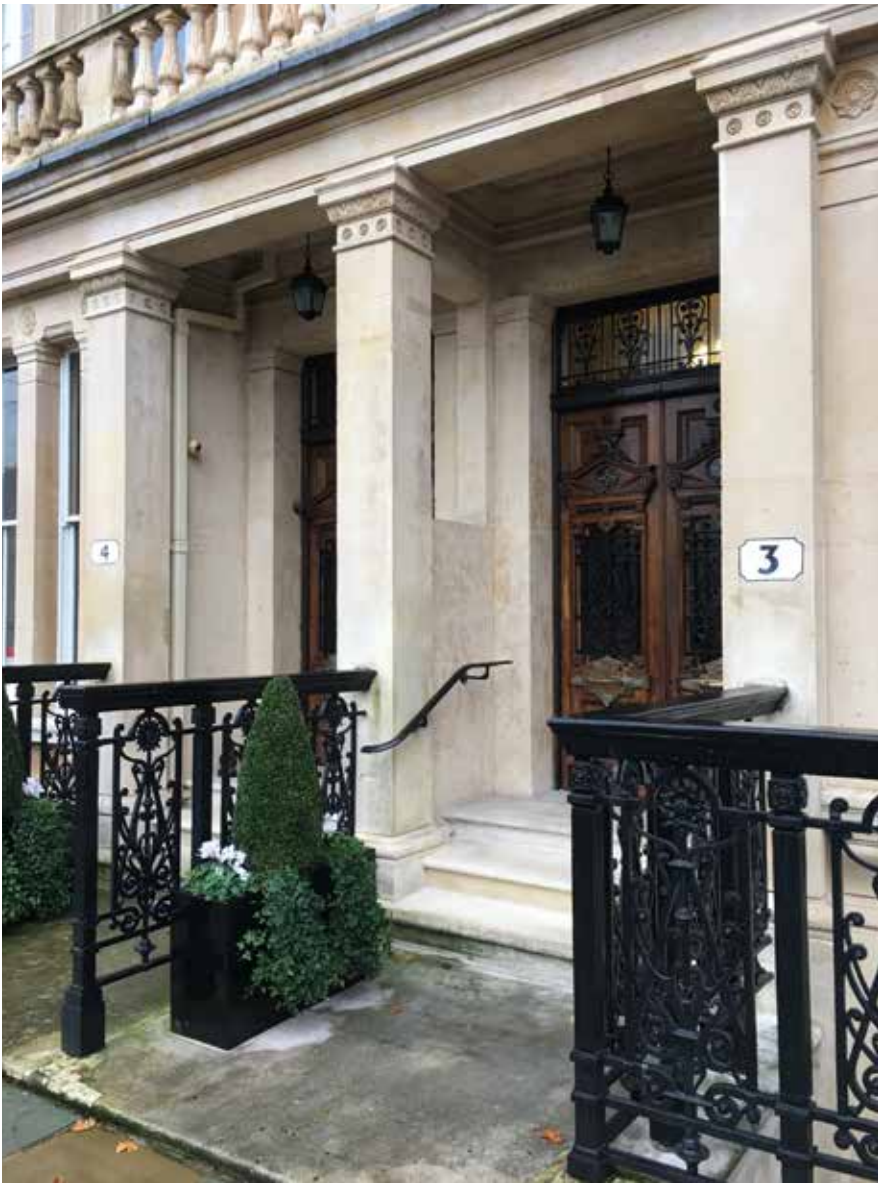
Poor surface finish to this recessed entrance .

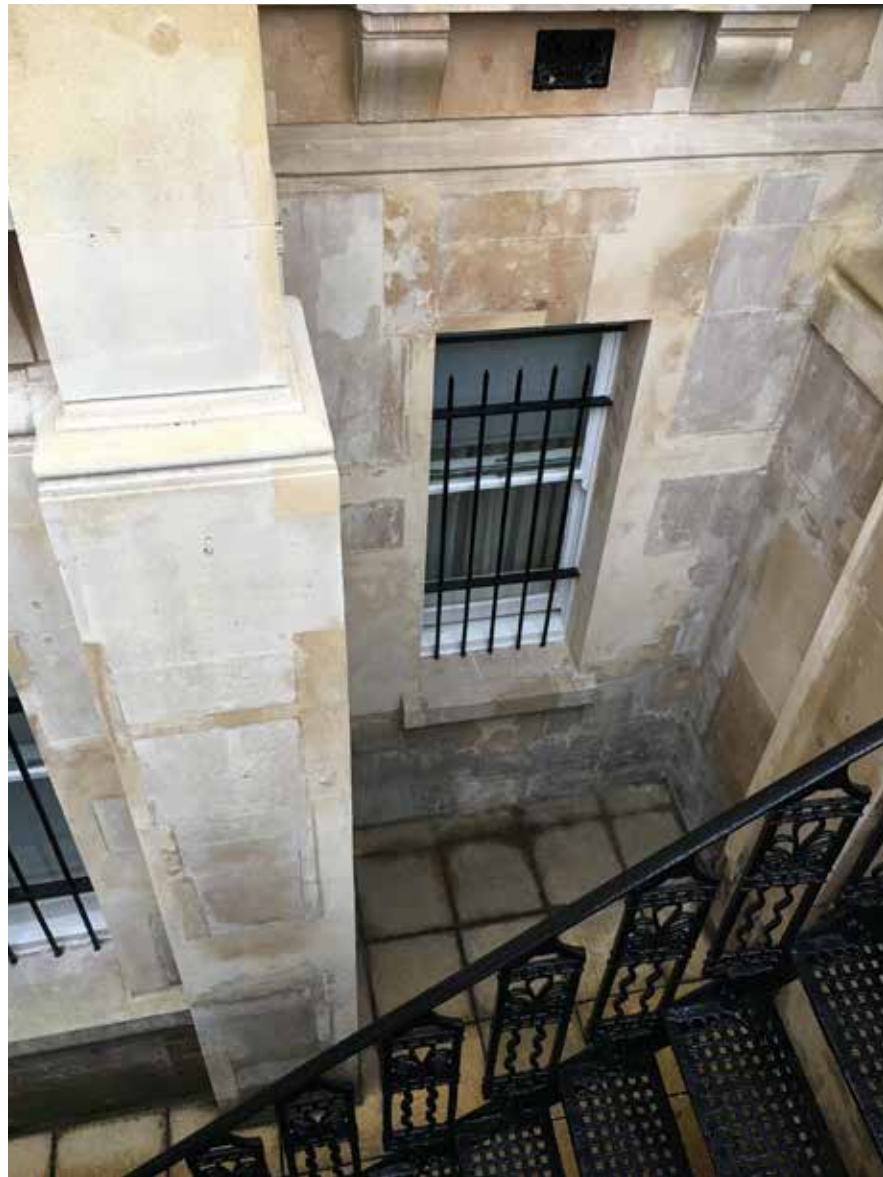
Stone in basement areas frequently displays extensive variability in colour.

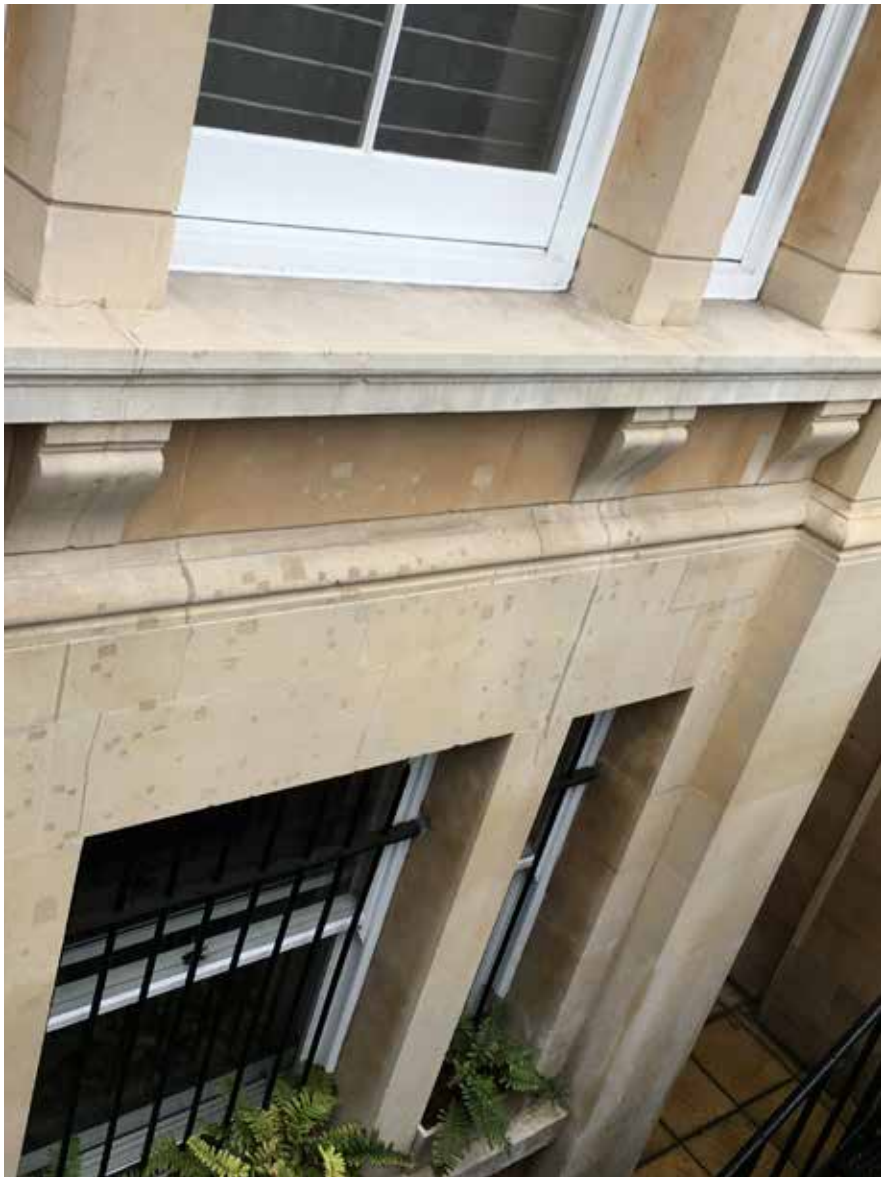
The repair mortar on the dark stone is too light and the repair mortar on the light stone is too dark.

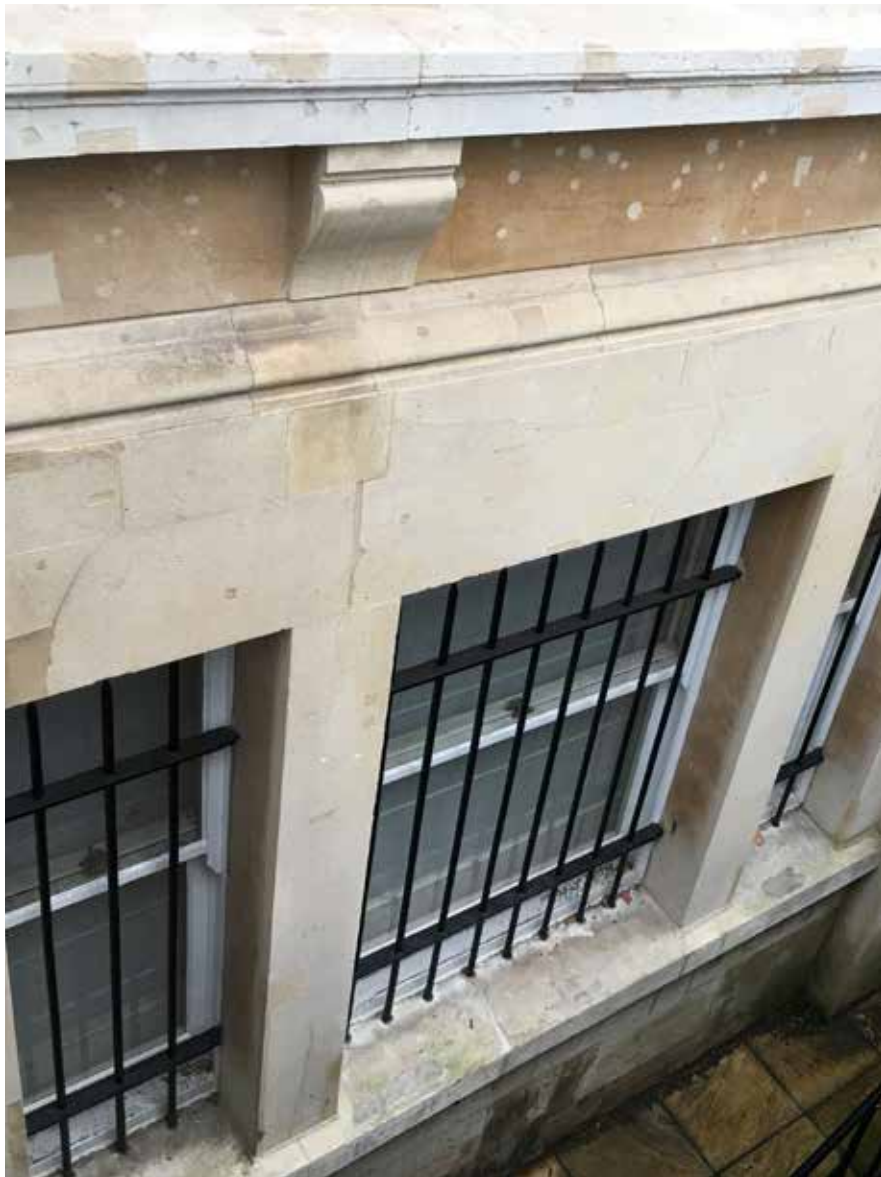
In this case the repair mortar on the dark stone is also too light.

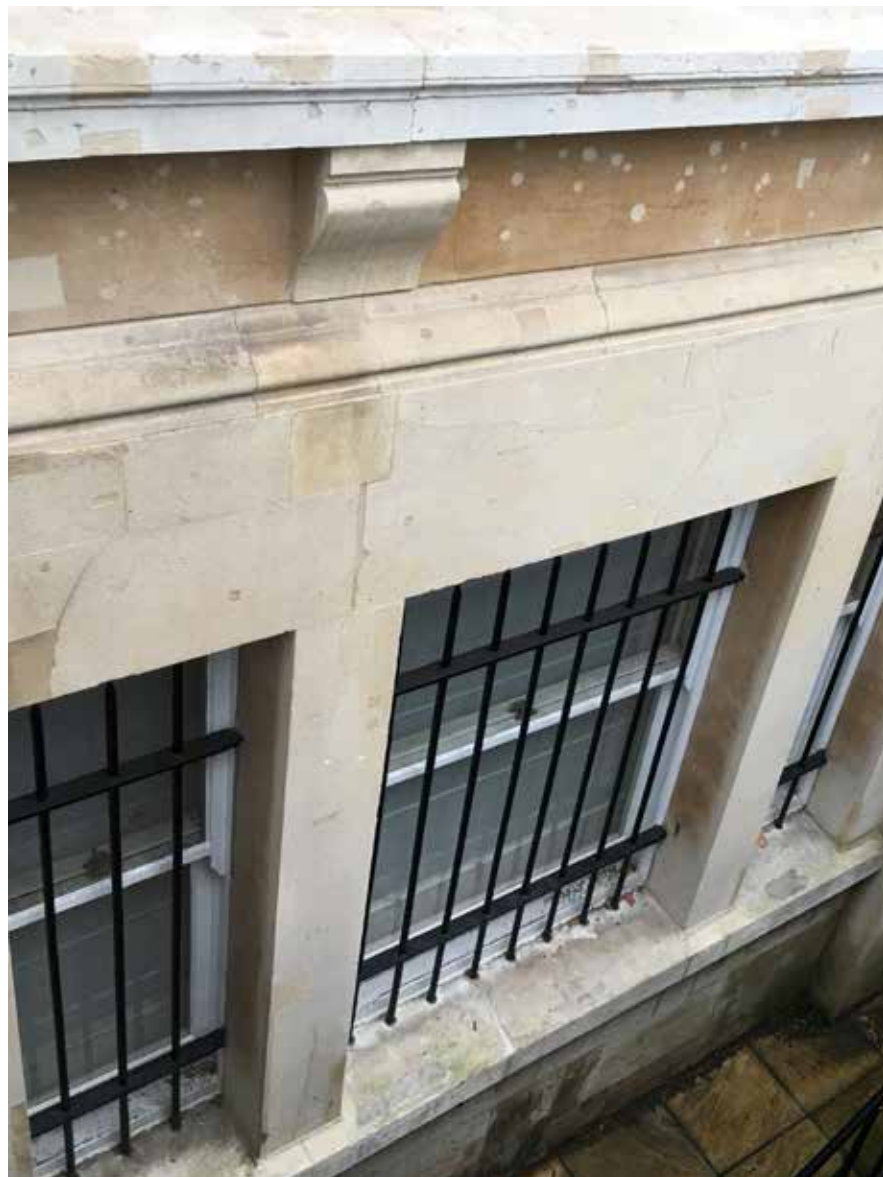
Pre-existing contrasting repairs under the window sill of House 5.

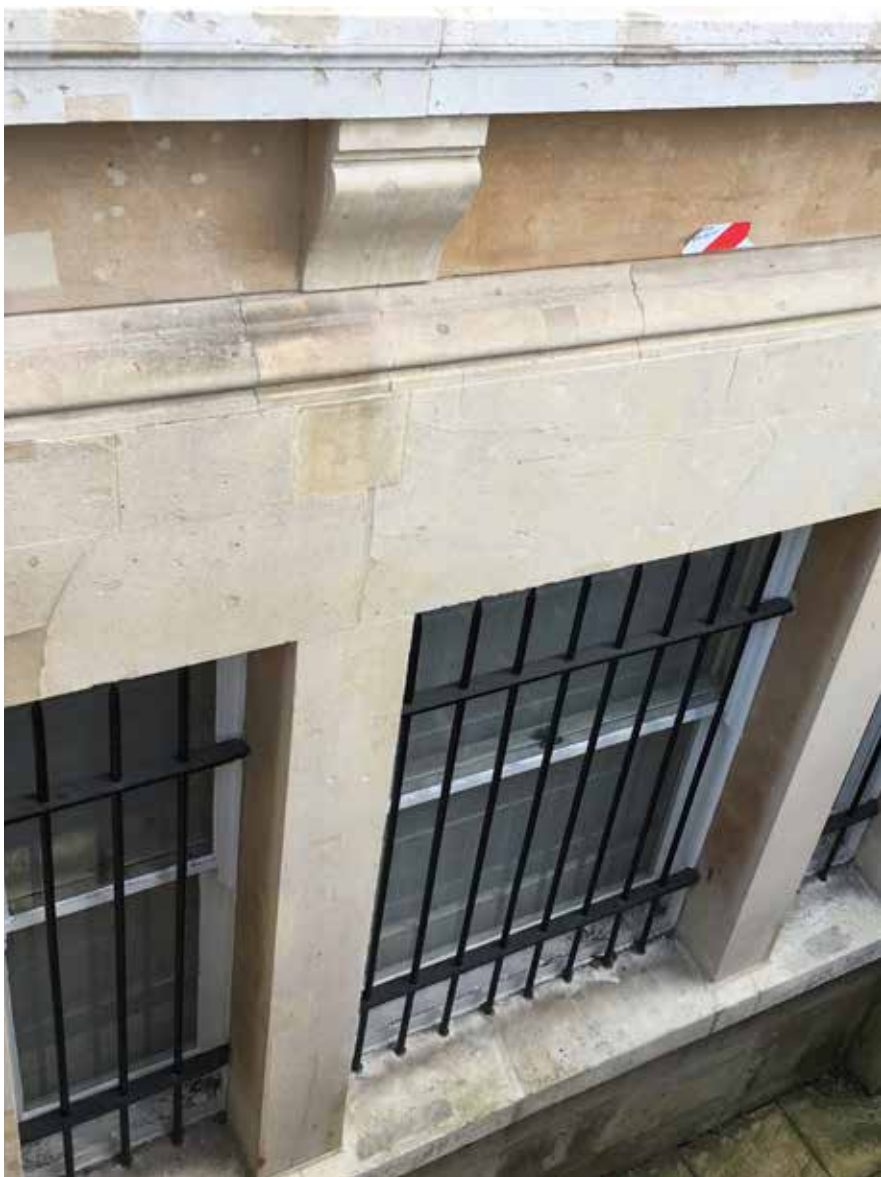
The remediated tinted repairs under the window sill of House 5. The area to the right of the bracket has been treated, while the area to the left of the bracket is untouched. These repairs are considered satisfactory.

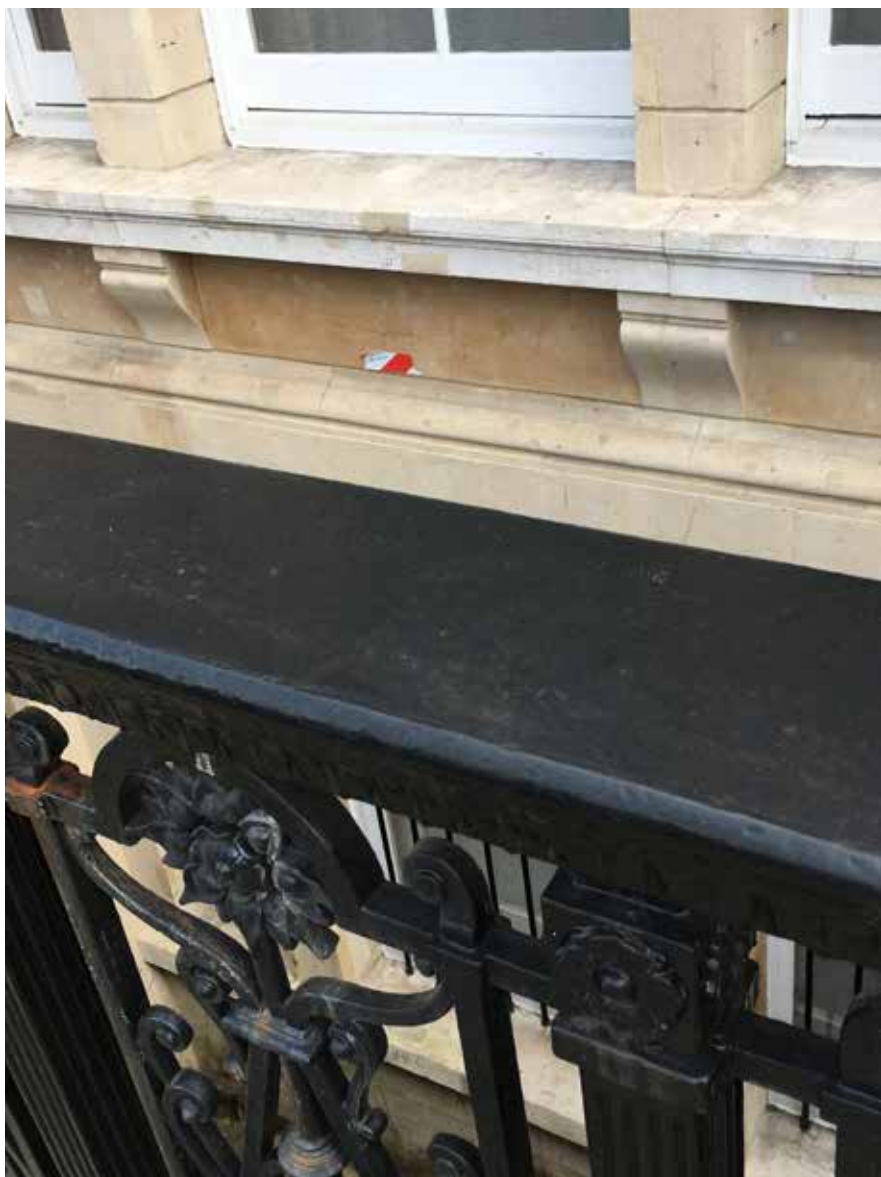
The repairs are almost imperceptible from the pavement which is the distance from which they are to be judged.

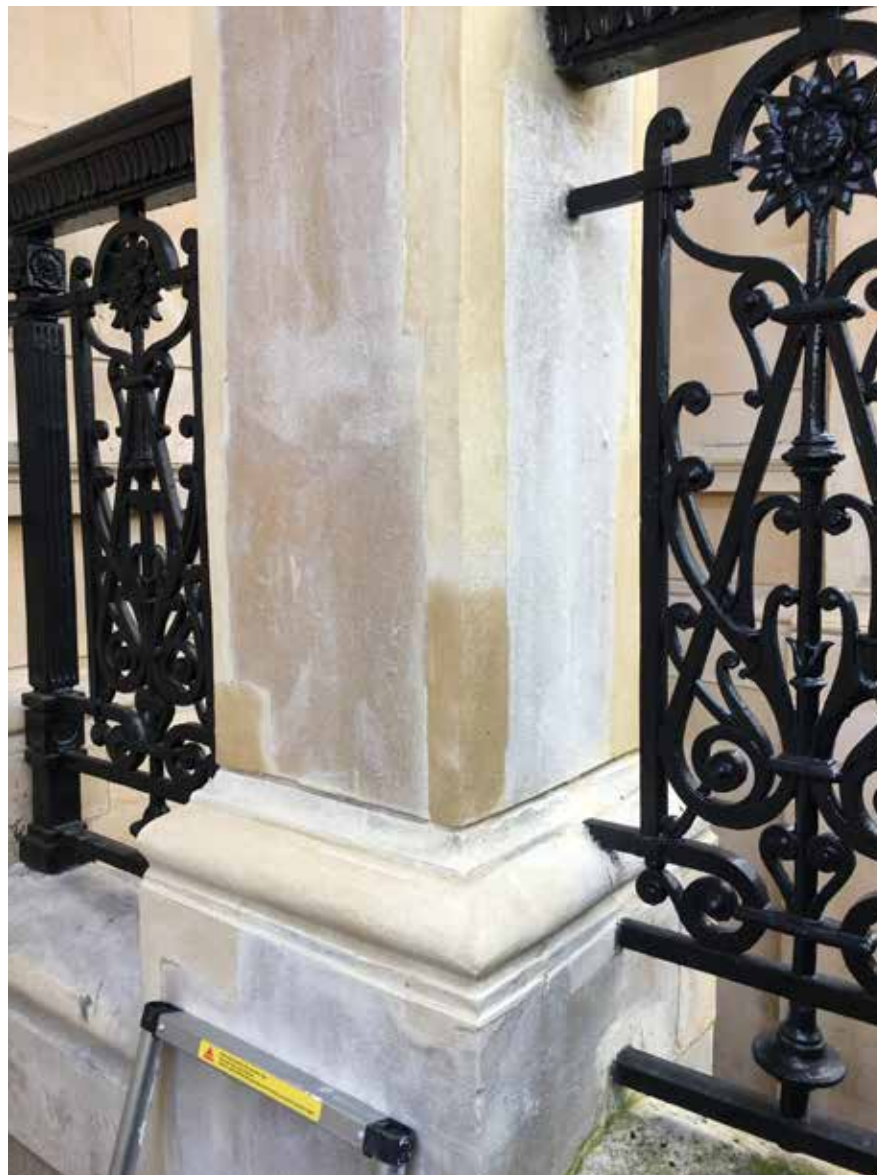
The pre-existing contrasting corner repair at the column base between House 5 and House 6 has an orange tinge. The outward face of the column has weathered to a very light colour, while the side of the column remains dark.

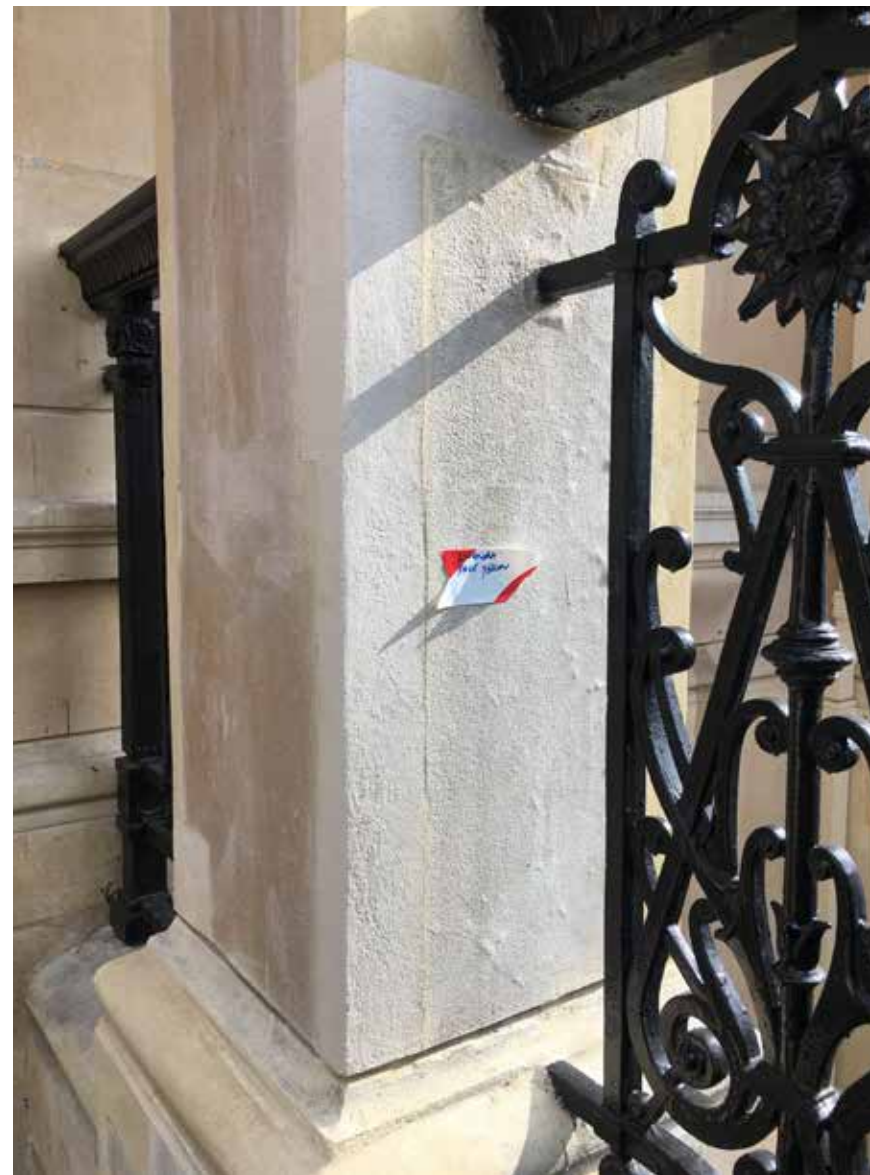
The tinting repair shortly after completion on March 6.

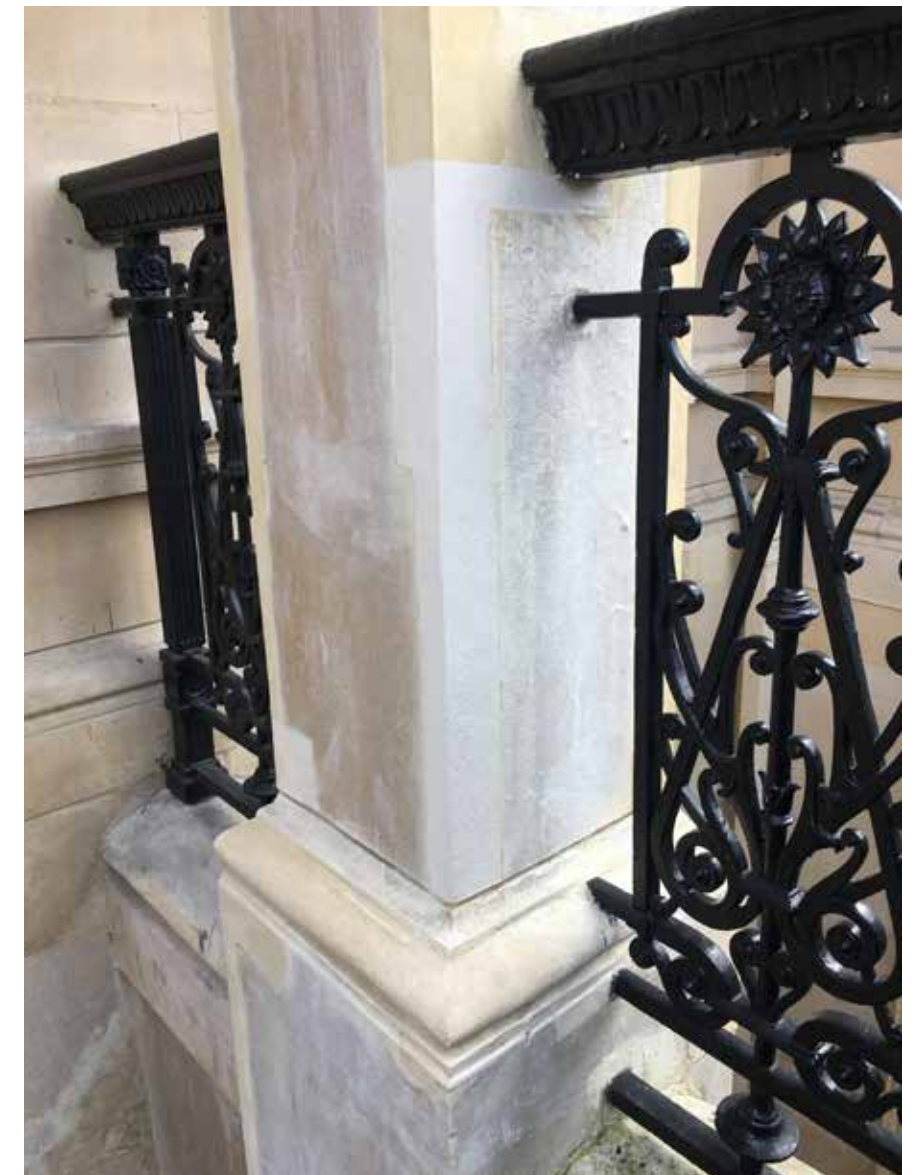
The corner repair after ten days. The side facing outwards is considered satisfactory, while the lateral face still has a strong contrast to the darker adjacent stone.

In the circumstances of a full remediation contract further tinting would be necessary to the lateral face.
