**2 - 9 CAMBRIDGE GATE, LONDON NW1**

**STONE REPAIR PROPOSALS AND HERITAGE ASSESSMENT 2024**

ROBERT LOADER ARCHITECT

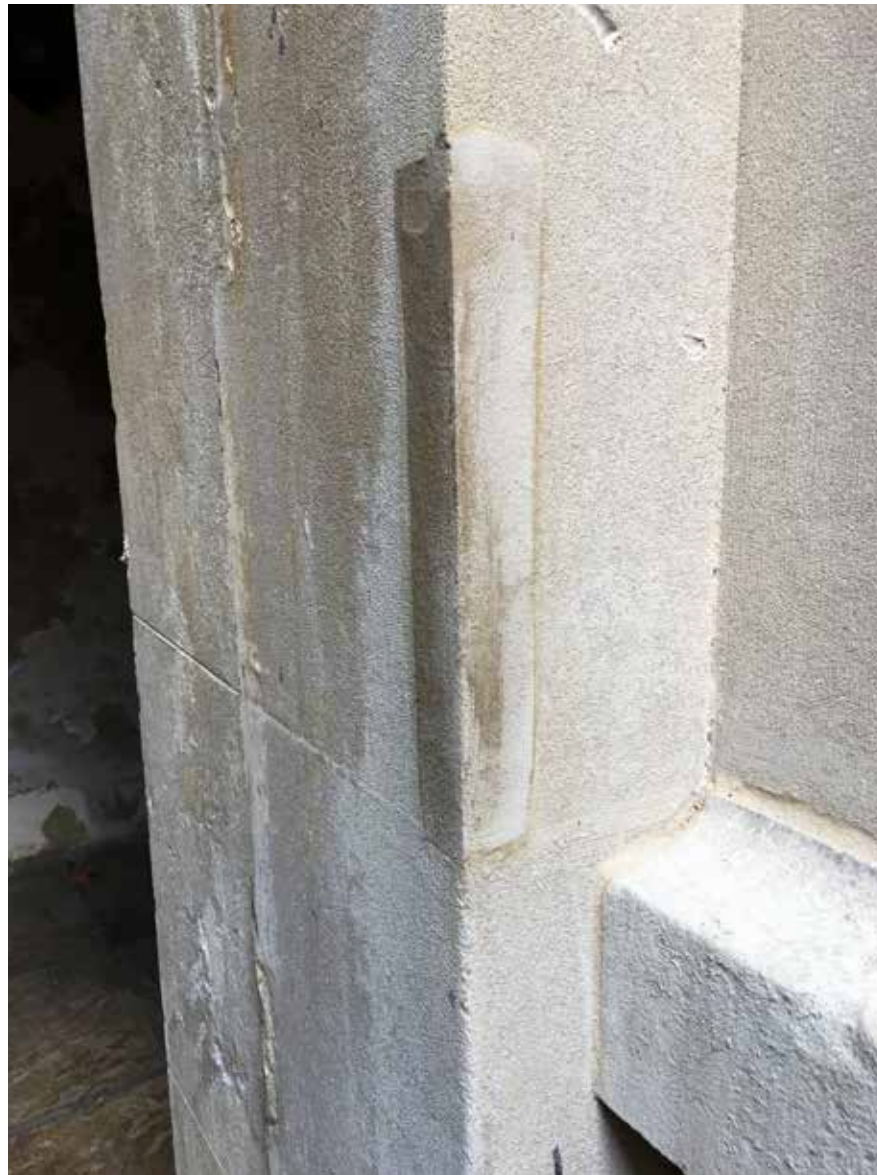
The tinting repair while drying on March 6.

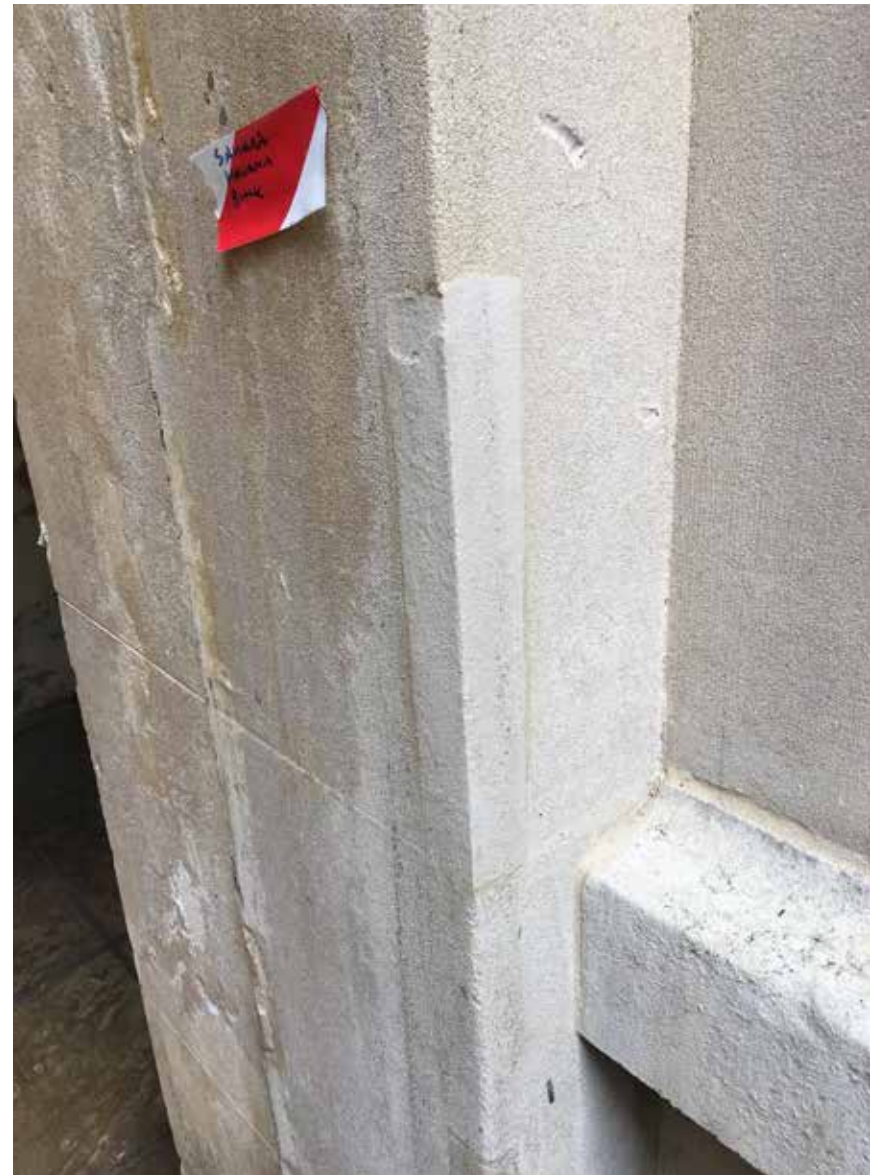
The corner repair after ten days. This repair is considered satisfactory.

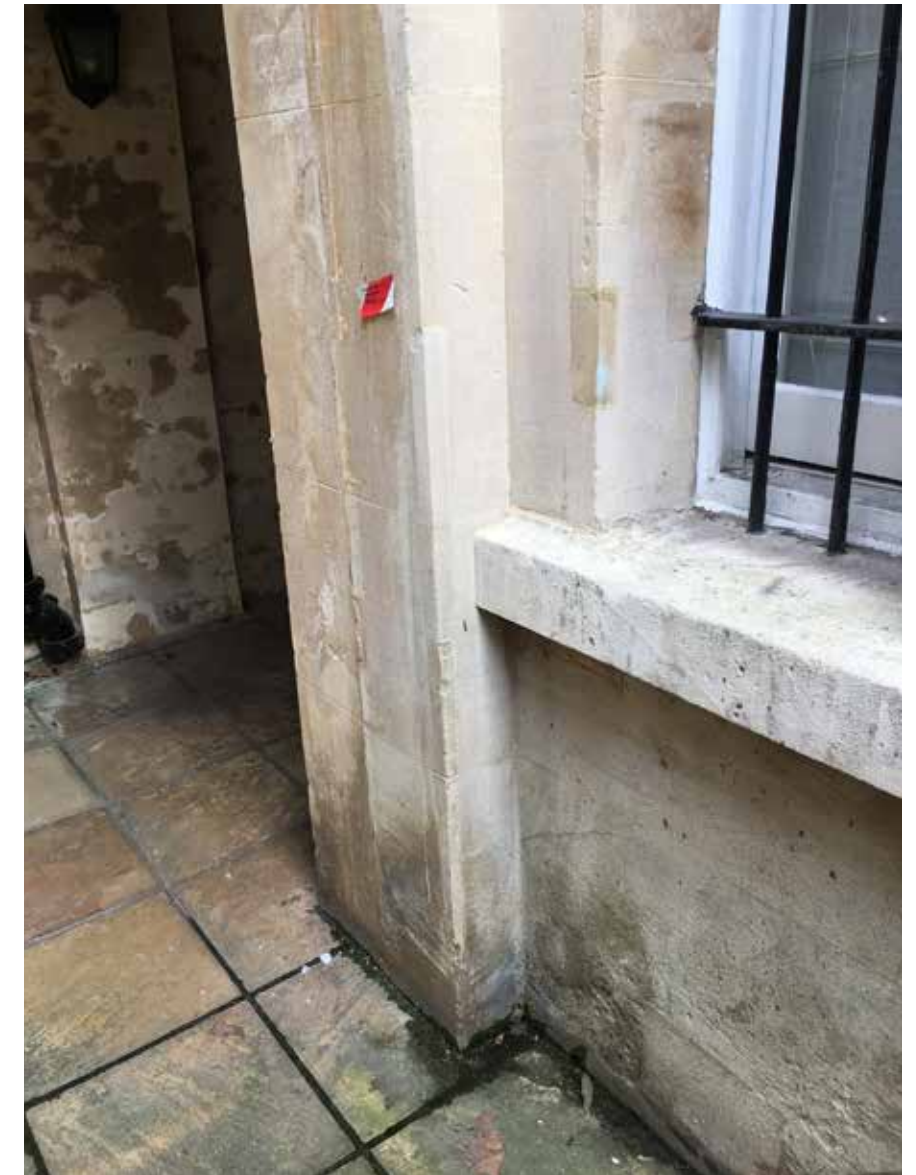
View from three metres. The dark colour of the pre-existing repair can be seen in the untreated corner repair to the right.

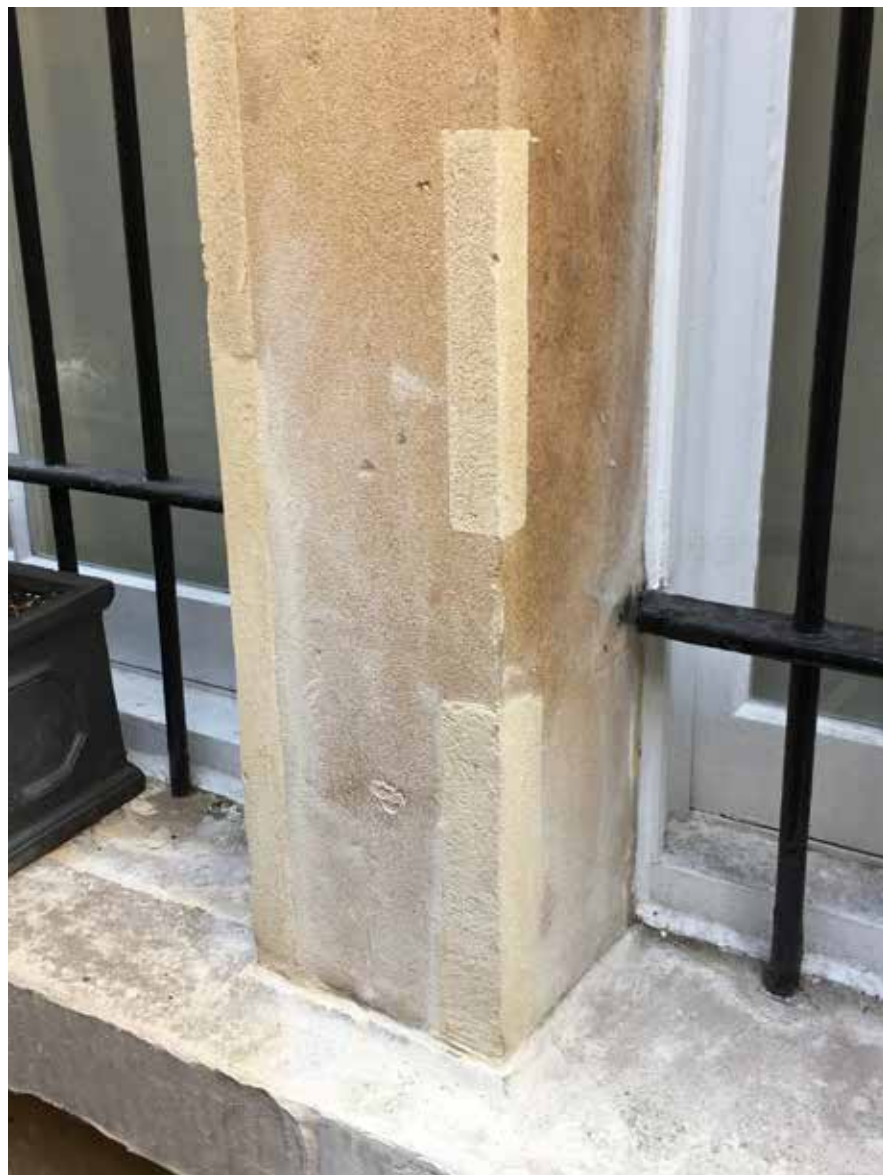
The pre-existing contrasting corner repair in the basement area of House 5 is very much lighter than the surrounding dark stone.

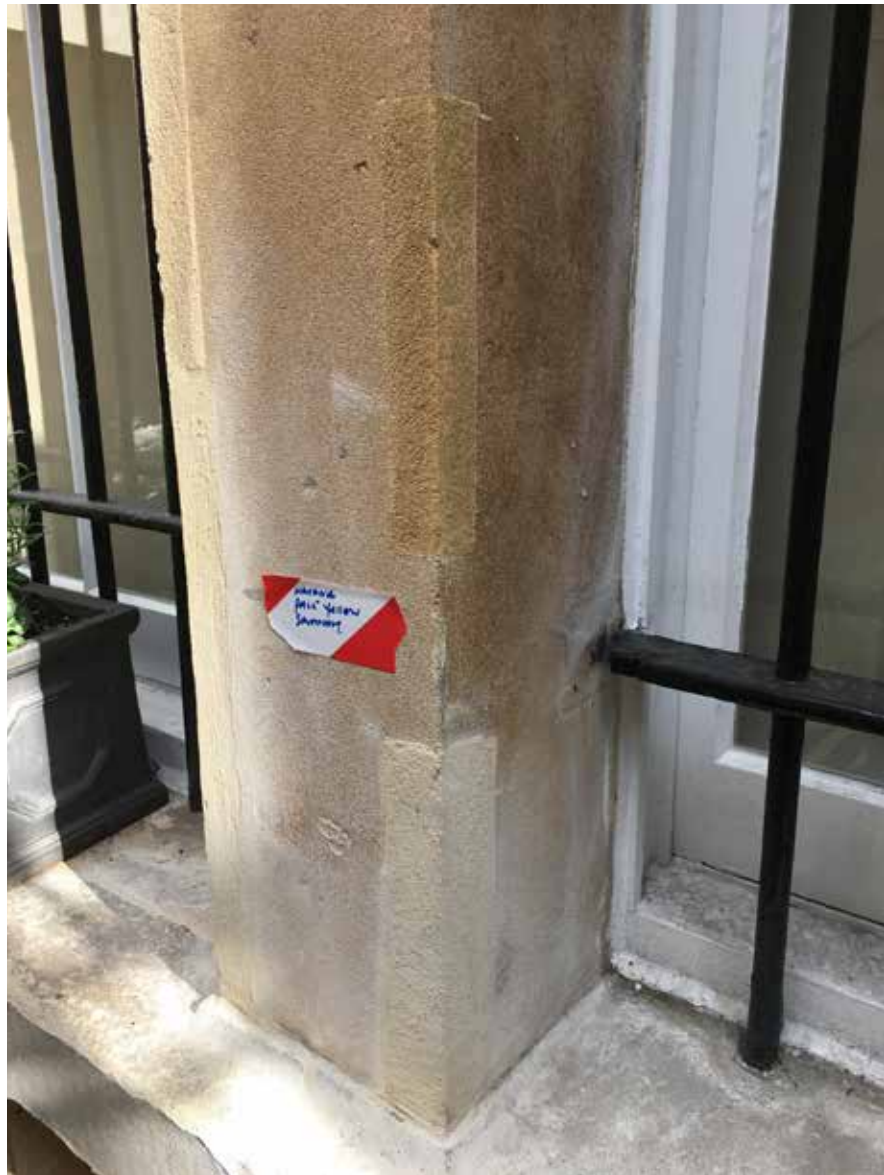
The tinting repair shortly after completion on March 6.

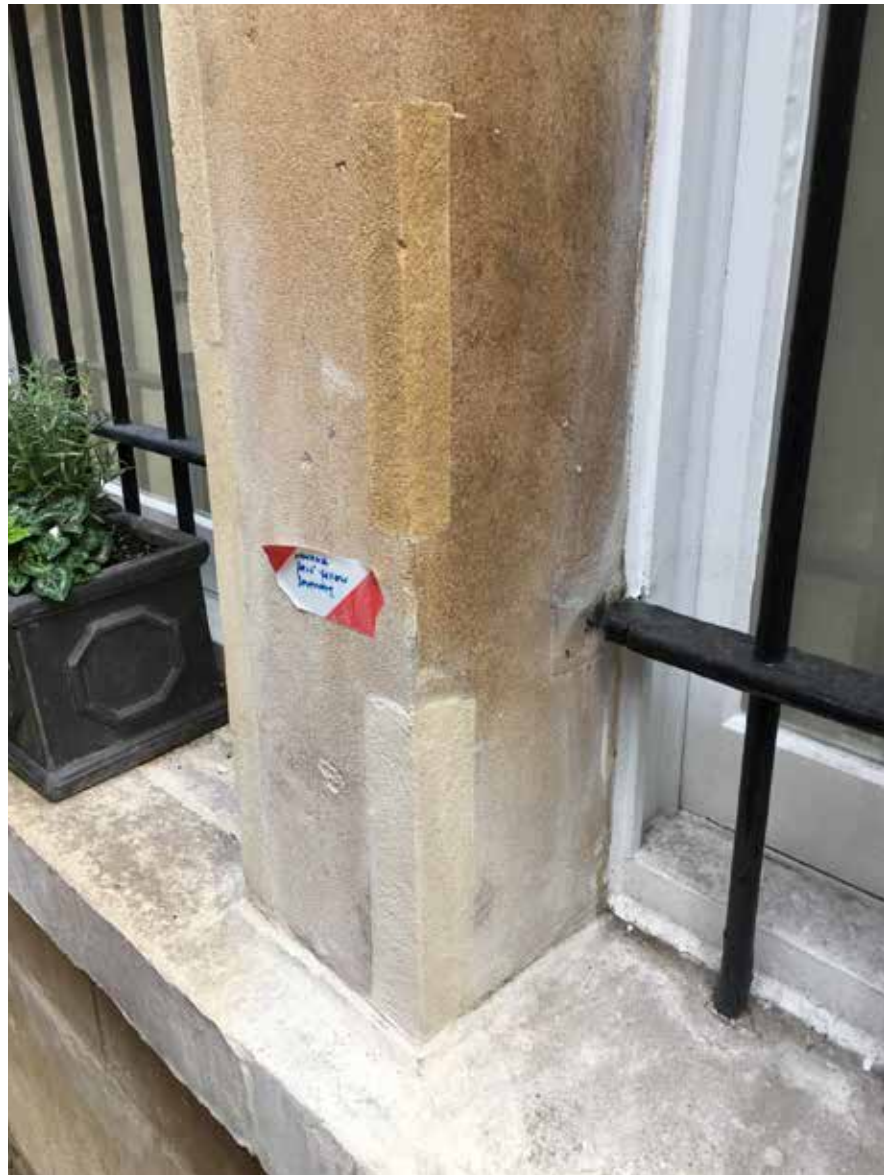
The corner repair after ten days. The repair is considered satisfactory.

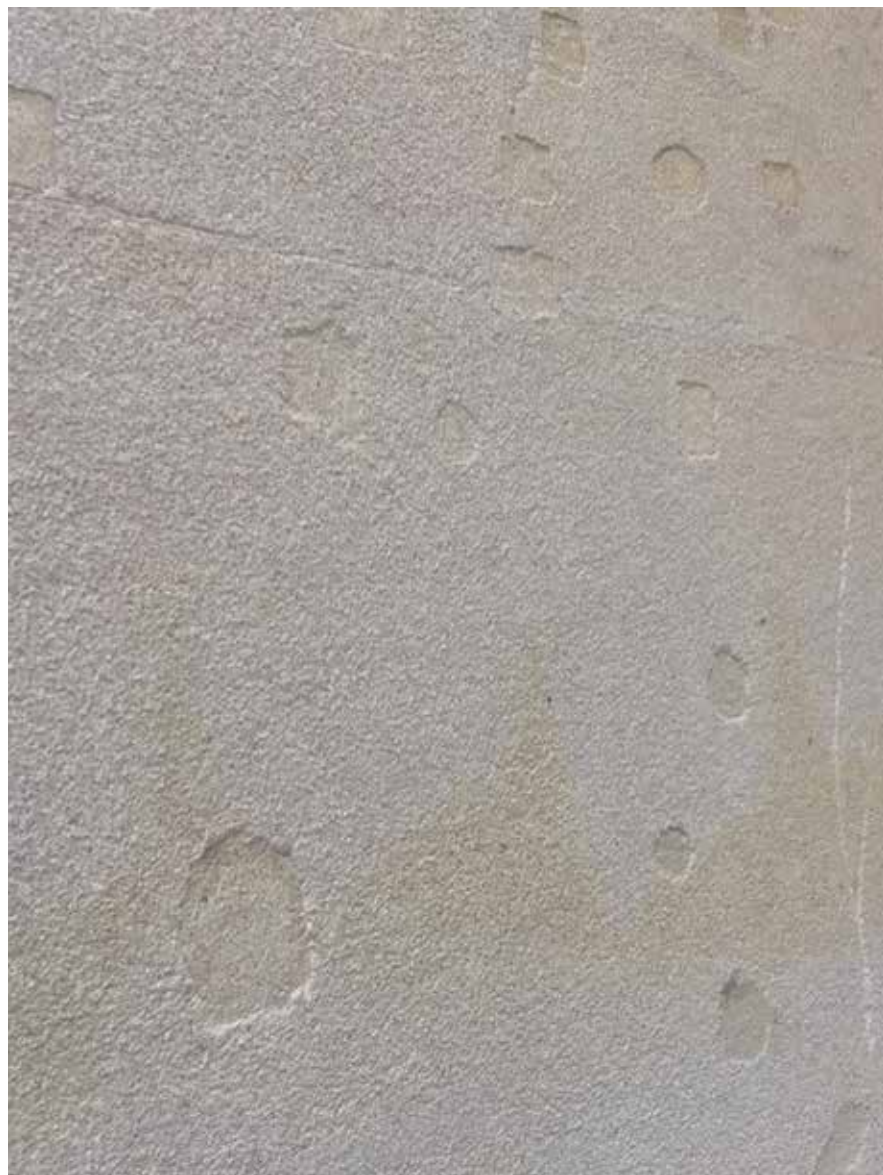
The pre-existing reapiers provide a good colour match, but have shrunk.

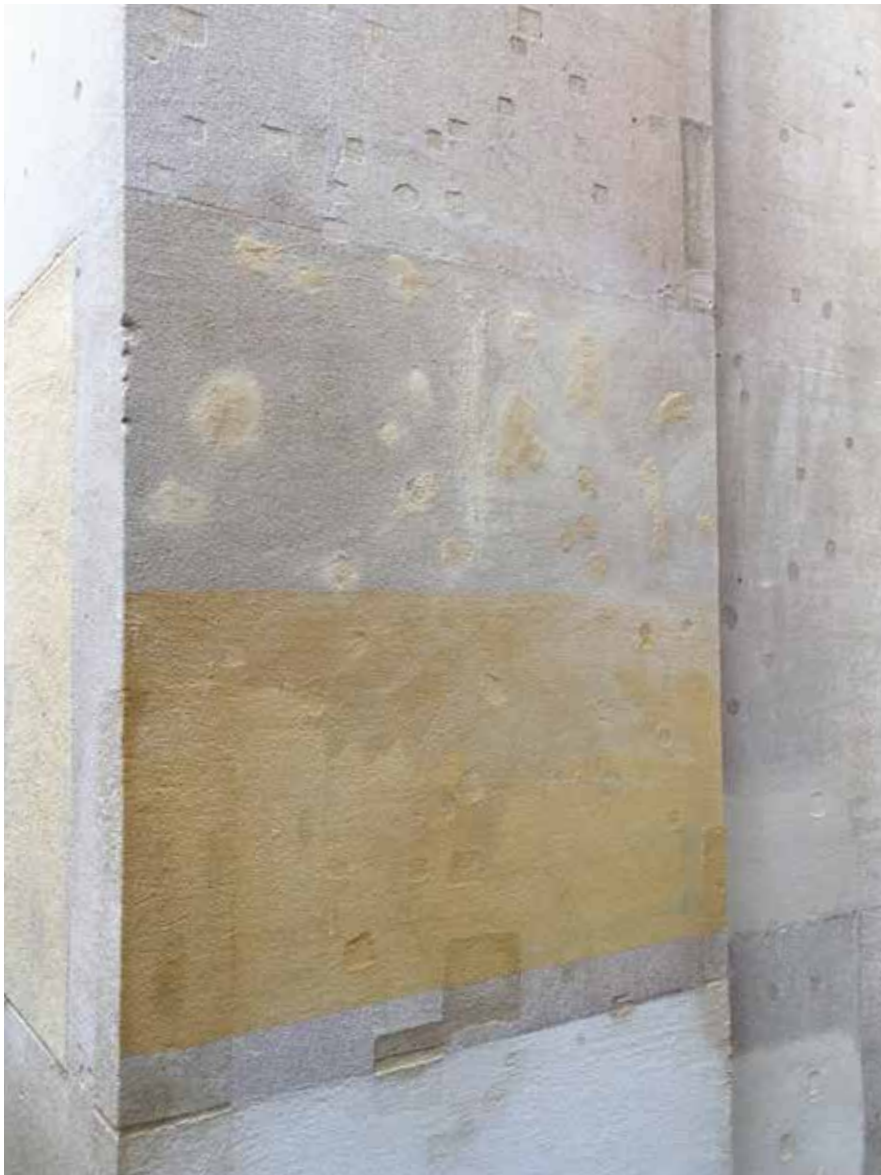
The reapiers have been filled, but not yet rubbed down on March 5.

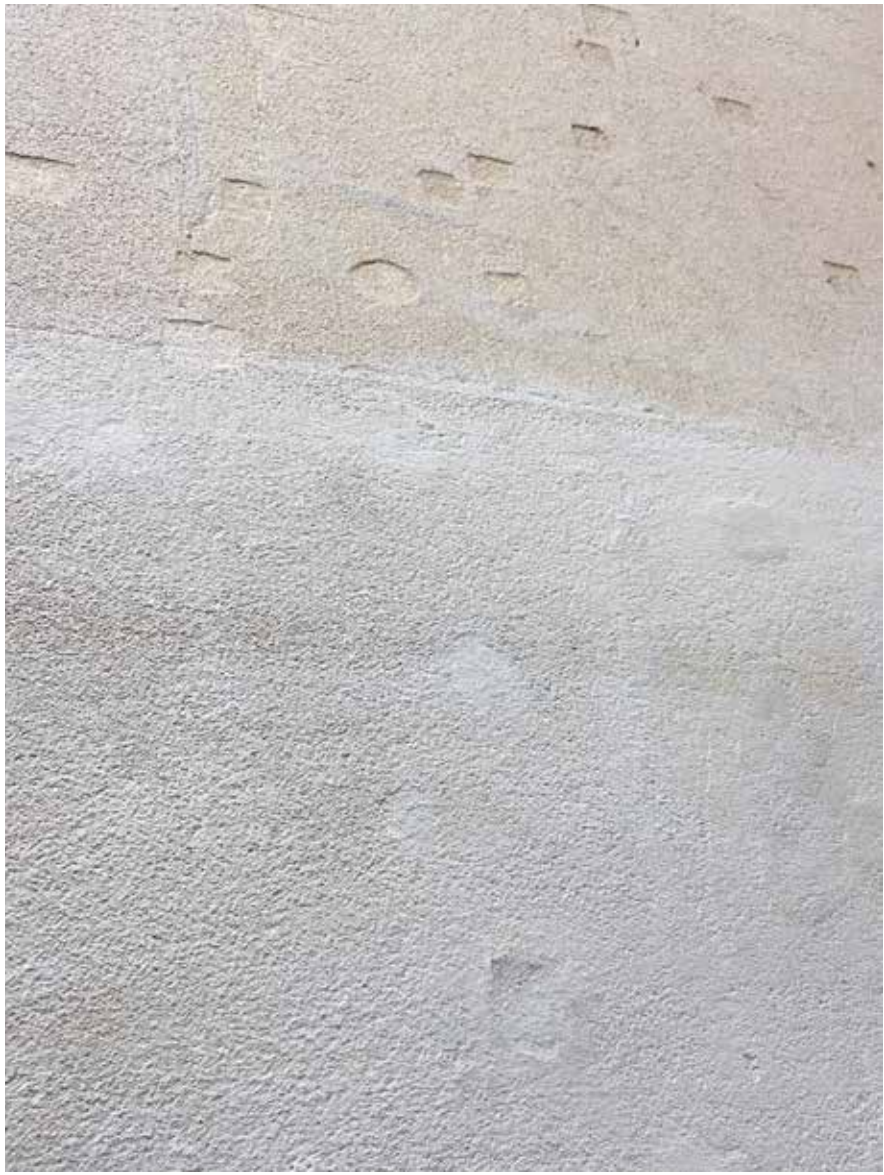
The repair mortar has been rubbed down and limewash applied to the extent of the stone joints. The repair is not yet satisfactory.

In the circumstances of a full remediation contract further rubbing down to the face would be necessary.

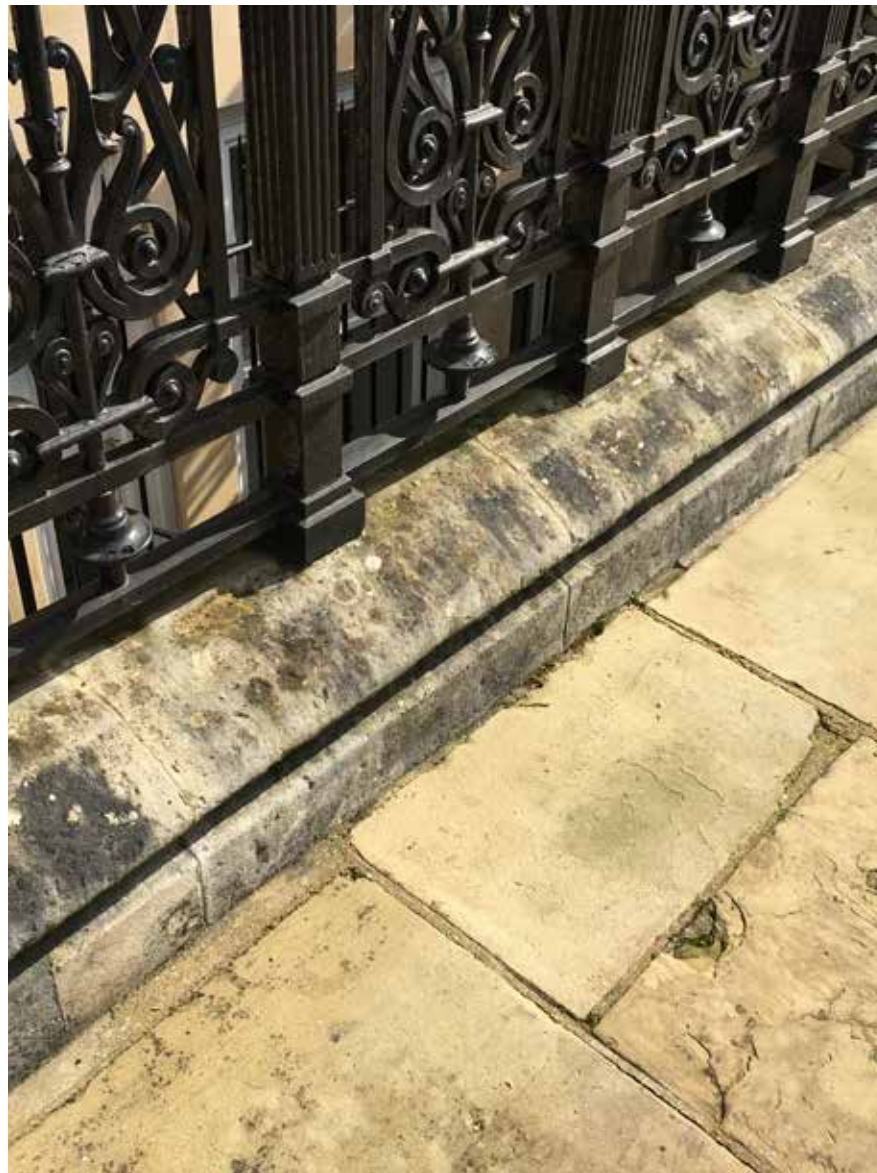
The heavily soiled stone plinths below the railings is to be cleaned.

The stone plinth under the iron railings is to be cleaned using Doff steam cleaning equipment.

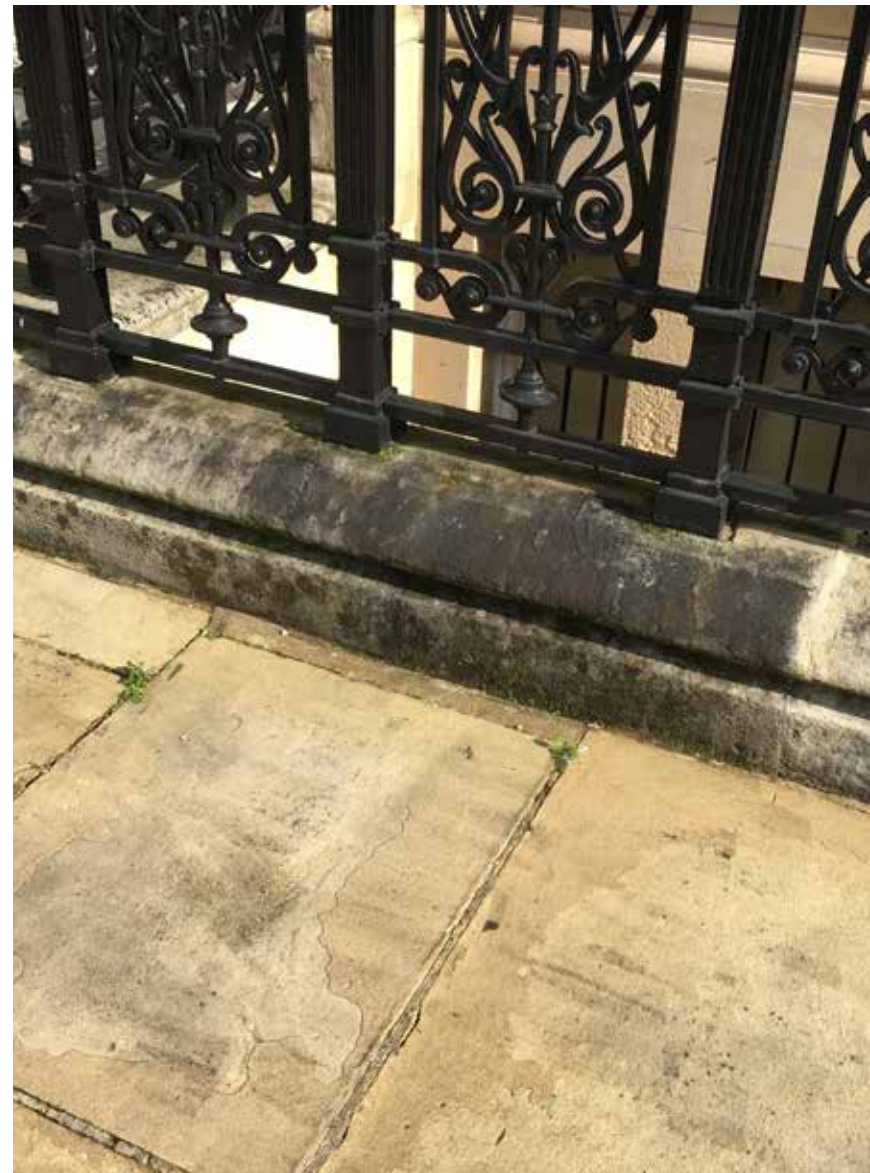
The heavily soiled stone plinths below the railings is to be cleaned.

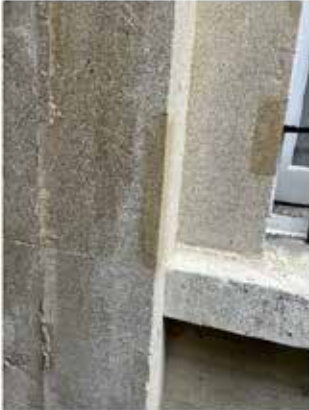
Item 1: basement of house no 5 lhs jamb.

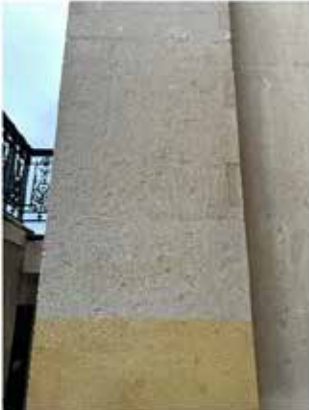
Item 2: basement to house number 5 - a series of small repairs, filled with bath premix (nh13.5) then toned to suit

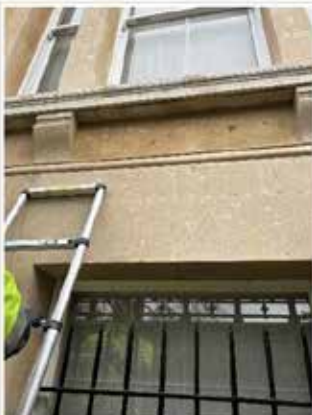
Item 3: house number 5 ground floor below window. Darker stone with light repairs toned in.

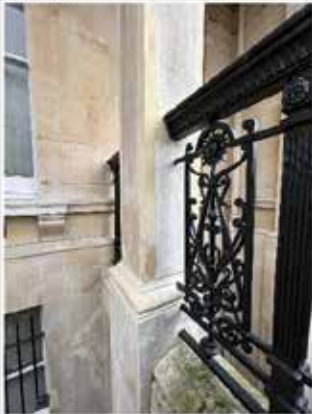
Item 4: House number 5 rhs as you enter staircase. Original repair is very orange and does not match the surrounding stone.

Please note lots of smears surrounding the repair.

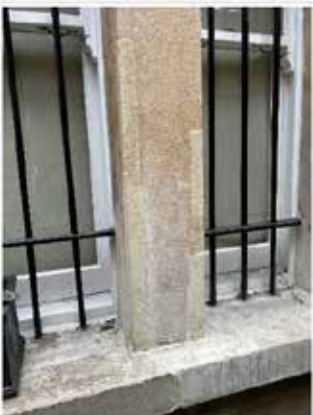
Item 5: House number 7 rhs mullion. Repairs are incorrect colour and smears need to be removed

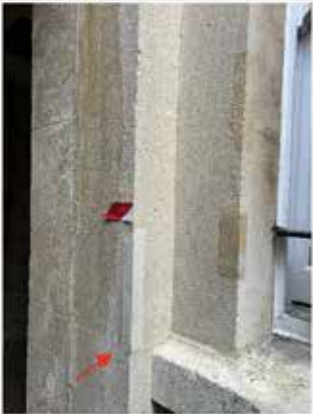
Item 1: shows tinting works carried out.

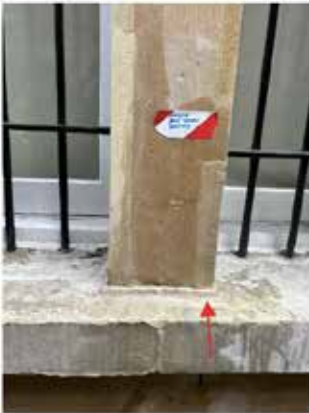
Item 5: The repair has been toned in.  We have used a carbo block- sponge and water used too carefully remove the smearing of the original repairs.
Inspecting Party (e.g. Client, Architect)	Robert Loader
Inspecting Party Name	James Fletcher
<b>Williams Restoration Sign Off</b>	
WR Manager Name	Craig Williams
WR Manager Signature
