Enforcement Delegated Report		Receipt date:	12/10/2023
Officer		Enforcement Case	
Joshua Cheung		EN23/0835	
Breach Address		Photos & Other material	
Kelley House, 18-20 Royal College Street, London, NW1 0TH		See appendices A – V (separate documents).	
Authorised Officer Signature

Site Description

The site forms two of the nine buildings of the "NUMBERS 6-22 ROYAL COLLEGE STREET, AND ATTACHED RAILINGS AND BOLLARD IN PEDESTRIAN WAY OF NUMBER 12" listed terrace, which lies near the Kings Cross St Pancras Conservation Area.

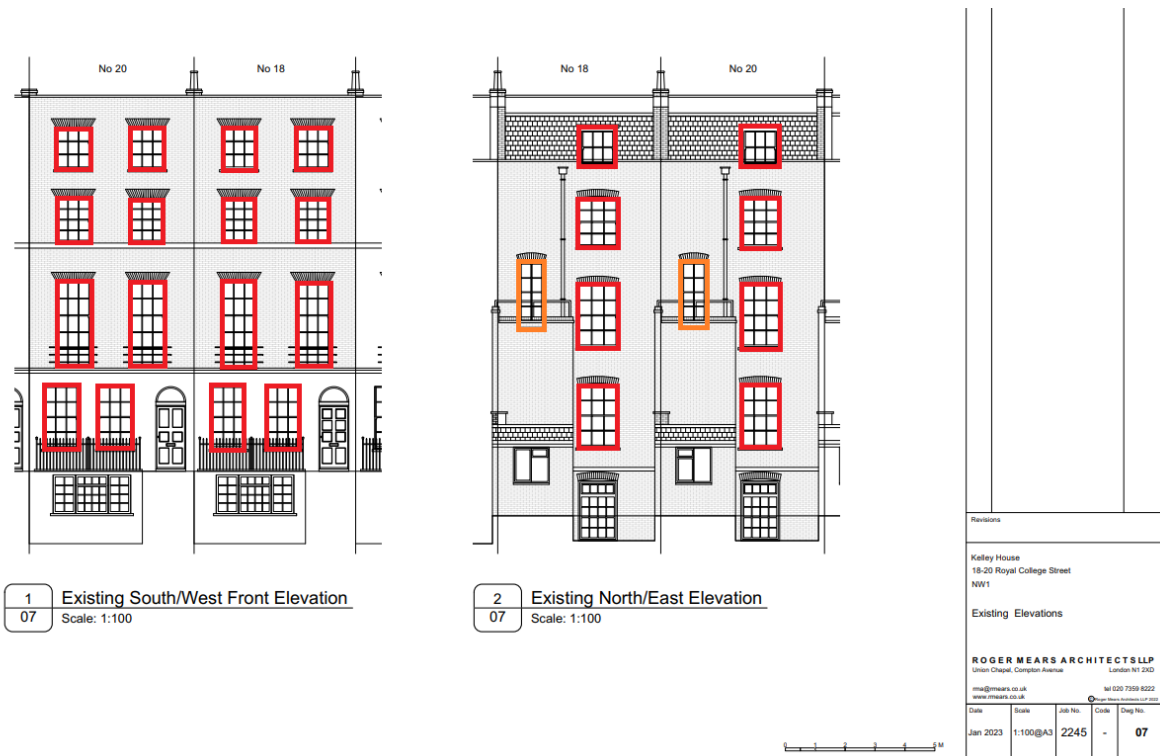
Appendix 1: Annotated version of Drawing 2245-07 ‘Existing Elevations’ of the 2023/0285/L consent

Relates to breaches (1, 2, 3), *(6, 7, 8), and (9): The replacement of all the original single-glazed timber fittings with double-glazed laminate "timber/composite" counterparts/additions: Sash windows (labelled W1 - 27, Appendices A, B, C); Casement windows (labelled CA1 & CA2, Appendix B); Top-hung casement windows (labelled CA3 & DR1, Appendix B); and Timber doors (labelled DR2 & DR3, Appendix D).

All new fittings are coated in 'white weather sealant' and have stuck-on glazing bars and thicker frames – both of which also have modern detailing. These features are located across all floor levels of the front, rear and flank elevations of the site.

Per the Heritage Statement of the 2023 consent, it was mutually agreed that it was highly beneficial to overhaul and repair the pre-existing fittings, with the front elevation windows holding "very high" significance and rear elevation windows holding "medium" significance. Despite this, the responsible party has surprisingly replaced all windows and doors with unsympathetic and low-quality replacements/additions which harmfully alter the historic character and appearance of the site and contributes to the cumulatively erosion of its significance. The site lies mid-terrace thus in a prominent position, so against surrounding timber windows the undesirable effect of the new front elevation windows on the townscape and wider area is exacerbated.

1. Replacement of the timber sash windows located on the front and rear elevations across the ground, first, second and third floor levels with laminated timber/composite sash windows – **Action**.

2. Replacement of the two timber doors (one in each property) at the two-storey rear extensions’ flat roof terraces with laminated timber/composite doors – **Action**.

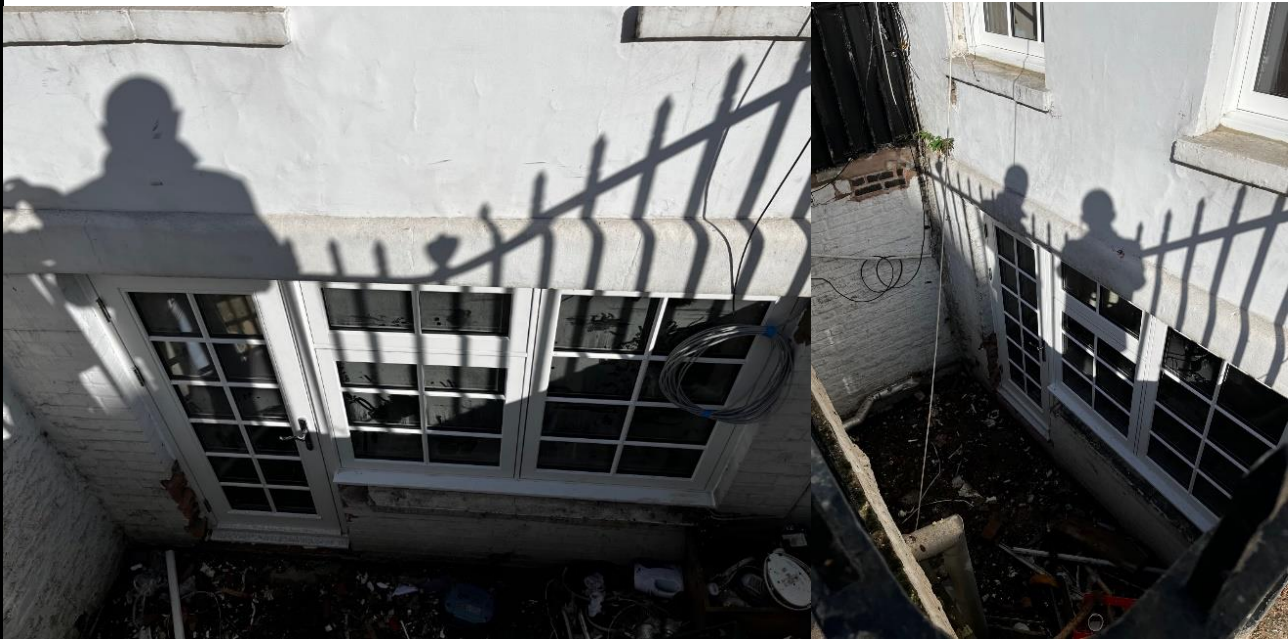
Appendix 2: Annotated image of unauthorised casement windows and doors

Relates to breach (3): In reference to [Appendix E](#), following the removal of the timber picture windows and demolition of sections of masonry (circled in black), the installation of modern timber/composite casement windows and doors leading from the front basement rooms into the front lightwell (labelled DR4 & CA4, and DR5 & CA5). **And breach (4):** Access into the front light well 'storage rooms' have been boarded up (highlighted in red and orange).

Whilst picture windows are not of historic interest, where sash windows are, they have less of an impact as the new casement window and door as they did not effect the plan form and possess the same undesirable effect of the timber/composite materials. This part of the works therefore contributes to the further departure of the historic interest of this part of the site and the overall cumulative loss of historic fabric through the removal of the brickwork.
