Appendix M – No.20 rear rooms: Damaged chimney breasts

Appendix N – Drawing 2245-12 “Proposed Basement Plan” of the 2023/0285/L consent (annotated) – Nos.18-20.

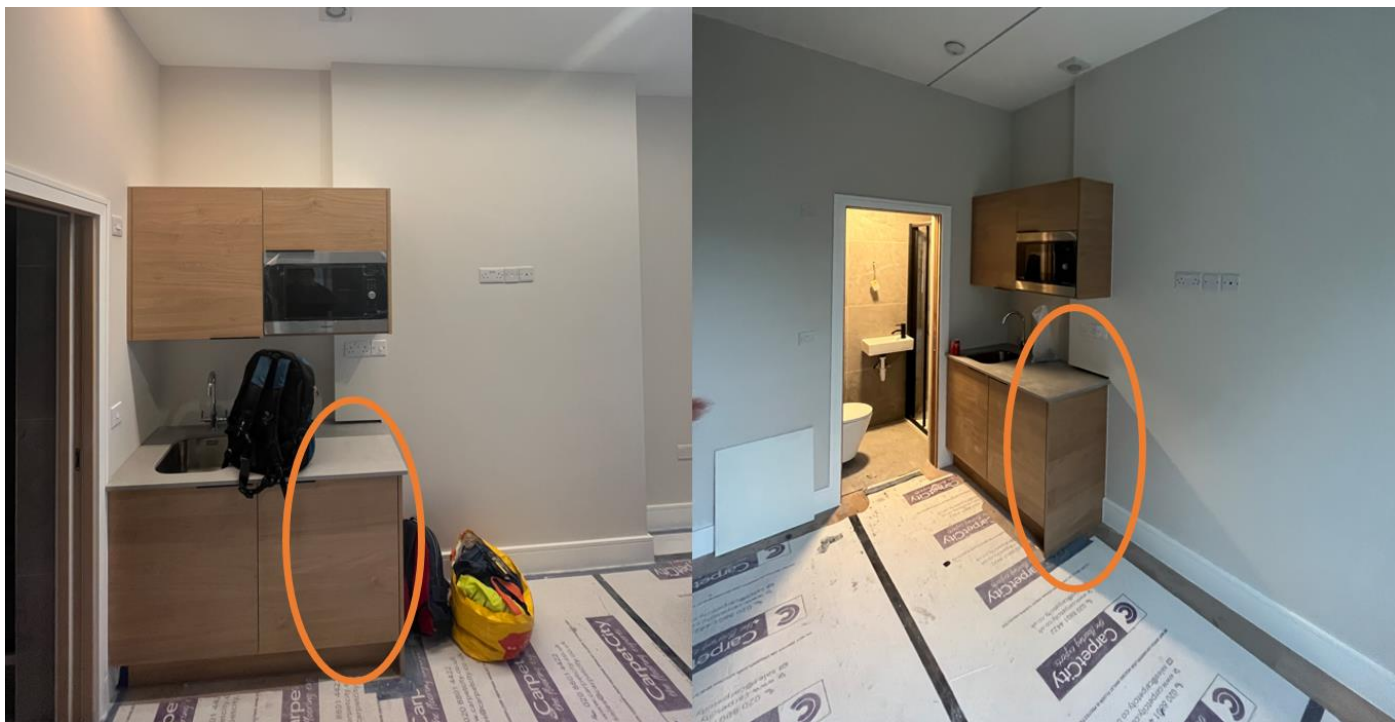
Ground floor [left] & first floor [right]: Damaged chimney breasts (circled in orange).

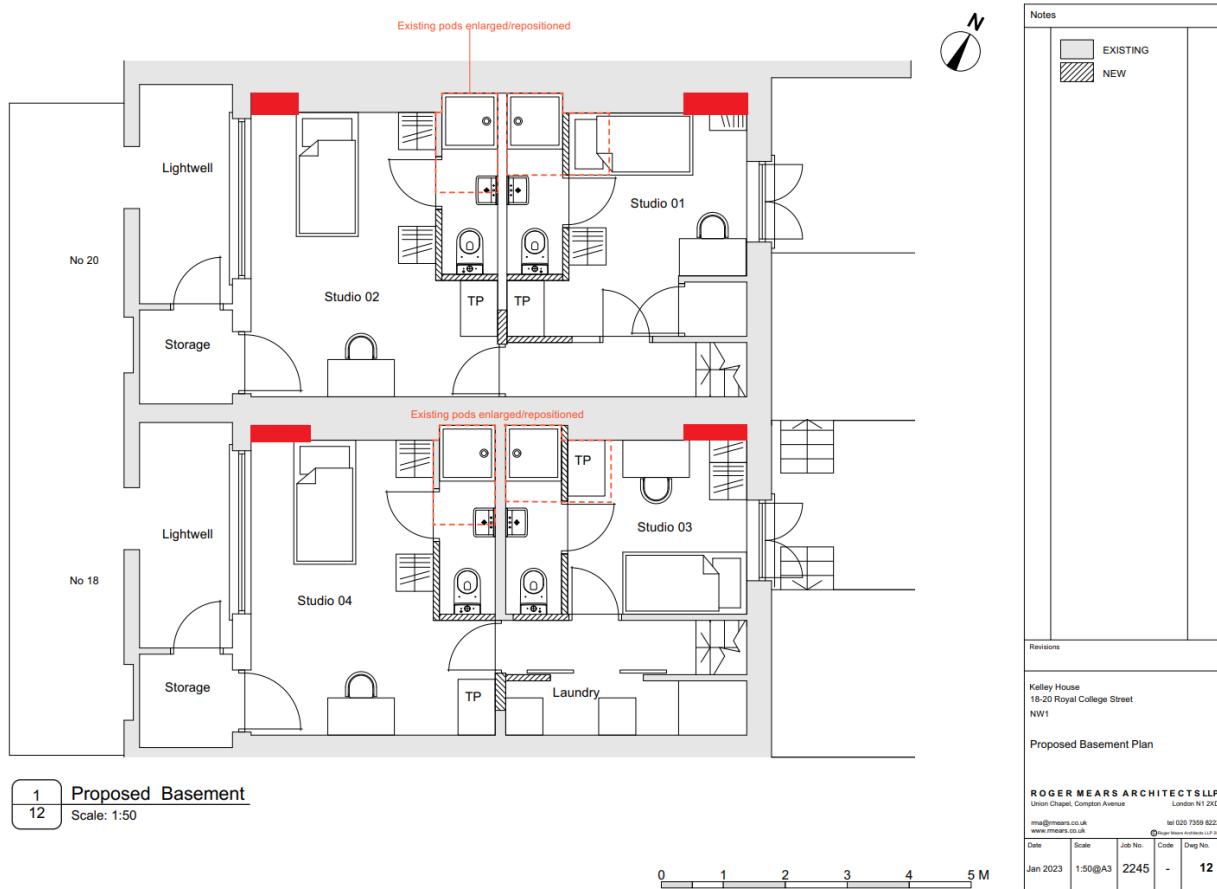
Red box annotations showing the positions of the alcoves which have been infilled at basement level.

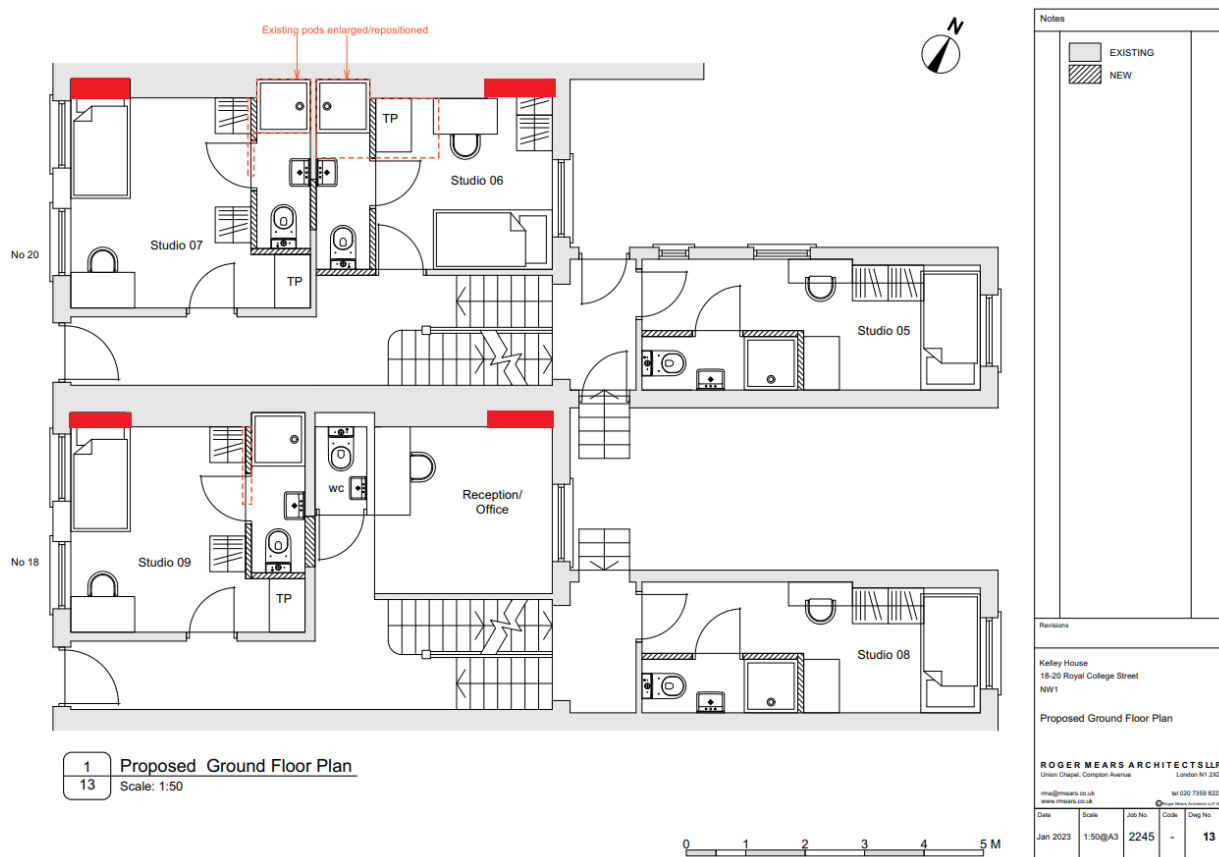
Appendix O – Drawing 2245-13 “Proposed Ground Floor Plan” of the 2023/0285/L consent (annotated) – Nos.18-20.

Red box annotations showing the positions of the alcoves which have been infilled at ground floor level.

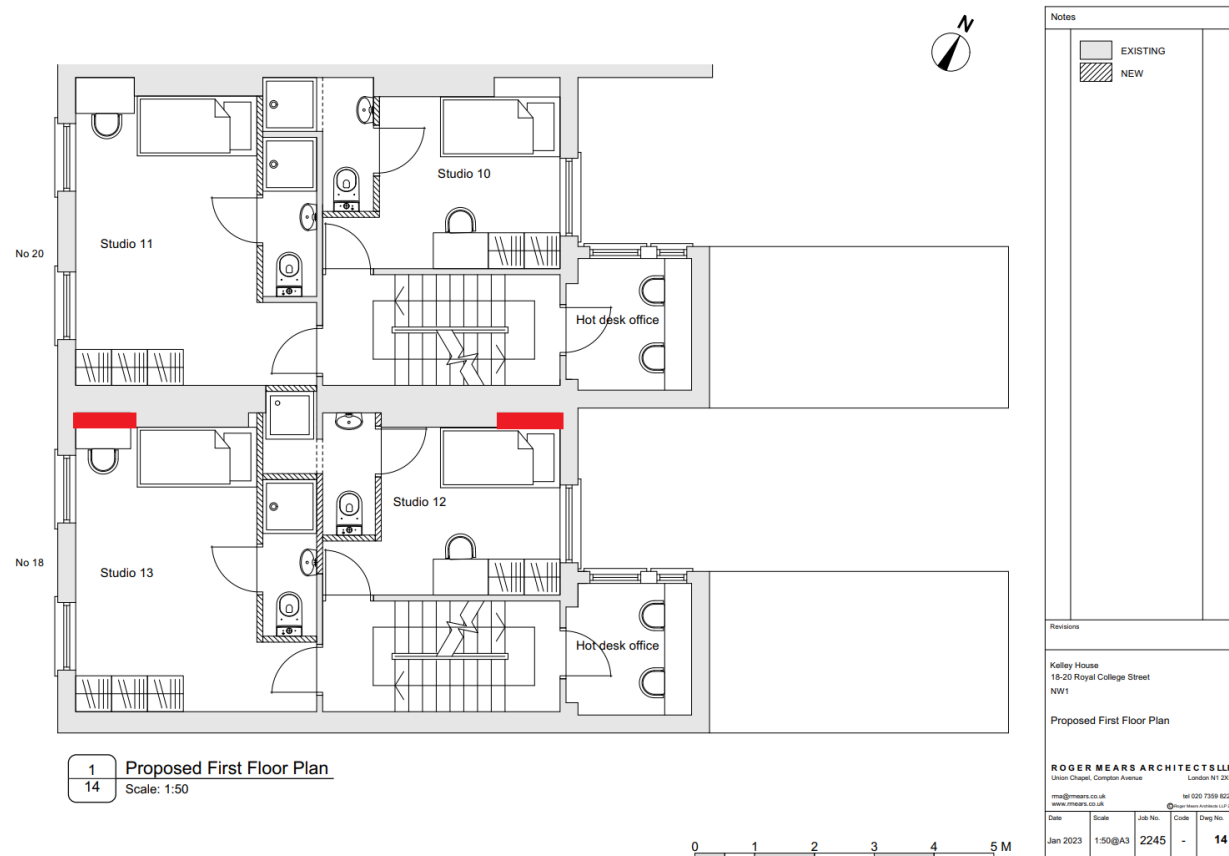
Appendix P – Drawing 2245-14 “Proposed First Floor Plan” of the 2023/0285/L consent (annotated) – Nos.18-20.

Red box annotations showing the positions of the alcoves which have been infilled at first floor level.

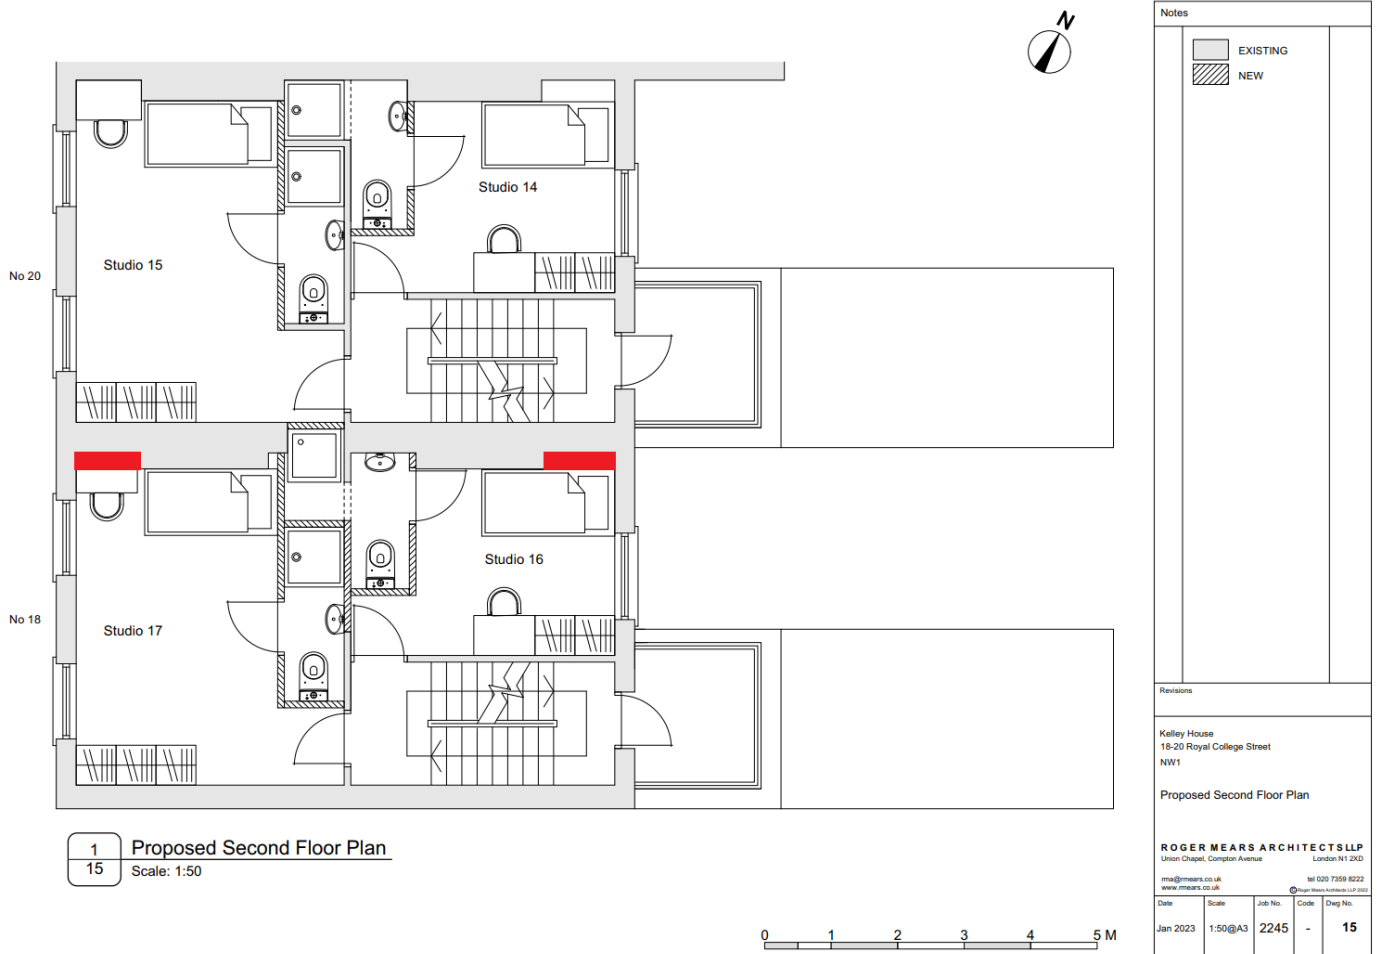
Appendix Q – Drawing 2245-15 “Proposed Second Floor Plan” of the 2023/0285/L consent (annotated) – Nos.18-20.

Red box annotations showing the positions of the alcoves which have been infilled at second floor level.
