Arboricultural Appraisal Report

Damage Investigation at:

28 Park Village East
London
NW1 7PZ

CLIENT:	Crawford & Company
CLIENT REF:	[REDACTED]
MWA REF:	[REDACTED]
MWA CONSULTANT:	Giles Mercer (BSc Hons)
REPORT DATE:	17/03/2021

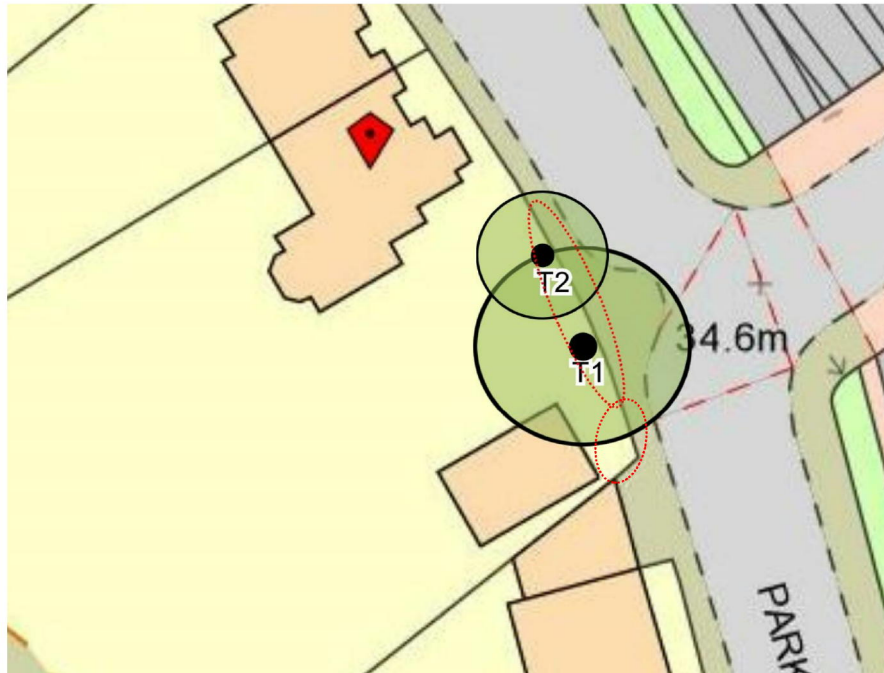
Site Plan

Approximate areas of damage

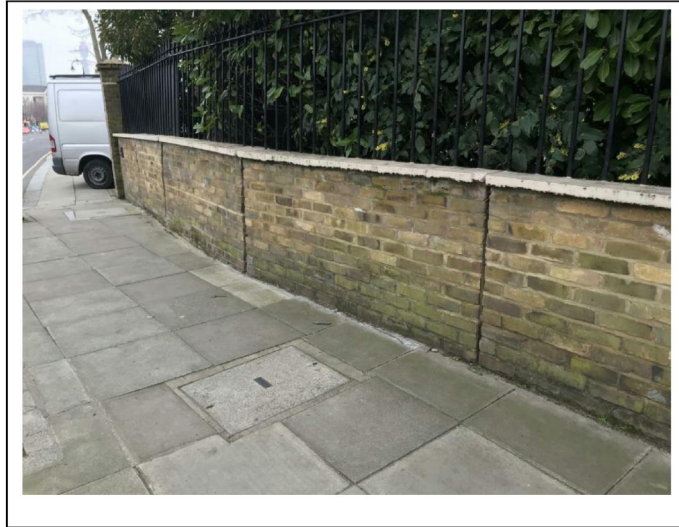
- 4.8 Both the Horse Chestnut (T1) and the Lime (T2) are located in very close proximity to the boundary wall and the deflection / distortion and cracking noted to the boundary wall is the result of direct damage caused by the incremental growth of the tree stem and by the secondary thickening of the tree roots.

View of distorted wall

- 5.3 In the event the wall is to be retained, in order to provide a durable solution, we recommend that the two trees are removed. Should replanting be considered we would advise that adequate space is allowed for future growth and that a root barrier is installed if the wall is to be rebuilt.

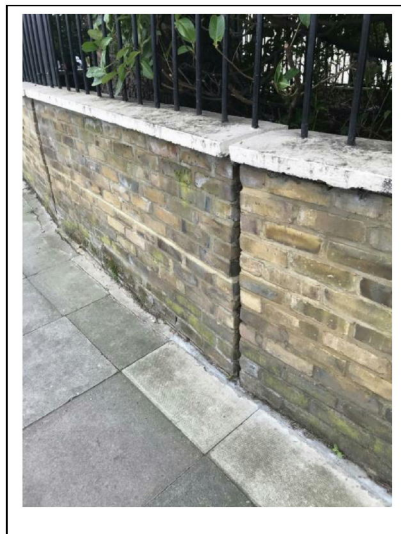
View of distorted wall

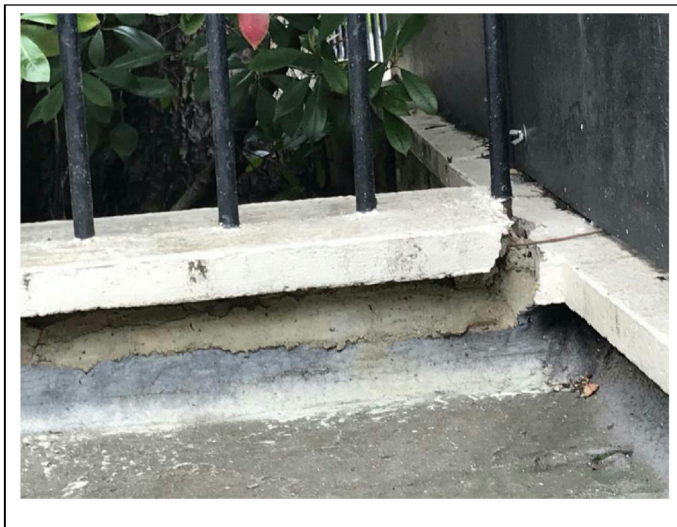
View of crack displacement

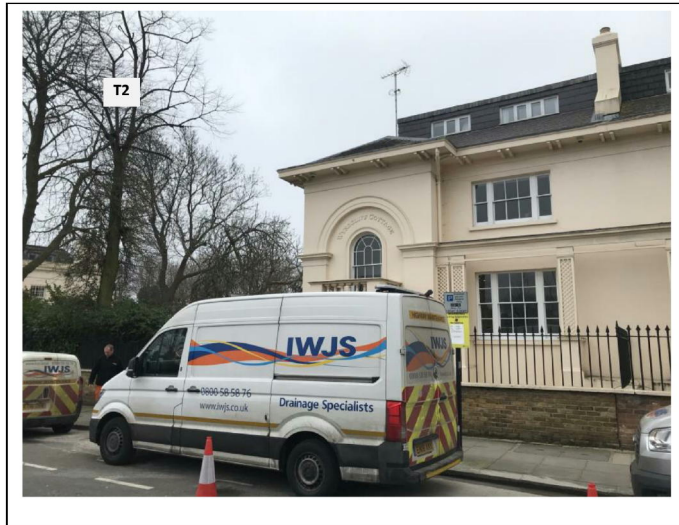
View of Lime (T2)

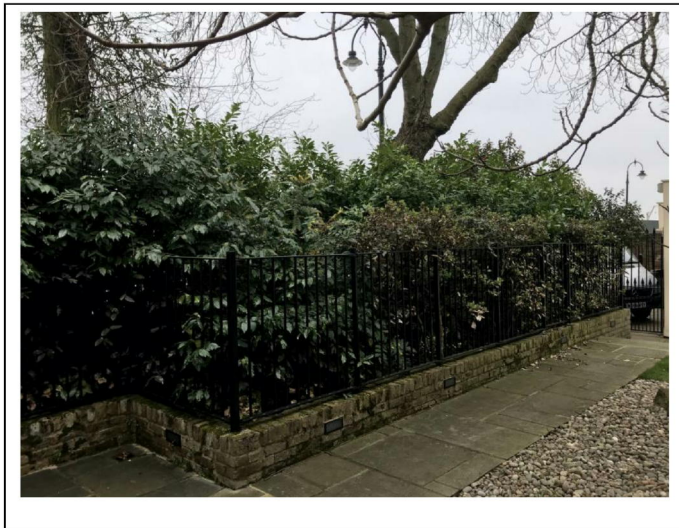
View of fenced off section to rear of boundary (retaining) wall showing T1 and T2.
