TECHNICAL REPORT

28 Park Village East
London
NW1 7PZ

Prepared for

Chubb Insurance Company of Europe SA

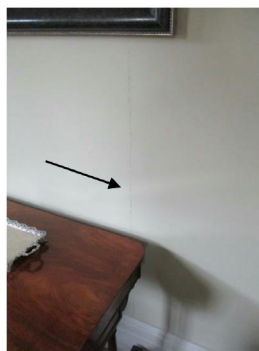
Cracking to dining room partition in sitting room

Sitting Room - 2mm vertical tapering crack to dining room partition (crack wider at bottom), various cracks noted to ceiling, hairline horizontal crack to flank wall rear window reveal.

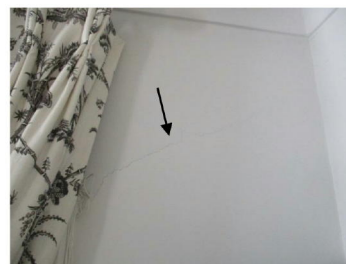
Cracking to rear wall in rear left hand bedroom

Rear Left Hand Bedroom - Cracking to ceiling, hairline diagonal crack to right hand side of rear window, hairline diagonal crack above door to en-suite.

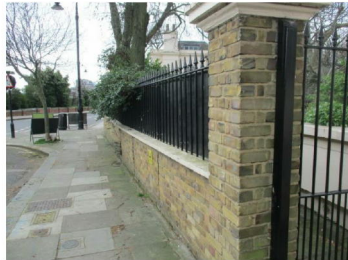
Front Boundary Wall - Left hand gate pier is leaning towards the road and metal gate has been adjusted to fit increasing opening, 4mm stepped crack to wall to left hand side of left hand pier, boundary wall is generally leaning along its length towards the road, 25mm horizontal crack at left hand end of wall by gates to garage.

The movement to the front boundary wall and garden retaining wall appears to be due to a combination of foundation movement and physical damage due to the proximity of the insured's trees to the walls. The damage to the wall is such that a scheme of localised rebuilding will be required in order to properly reinstate the wall.

View of front boundary wall

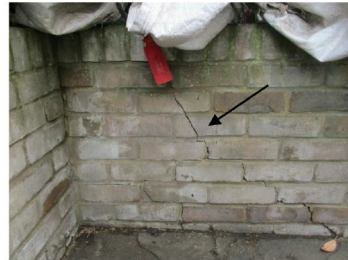
Garden Retaining Wall - 4mm vertical crack on left hand corner, 4mm stepped crack by gate to garage, hairline stepped previously repaired crack by boiler flue.

Cracking to garden retaining wall

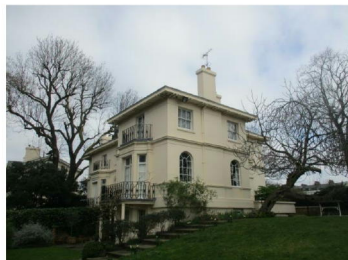
View of rear of property

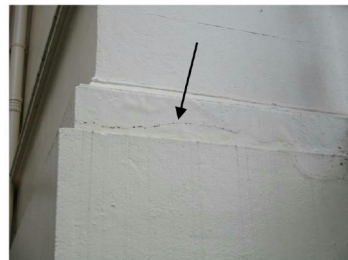
Rear Elevation - 4mm horizontal crack to kitchen left hand bay window cill, 3mm horizontal crack at ground floor level to right hand side of bay.

Cracking to rear right hand corner

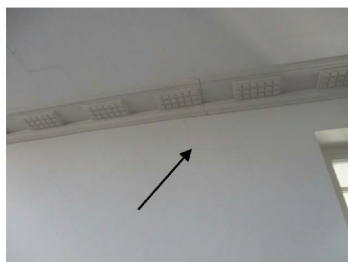
Hall, Stairs and Landing - Cracking to hall ceiling and evidence of previous water leak staining, hairline diagonal crack to left hand side of front door, crack across ceiling on 1st floor landing, hairline vertical crack down junction of front wall and 1st floor study partition (small area of disrupted plaster at low level).

Cracking in hallway

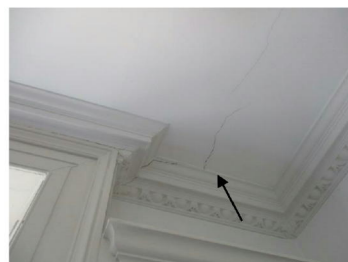
Ground Floor Study - Cracking to ceiling and coving in front left hand corner, hairline vertical crack to hall partition.

Cracking to ceiling / coving in ground floor study

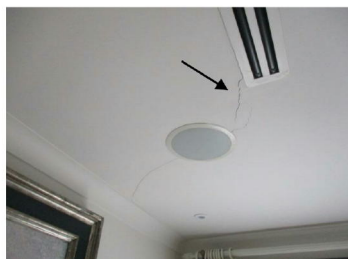
Cracking to ceiling in rear left hand bedroom

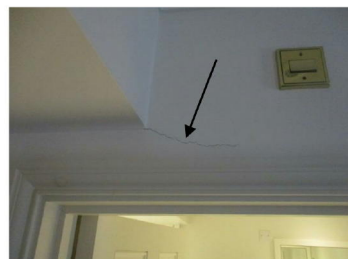
Cracking above en-suite door in rear left hand bedroom
