ADDENDUM TECHNICAL REPORT No.2

**28 Park Village East
London
NW1 7PZ**

Chubb Insurance Company of Europe SA

DATE 29 August 2024

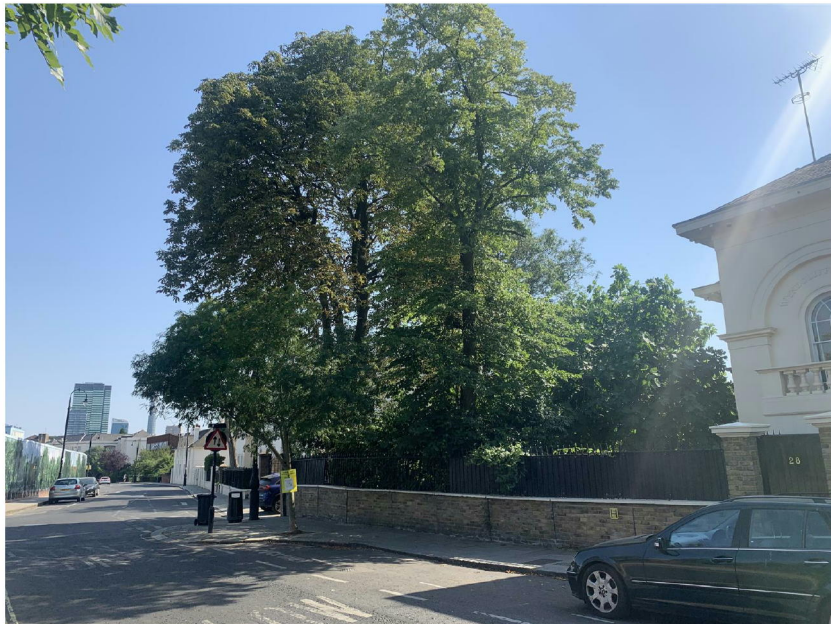
The section of wall of concern forms the front boundary between the left front entrance pillar and the right pillar of the drive in front of the garage.

Boundary wall section of interest

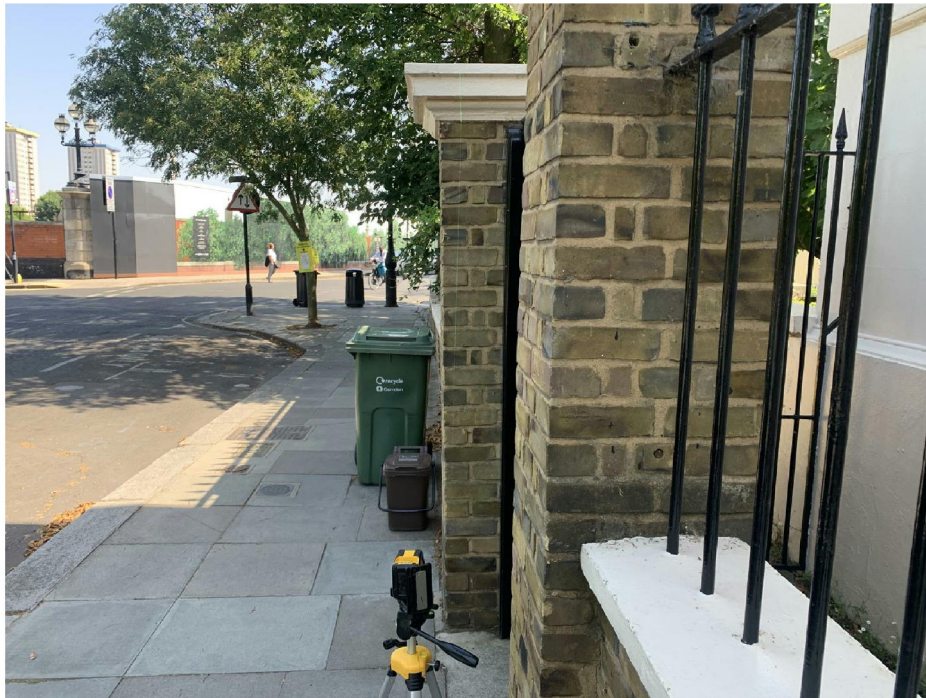
The left front entrance pillar is formed of 450mm square brickwork, extending a height of 2.06m from the pavement and with a stone capping. The pillar leans outwards towards the pavement, measured at 73mm over the pillar height, which equates to **1 in 28** out of vertical.

Left front entrance pillar lean

The subsidence issue can be addressed by removing the cause ie the trees of influence. This will allow the ground to gradually stabilise so that remedial works can be implemented. Arboricultural recommendations obtained from MWA Arboriculture recommend removal of T1 Horse Chestnut and T2 Lime. By addressing the subsidence issue, the tilt will also reduce thus significantly reducing the risk of the wall toppling/collapsing onto the public pavement.

If tree works are implemented, remedial works would involve partial rebuilding and repairs for which an estimate has been obtained from Lawnscape at [REDACTED] (December 2023 prices).

If the trees remain, we see no alternative but to rebuild the whole section of wall and pillars on a piled foundation taken below the depth of influence of the tree roots. As per Panel G, the brickwork can incorporate lintels to span the trunk growth in Panels D & G but the new piled foundations will inevitably cut some roots. An estimate has been obtained from Optera Structural Solutions in the sum of [REDACTED] (August 2023 prices)

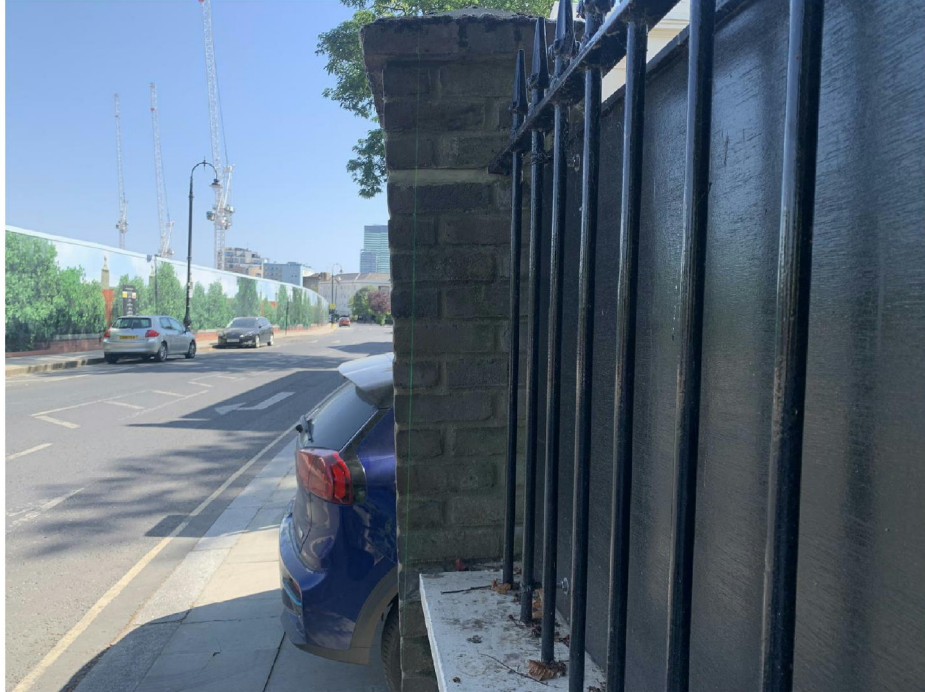
The right driveway pillar is similar 450mm square brickwork, 2.3m high with a pyramid concrete cap. This pillar also leans out towards the pavement, measured at 140mm over the full height, which equates to **1 in 16** out of vertical.

Right drive pillar – green laser line is vertical

The driveway provides an indication of the movement. Beneath most of the driveway is an underground Flat, so foundations are deep and unaffected by the movement. However, in front there is significant clay shrinkage which has caused the pillar to lean significantly.

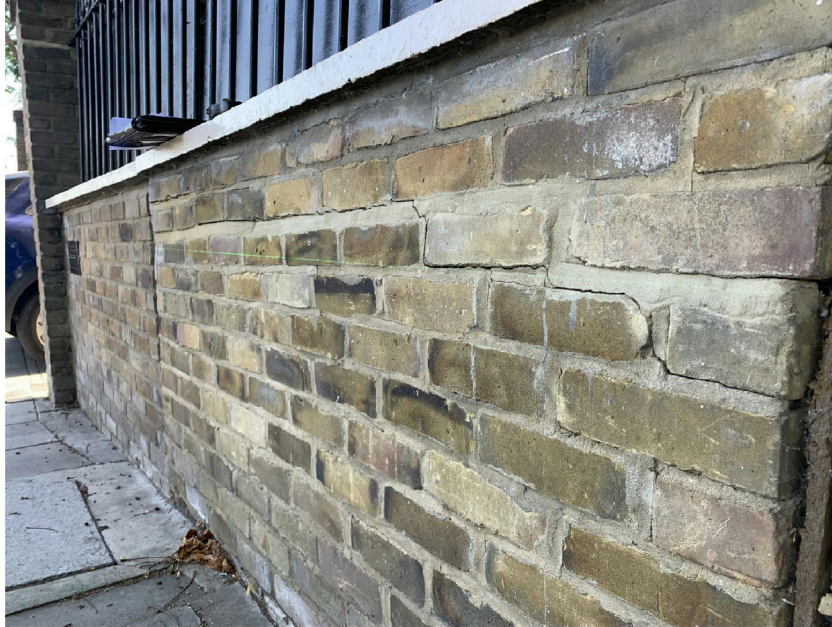
H	2.0m	Bulge out adjacent to T2 trunk and leans out.	1 in 34 down to right side	Stepped horizontal crack at high level, previously re-pointed but has re-opened.
I	1.9m	Severe lean out as per Drive pillar	1 in 95 down to left side	Previously re-pointed cracks have re-opened Attached to Drive pillar.

Panel H – Cracking, bulging out and tilt down to left (as shown by laser line)

In this instance, the tilts on both pillars and Panel H are less than 1 in 50 and those of Panels A, B & I are less than 1 in 100. Whilst we do not consider there is immediate danger of collapse, the physical damage is in excess of normal serviceability requirements and the tilt increases the risk of collapse.

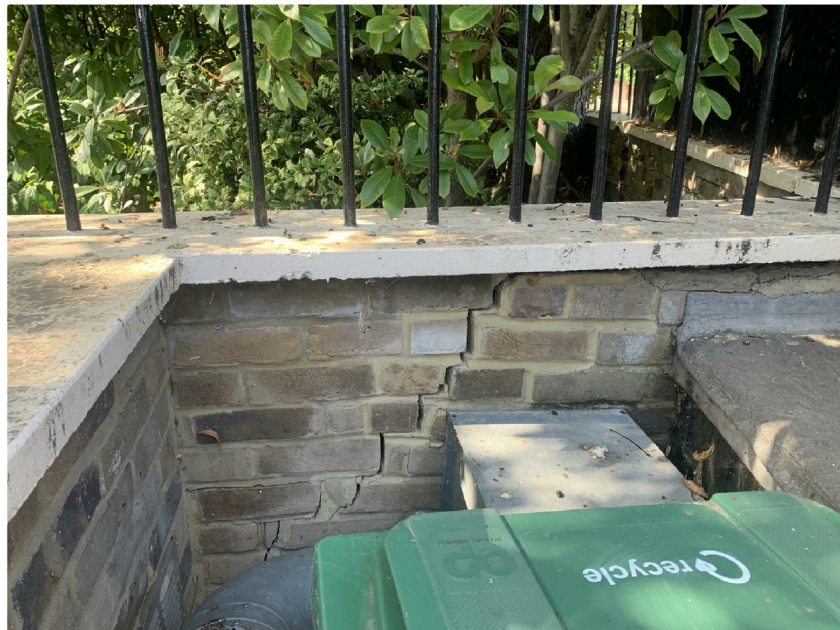
- Right gate on drive has been adjusted on several occasions due to movement
- Paving has dropped in front of drive. Paving slab cannot easily be re-set due to hard spot provided by roof slab of flat which extends under driveway.
- Road and pavement has dropped in front of drive. Rain gathers rather than flow into road drains which are visibly higher.
- Paving slab loose just inside front entrance pillar.
- Stepped crack on internal perpendicular garden wall near drive end, open 12mm after previous filling and repointing.

Cracking to perpendicular wall near Drive end

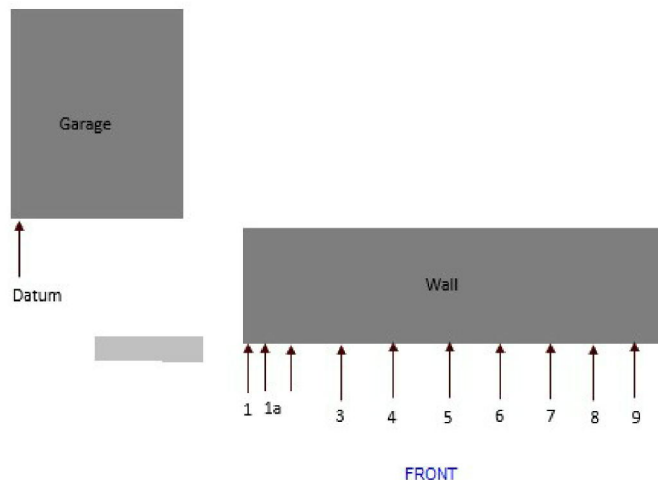
Level monitoring along the wall at 1 panel intervals has been carried out over the period August 2022 to November 2023, following which the monitoring points were either destroyed or removed by other parties (the wall faces the public footpath).

Monitoring positions are shown below:

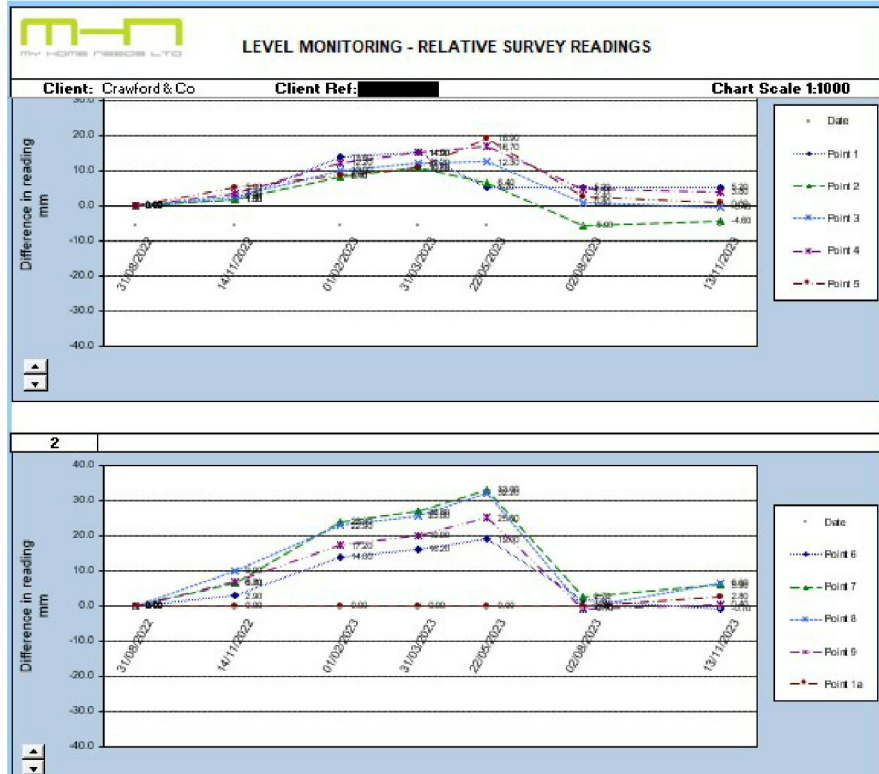
Readings are shown in graphical form overleaf. The datum was placed on the garage which has a deep foundation, so is considered to be relatively stable and unaffected by clay shrinkage movement.

The readings show upward ground movement ranging from 10mm to 32mm over the period August 2022 to May 2023, correlating with rehydration (swelling) of the clay. From May 2023 to August 2023, the movement is downwards ranging from 4mm to 30mm. This correlates with shrinkage of the clay during the drier summer months. From August 2023 to November 2023, there is some slight upward movement at some points, indicating that the winter rehydration (swelling) is re-starting. Overall, the pattern of cyclical movement is consistent with clay shrinkage and swelling beneath the footings of the wall and piers.
