Site Investigation Report

28 Park Village East
London
NW1 7PZ

Client: Crawford & Company

Site Visit Date: 25/06/2019

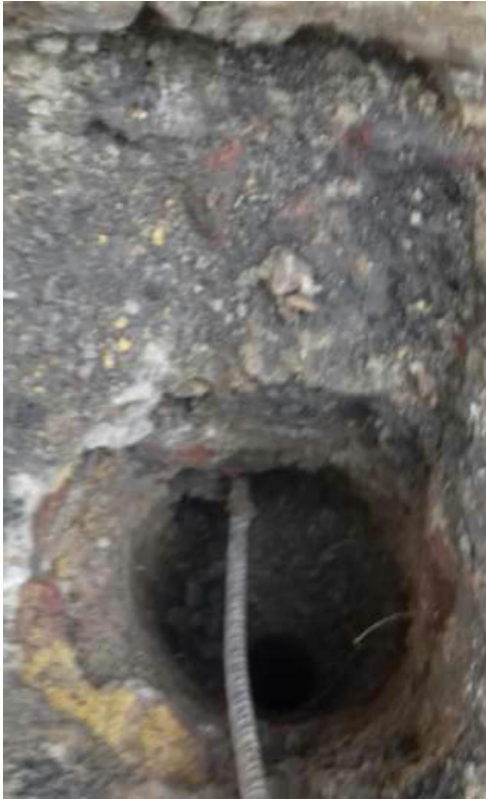
Photo 2 – EH1 Foundation Pit

Roots visible to 0.70m.

Roots of live appearance were encountered in EH1 to a depth of approx. 0.70mbgl.

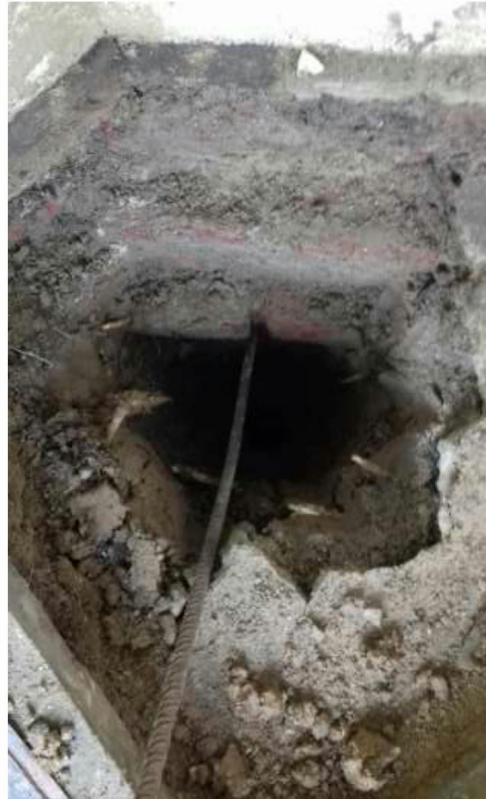
Photo 3 – EH2 Foundation Pit

Roots of live appearance were encountered in EH1 to a depth of approx. 1.00mbgl.

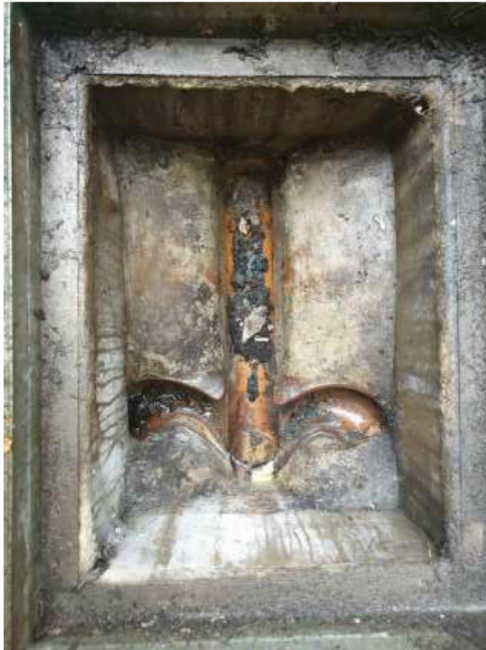
Photo 4 – IC1

Both inspection chambers were in good working condition with no sign of any defects. The runs to the rear of the property had multiple minor defects with medium displacements within Run A and settled deposits with Run D.

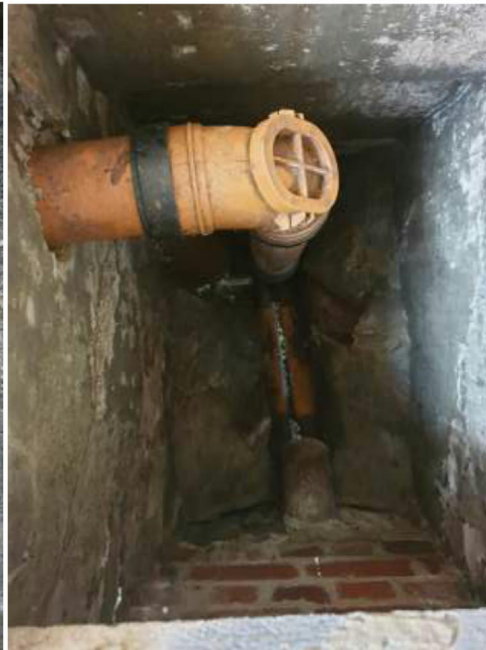
Photo 5 – IC2

The runs with IC2 was greatly restricted due to the angle of the pipes entering the chamber. By testing the internal toilets, it was possible to determine the approximate source for the drains unexamined.
