## Parliament Hill Lido, Hampstead Heath, North East Boundary Wall

### Structural Assessment Report

**Ref:** 231038/E Painter

**Date:** 18 Dec 2023

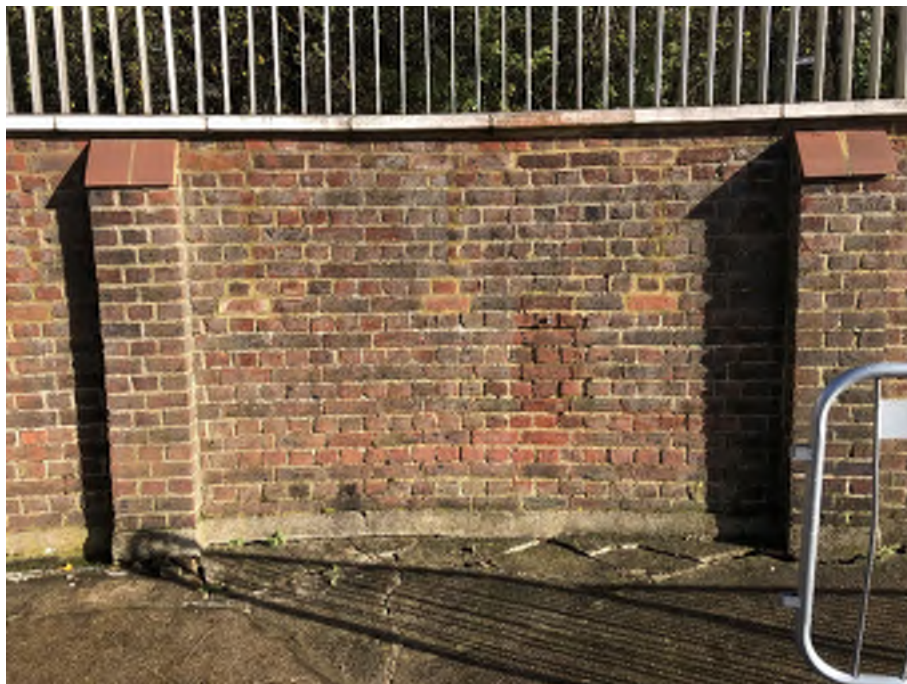
Figure 02 – Typical bay.

- 2.2 The north east boundary wall consists of 14 bays of single brick thick wall in English bond measuring 230 mm thick and 1.9 m tall (on the south west elevation) for the majority of its length and is divided by full height brick buttresses on the south west elevation of the wall, each topped with a sloping tile capping. Each buttress measures 120 mm deep and 345 mm wide keyed into the boundary wall. Mortar joints are largely composed of a cementitious mortar of varying ages. The boundary wall is topped by a grey coping stone which protrudes beyond the inner and outer faces of the wall by 65 mm. Atop the coping stone, a metal fence has been attached to limit entry and minimise wind loading on the wall (see Figure 02).

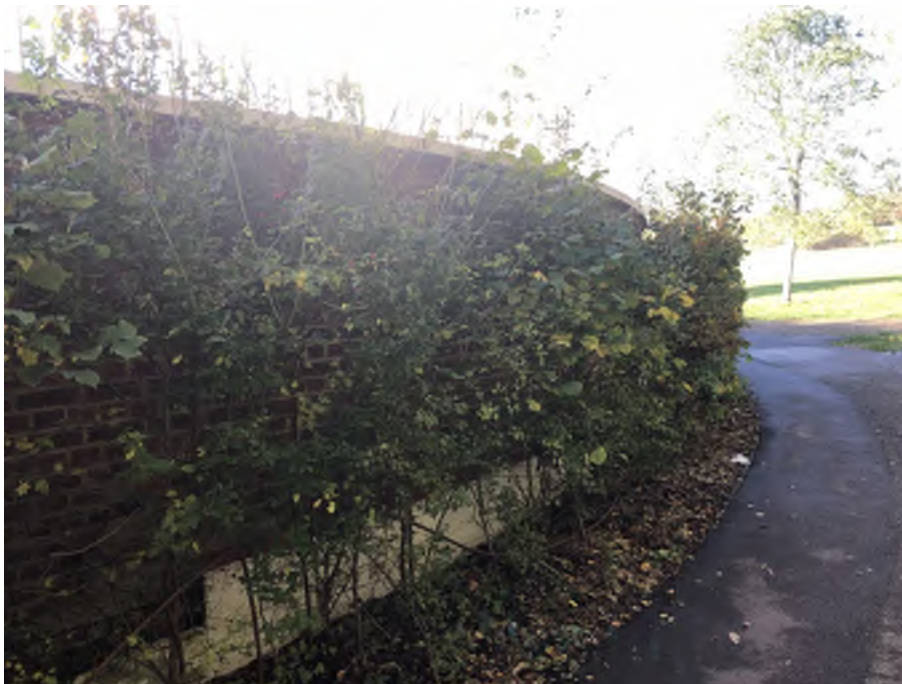
- 2.5 Hedges are planted along the entire perimeter of the boundary wall, limiting access to and visibility of the north east elevation (see Figure 03).

**Figure 03 – View of the north eastern elevation of the boundary wall.**

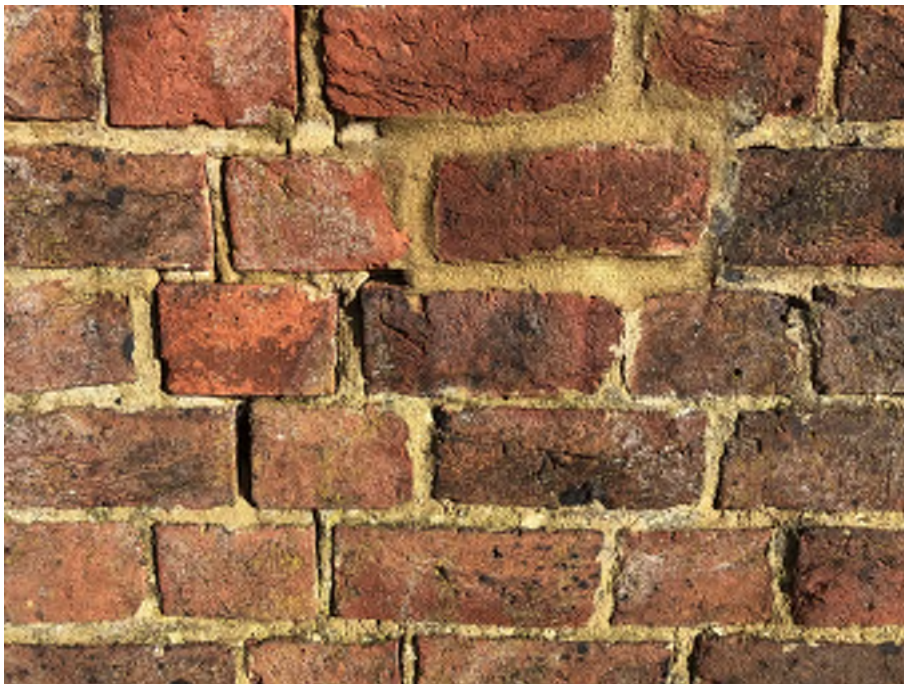
- 3.4 Following our inspection, the lean of each bay was tabulated and their stability assessed.
- 3.5 The bricks are in generally good condition with minimal spalling or cracking (see Figure 04).

- 3.6 The pointing is of varying age, aspect and condition. Large areas of apparently recent cementitious repointing were observed on the south west elevation of the wall, presumably to replace deteriorated mortar and repair cracks. Where cracks have been repointed some have since reopened, while others remain closed (see Figure 04). This indicates that the mechanism causing the cracking is active.

**Figure 04 – Representative area of south west elevation showing the relatively good condition of the bricks and variable age and condition of the pointing mortar.**

- 3.7 Otherwise, recently repointed mortar joints are in generally good condition although in some cases the profile of the joint is such that accumulation of water is probable. Older mortar joints are in generally good condition although some locations of degraded mortar are present so removal of degraded mortar and repointing with a sympathetic mortar mixture is recommended.

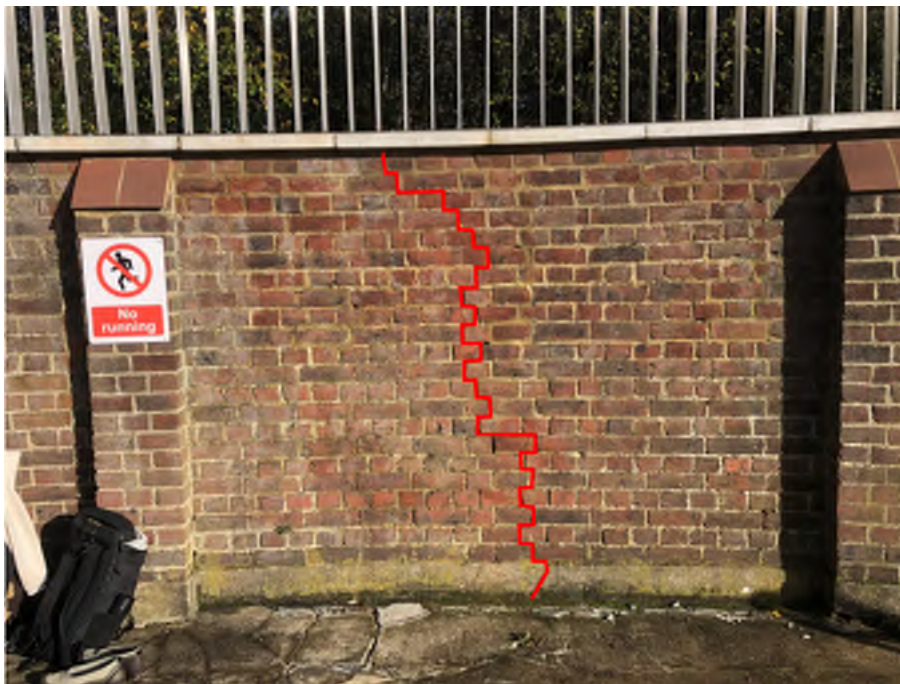
- 3.9 Vertical cracks, either open or recently repointed, are present across all inspected bays of the wall. In five of the seven inspected bays these cracks extend over at least half the height of the wall. Cracks are also present at most of the junctions between the buttresses and the wall.

**Figure 05 – Typical vertical crack on the south west elevation of the wall (red line indicates location of crack).**

5.2.1 Crack Remediation – To remediate the vertical cracks that have formed on the south west and north east elevations, Helibar reinforcing bars are to be installed within the mortar bed joints at suitable intervals.

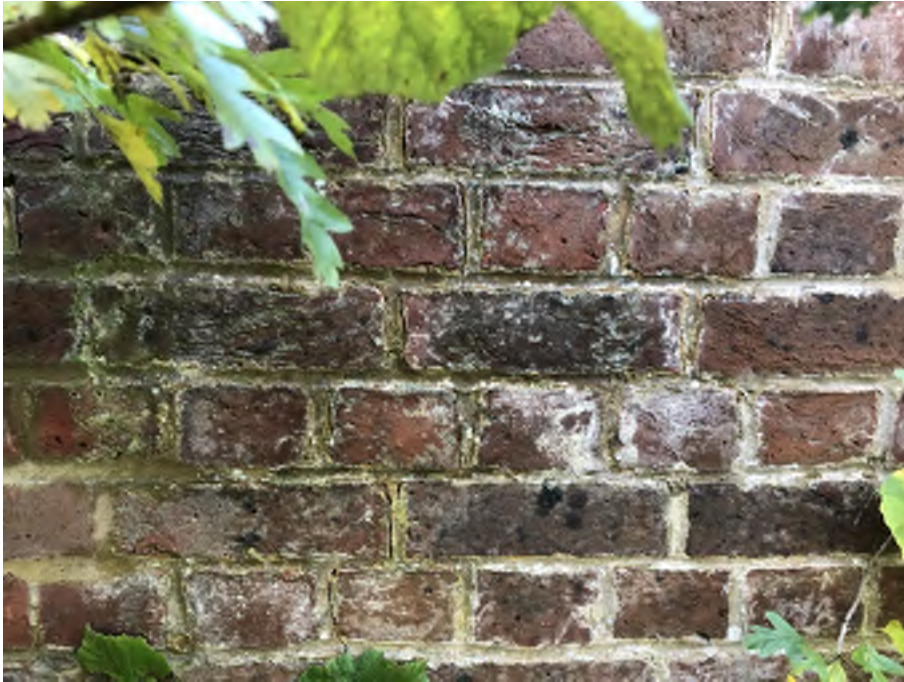
**Figure 06 – Typical vertical crack on north east elevation of the wall.**

- 3.10 Vertical cracks are also present on the north east elevation of the wall which generally extend over its full height (see Figure 06), although they are fewer in number than on the south west elevation. The position of these cracks broadly aligns with the position of the buttresses on the opposite side of the wall.
- 3.11 Horizontal cracks are present across the entirety of the inspected length of the wall between the base and the concrete terracing. The latter is generally in poor condition with fragments of the concrete pushed upwards along the length of the wall (see Figure 07).

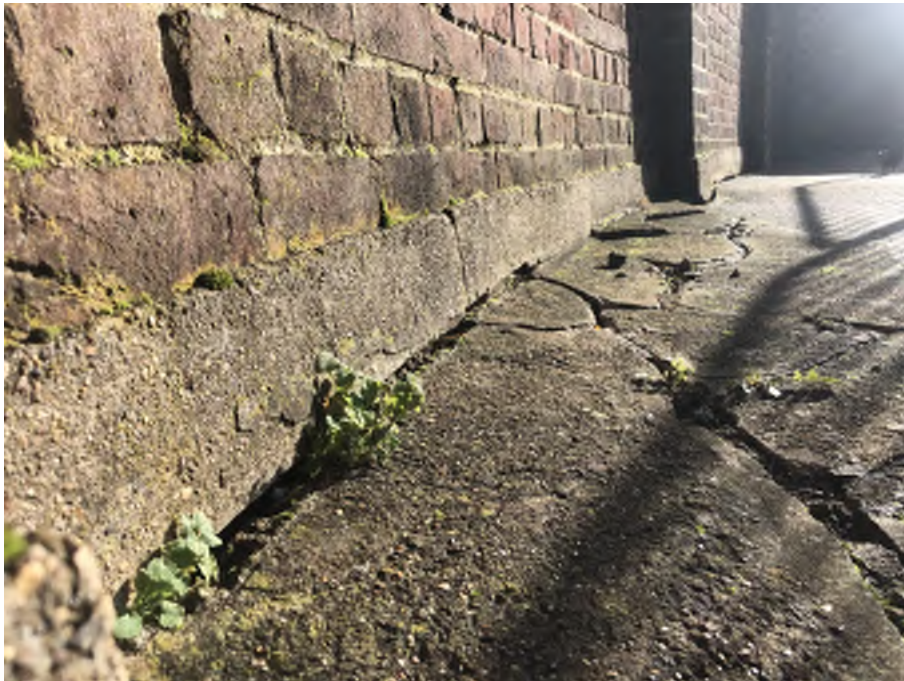
**Figure 07 – Typical horizontal crack along the base of the wall showing uplift of concrete sections.**

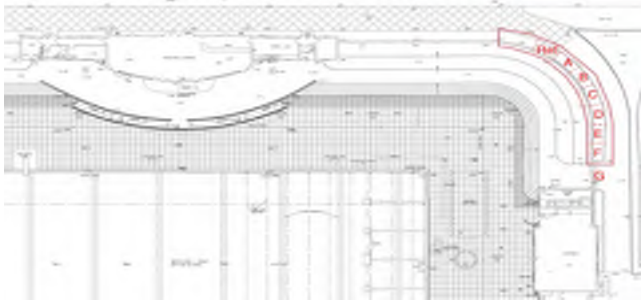
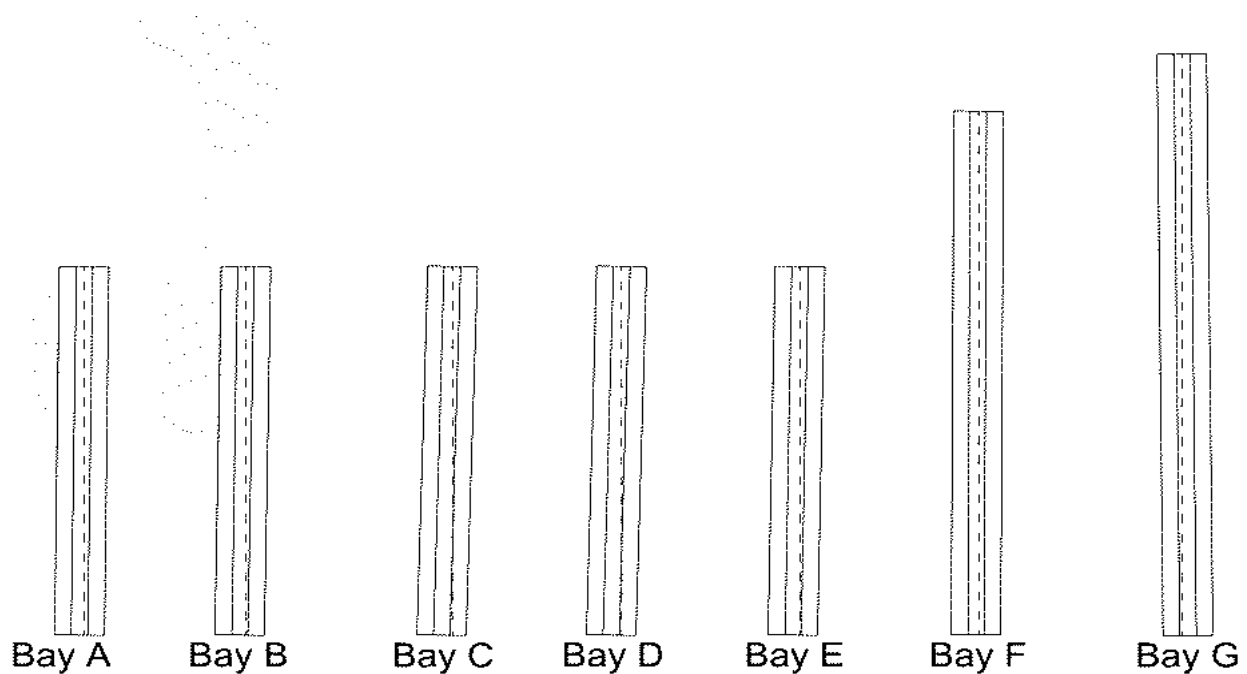
**Appendix 1 Calculation of Degree of Rotation and Determination of Stability**

- 3.8 Six out of the seven bays surveyed are leaning towards the north east (i.e. outwards) by between 0.3 and 1.5 degrees (9 and 51 mm) from the vertical, compared to the less than 0.1 degrees (1 mm) at the adjacent reference wall reconstructed in 2014. Bay G, closest to the eastern buildings, is leaning inwards by 0.5 degrees (18 mm) from the vertical. Bays C and D are considered unstable while the rest remain stable for the time being.

Bay	Ref.	A	B	C	D	E	F	G
Wall Height (mm)	1900	1900	1900	1900	1900	1900	1900	1900
Top (mm)	19	39	44	70	67	50	21	0
Bottom (mm)	18	16	15	19	18	17	12	18
Difference (mm)	1	23	29	51	49	33	9	-18
Angle - Vertical (°)	0.03	0.69	0.87	1.54	1.48	1.00	0.27	-0.54
Stability	Stable	Stable	Stable	Unstable	Unstable	Stable	Stable	Stable
